Geotechnical Aspects of the M = 8.8 February 27, 2010 Chile Earthquake

Geo-engineering Extreme Events Reconnaissance Turning Disaster into Knowledge

M = 8.8 Chile Earthquake

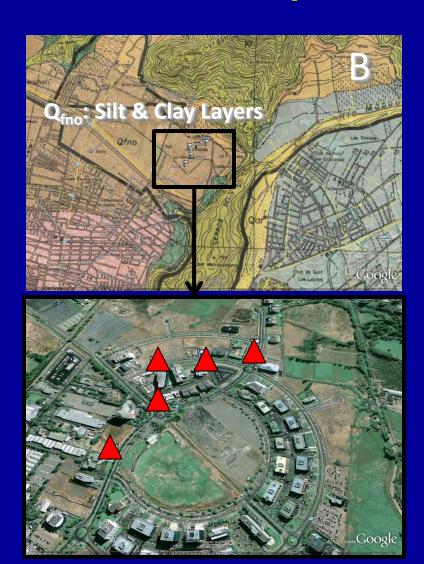
Localized Damage – Site Effects?

H/V peaks: 0.5-2sec (Bonnefoy et al, 2008)

Damage to 5 to 20-story buildings

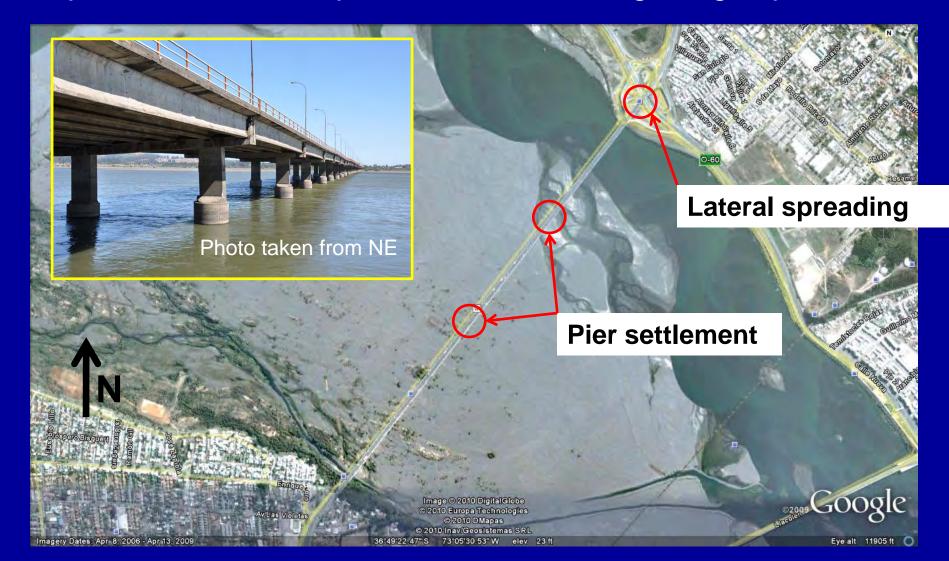
Juan Pablo II Bridge, Concépcion

Bent damage due to lateral spreading on NE approach Liquefaction-induced pier settlements along bridge span

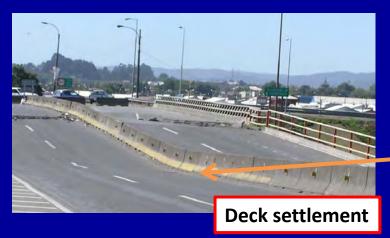
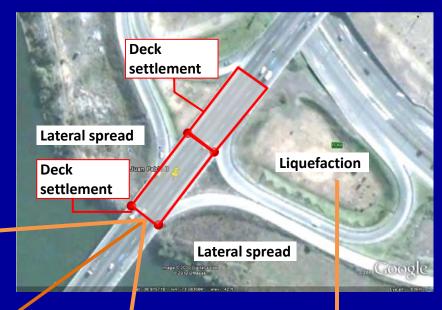
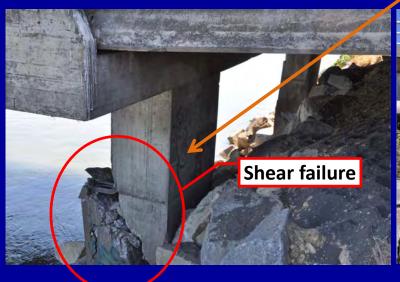
Juan Pablo II Bridge

Lateral spreading and bridge bent damage on NE approach

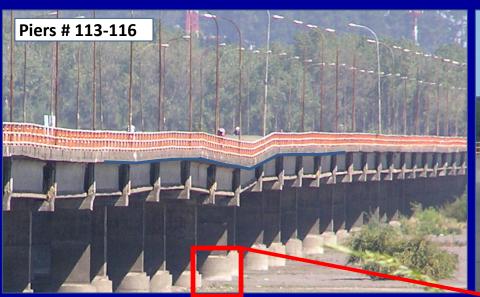
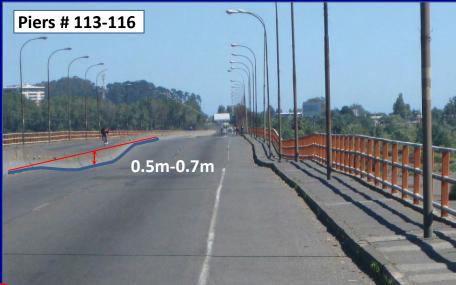
Juan Pablo II Bridge

Liquefaction-induced pier settlements along bridge span

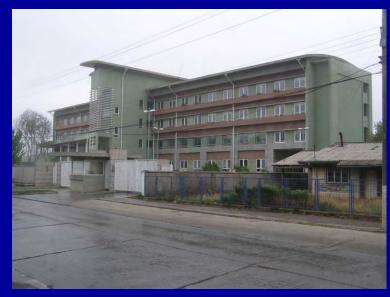
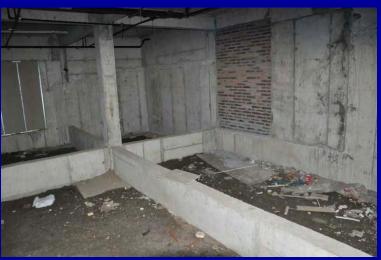
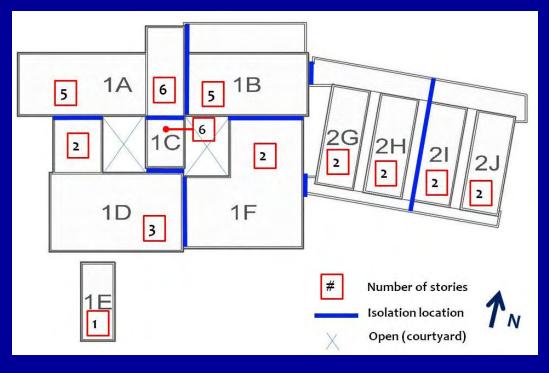
Effects of Ground Failure on Buildings Hospital in Curanilahue

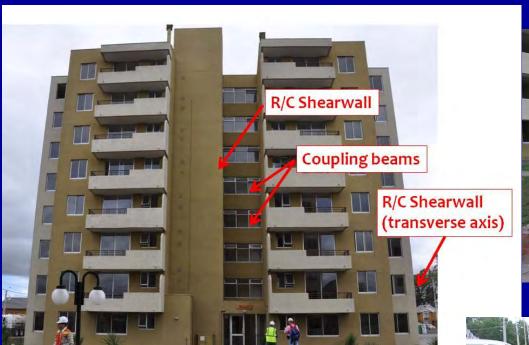
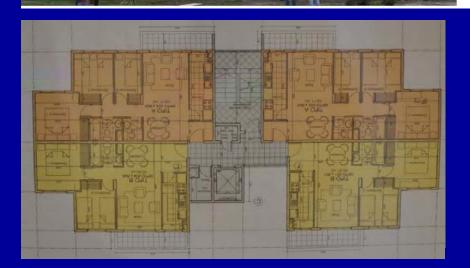
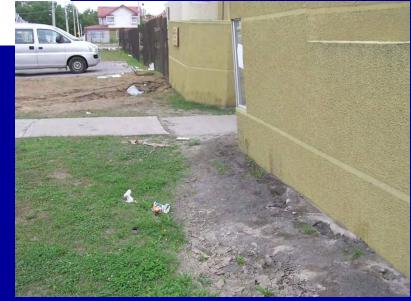
Effects of Ground Failure on Buildings Four 8-Story Condominiums, Concépcion

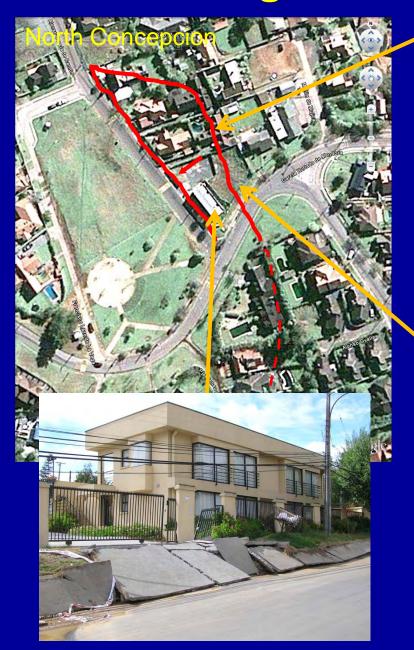
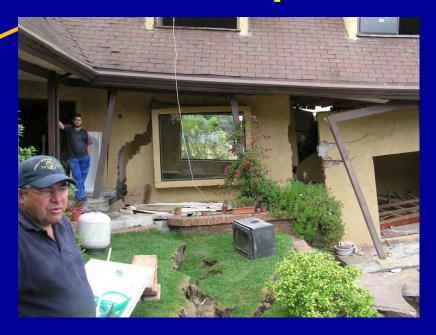
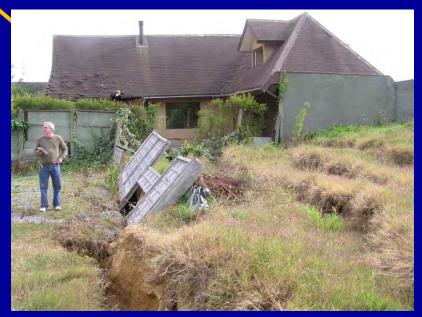
Slide Damages Homes But Not Apartments

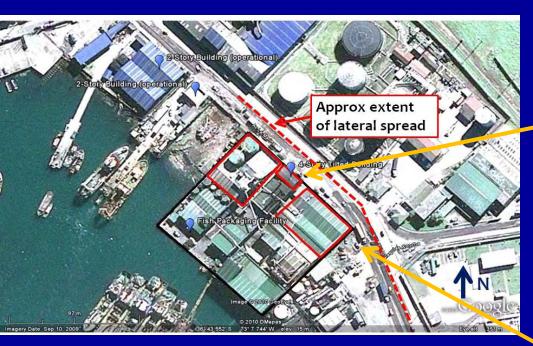
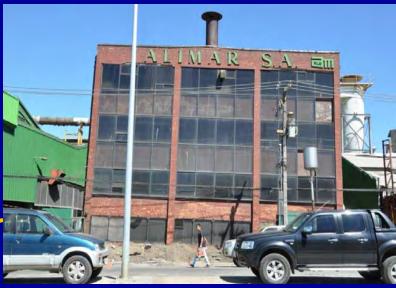
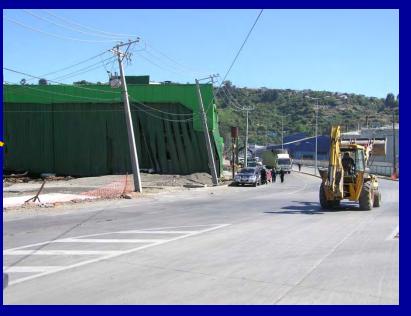
Lateral Spreading Effects on Industrial Facilities Fish Packing Facility, San Vicente

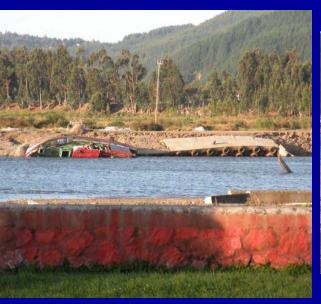
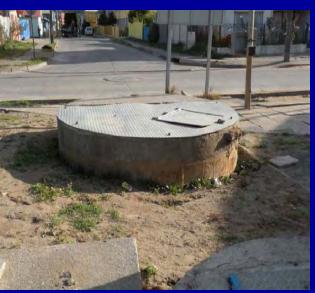
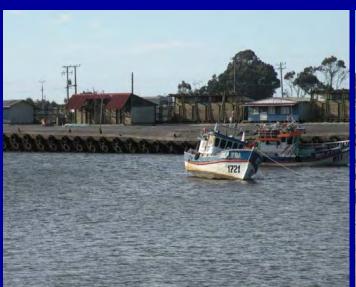
Lebu (Fishing Port & Village)

Uplift (~2m), quay wall failure, liquefaction – fishing industry devastated

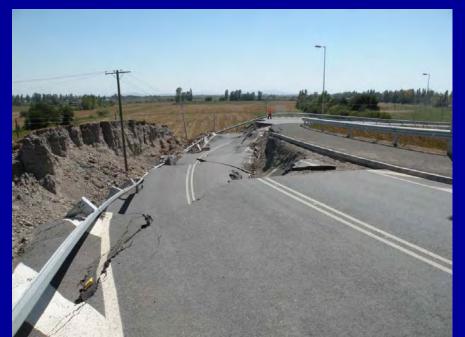
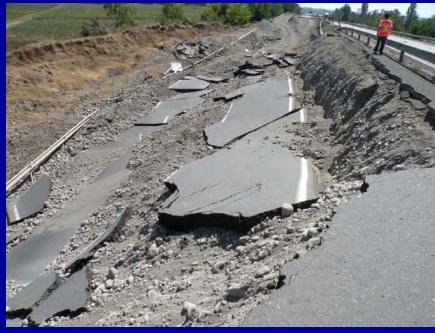
Embankment Failures along Highway 5

Possible liquefaction of thin seams in foundation soils led to translational failures of highway embankments

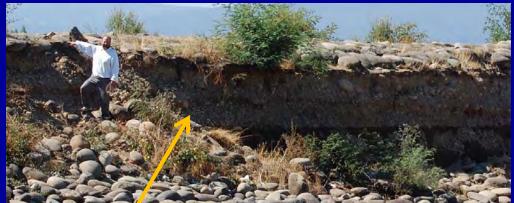
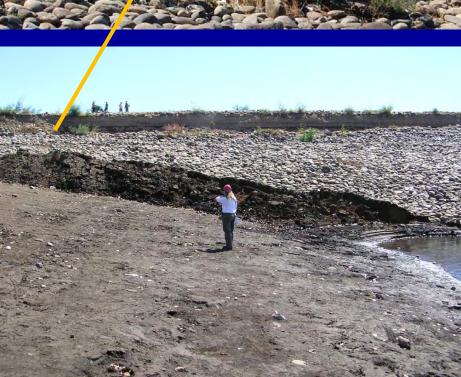
Coihueco Zoned Earth Dam Upstream Slope Failure

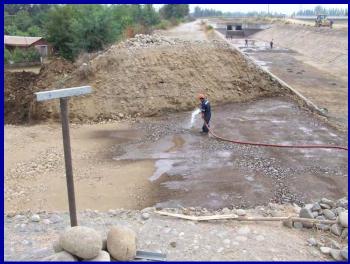
Levee Breach

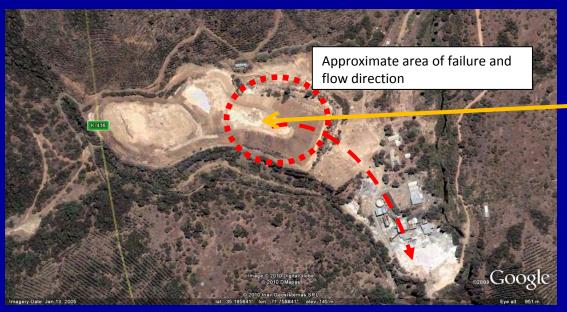
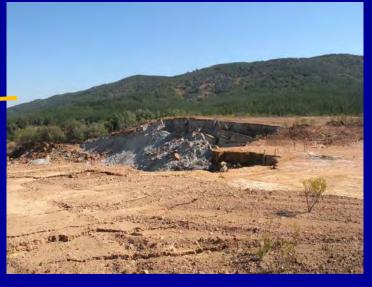
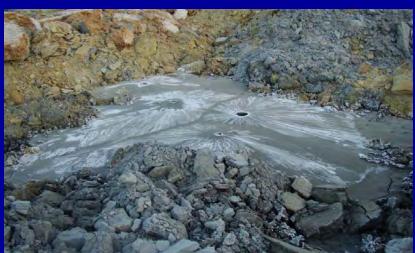
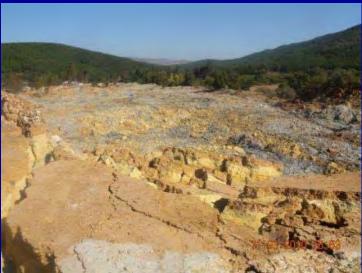
Las Palmas Tailings Dam Failure
