Preliminary Reconnaissance Report - 12 January 2010 Haiti Earthquake

Eduardo Fierro and Cynthia Perry of BFP Engineers, Inc.

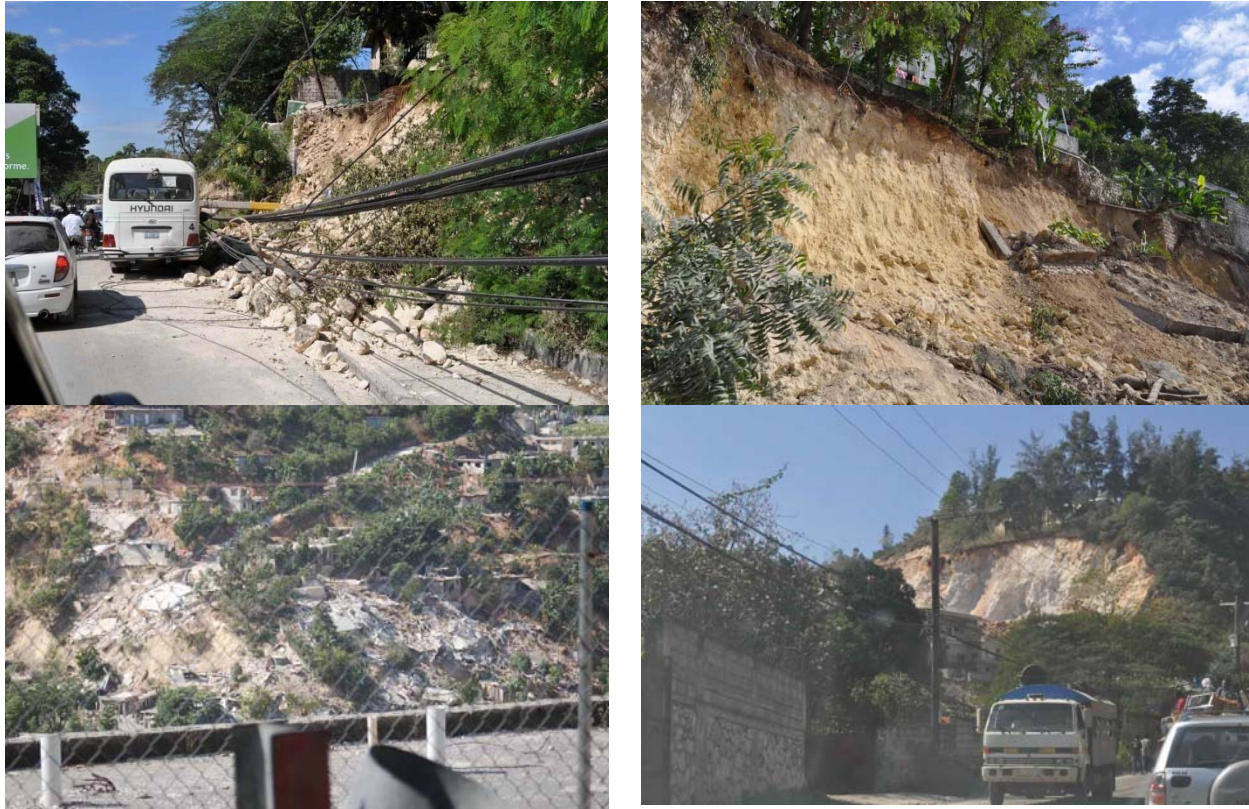
The epicentral region includes low-lying coastal areas as well as coastal mountains with elevations in the range of 500-2000 meters. Landslides were a common sight on hillsides surrounding Port-au-Prince. Landslides and rock falls blocked roads, brought down utility poles, and resulted in damage or collapse of many hillside structures. Maps of damaged areas in Port-au-Prince show pockets with relatively more or less damage than the surrounding areas, indicating that local soil conditions may have contributed to the variation in damage. Dramatic evidence of liquefaction and lateral spreading was evident at the port where several docks and port structures were damaged or disappeared completely into the harbor.

Figures 4, 5, 6, 7 (clockwise): Landslide caused collapse of power pole; Failure of rubble and unreinforced masonry retaining walls; Landslide west of Port-au-Prince; Landslides contributed to damage of shanties on hillside near Petion Ville.

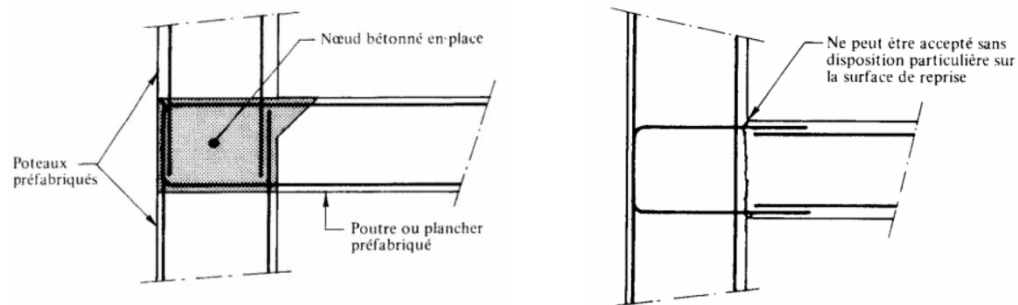
Figure 8: Beam-column joint details A & B from Regles BAEL 91 (Beton Arme aux Etats Limites), 2006. Details show column bars spliced in the beam-column joint and beam bars spliced at the face of the joint

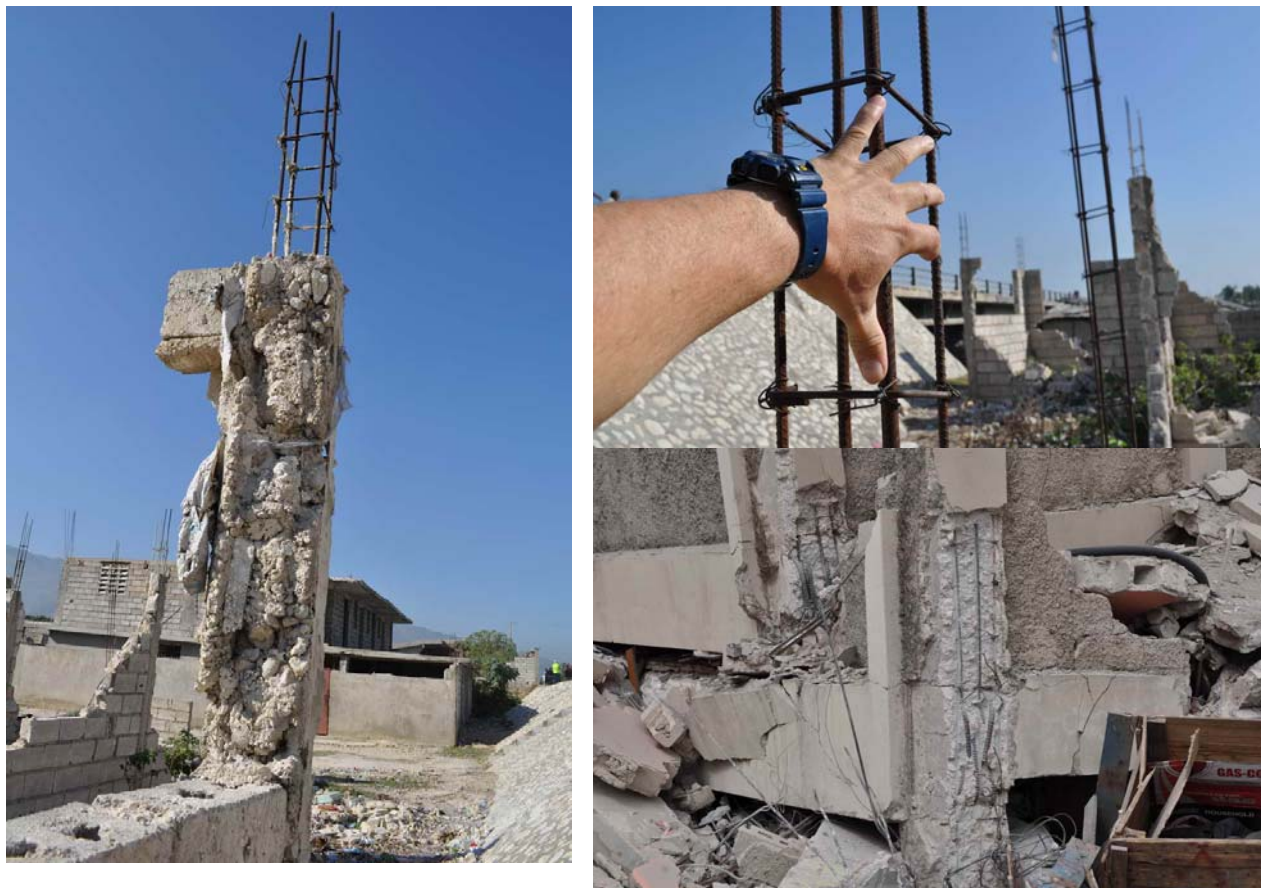
Figures 9, 10, 11 (clockwise): Typical concrete details with undersized members, mixed use of smooth and deformed reinforcing bars, undersized rebar often #3 and #4, shear reinforcing provided by smooth $\frac{1}{4}$ " diameter open hoops, no hoops in joint. Columns often sized to match width of 6" or 8" CMU block. Poor quality concrete, lack of consolidation, and corrosion of bars also seen widely. The combination of heavy construction and the complete lack of ductility resulted in thousands of collapsed structures and many thousands of fatalities.

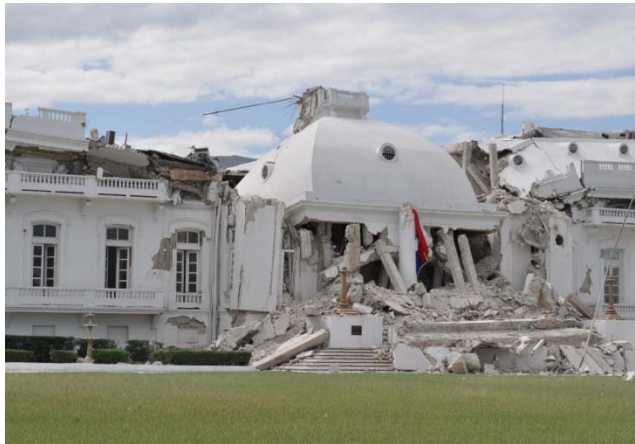
Figure 12: Presidential Palace. E-shaped plan; completed 1920; partial collapse. Many 1st story windows unbroken but cupola and much of 2nd story collapsed.

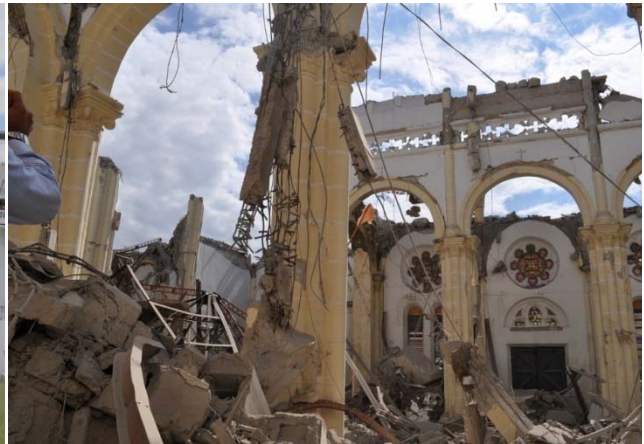
Figure 13: Port-au-Prince Cathedral. Built 1884-1914; collapse of roof and upper walls. Archaic reinforcing dangling from above; light steel roof framing visible in wreckage.

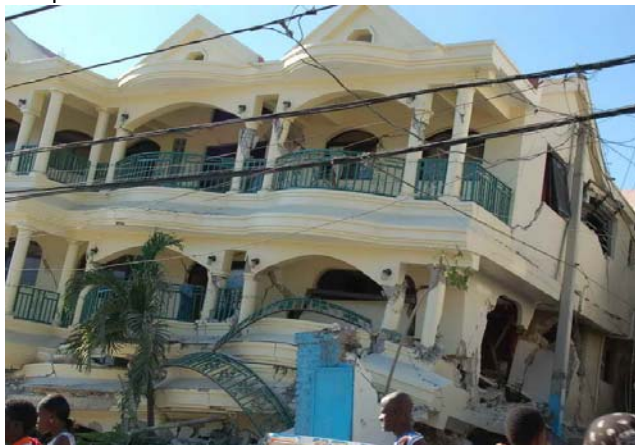
Figure 14: Modern 4-story colonial-style building (est. 5 yrs old), partial collapse of bottom 2 floors.

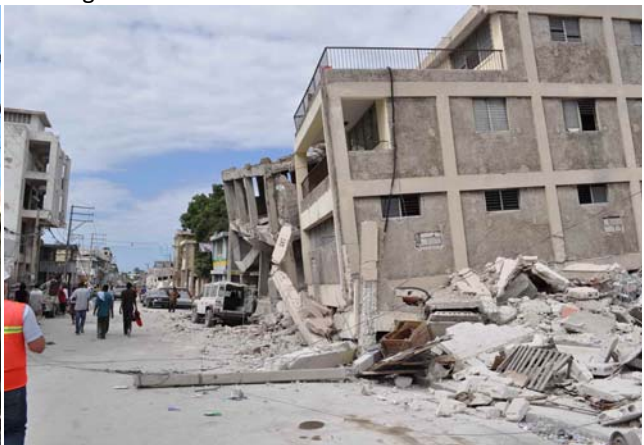
Figure 15: 5-story building; bottom two stories collapsed. Close-up of 1st-2nd story joints in Fig. 11.

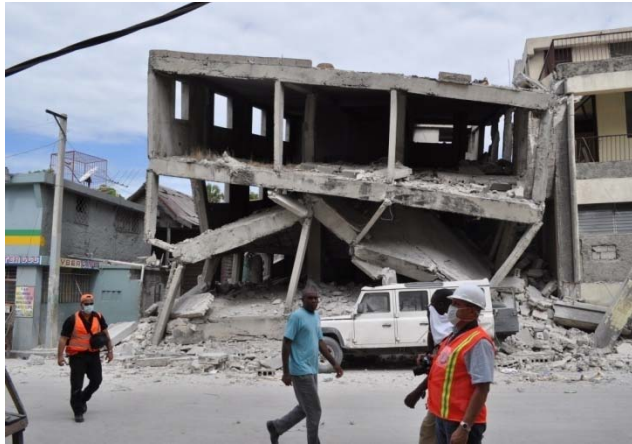
Figure 16: 3-story structure; never completed; collapsed at 1st floor and leaning on adjacent structure. Few transverse walls, heavy slabs, undersized and weak columns, and complete lack of ductile detailing all contributed to collapse.

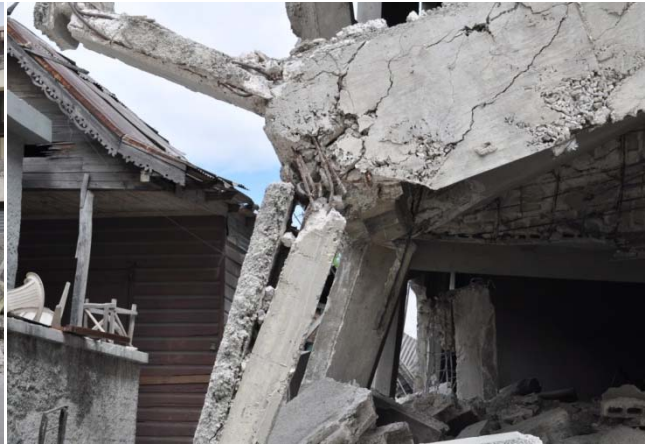
Figure 17: Close-up from 3-story collapse at left. Column dimensions 6"x12". Note column bars spliced inside the beam-column joint.

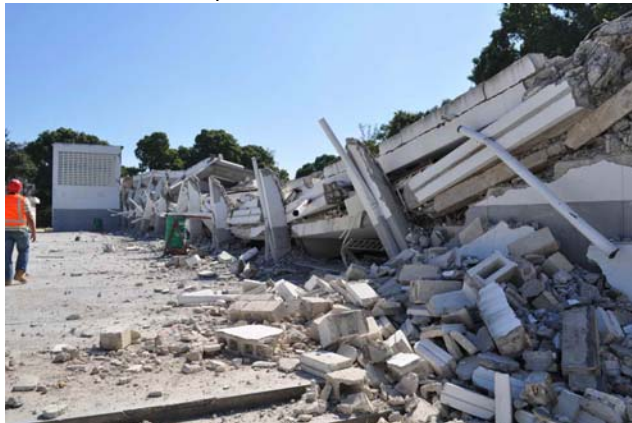
Figure 18: 2-story school in Leogane; complete collapse with many fatalities.

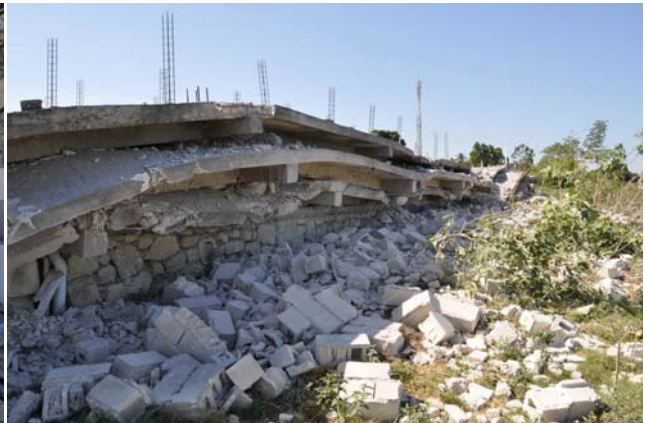
Figure 19: 3-story university building in Leogane, still under construction with weak columns and little or no masonry infill. Complete collapse.

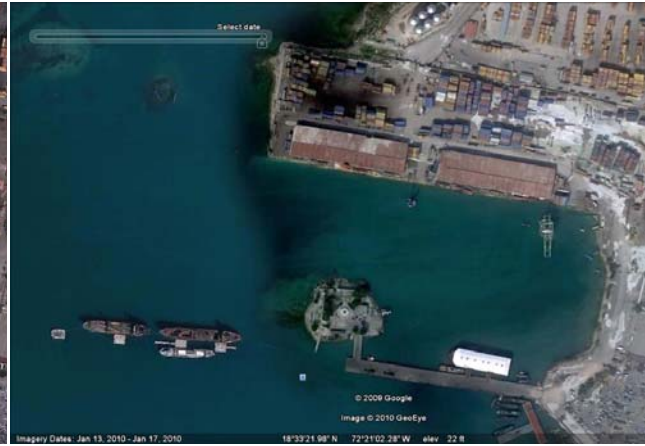
The infrastructure of Haiti will take many years to recover from this devastating earthquake. The main port in Port-au-Prince had two primary docks; one of these collapsed completely and the other suffered a partial collapse (see Figures 20-22). The adjacent fuel port lost the seaward end of the dock and the piles supporting the remaining section were all misaligned (Figures 23-27). The glazing all fell from the control tower at the international airport and masonry infill walls in the terminal were cracked, closing the airport temporarily. The team visited two electric power plants; neither one was in operation. The first was out primarily due to failures in the distribution system outside the plant; the second was down due to the failure of a fire water tank. The tank farm adjacent to the fuel port suffered extensive damage. Roads and bridges throughout the area suffered damage.

Figure 21: Note traveling crane at top of photo now immersed in water; no sign of dock. Half of dock at bottom of photo also gone. Note white patches onshore indicating residue from sand boils.

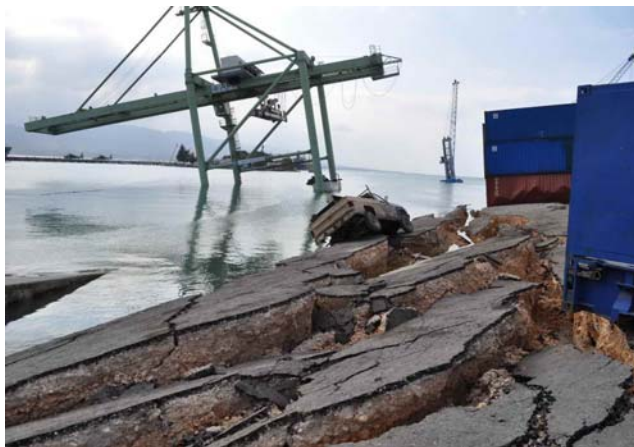
Figure 22: Commercial port; dock collapsed and crane immersed underwater. Signs of liquefaction, sand boils, and lateral spreading throughout port area.

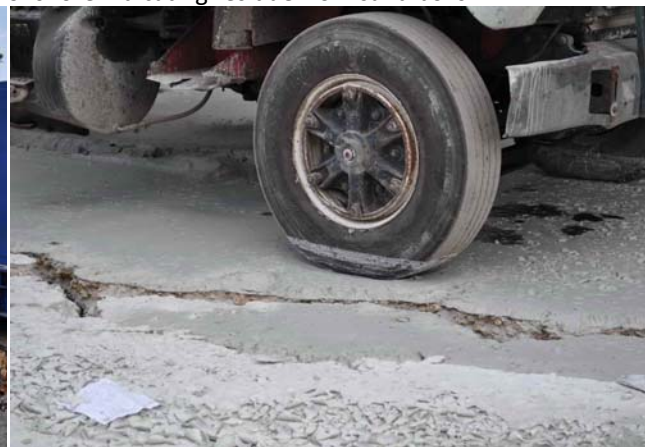
Figure 23: Mark on tire indicates height of sand flow at commercial port.

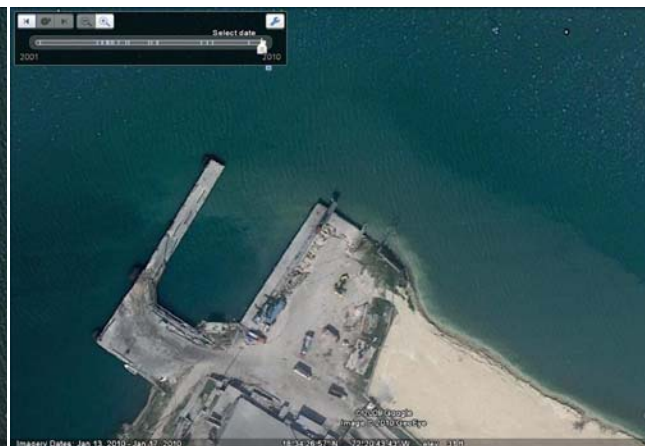
Figure 25: Fuel port; dock collapsed (note green truck visible hanging off end of remaining section).

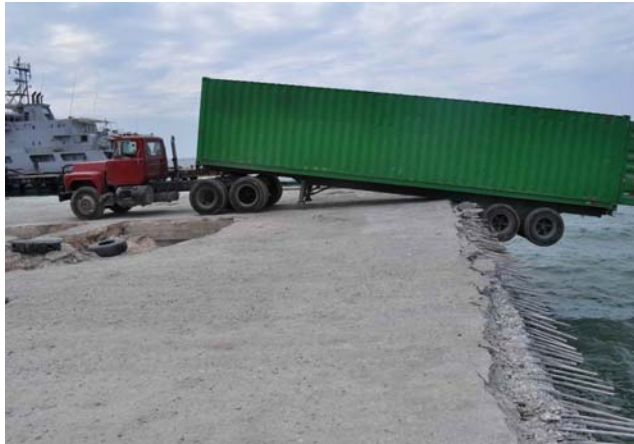
Figure 26: Fuel port, end of remaining section of dock.

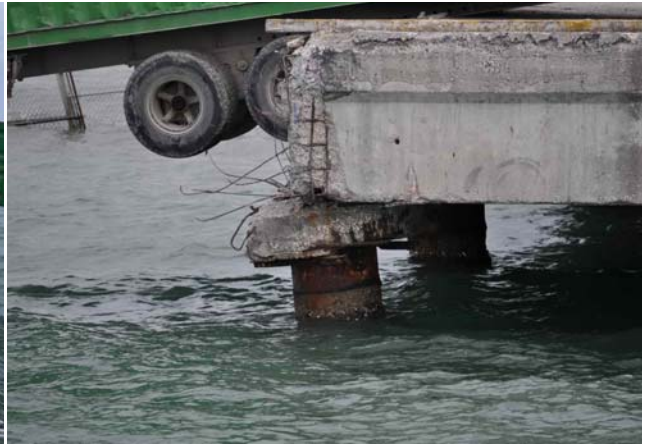
Figure 27: Precarious support for remaining section of dock at fuel port; all piles misaligned.

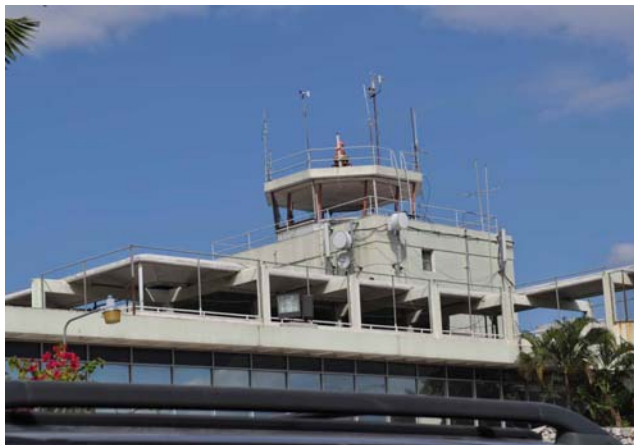
Figure 28: All glazing fell from control tower; Port-au-Prince International Airport. Infill walls in terminal cracked; mostly nonstructural damage.

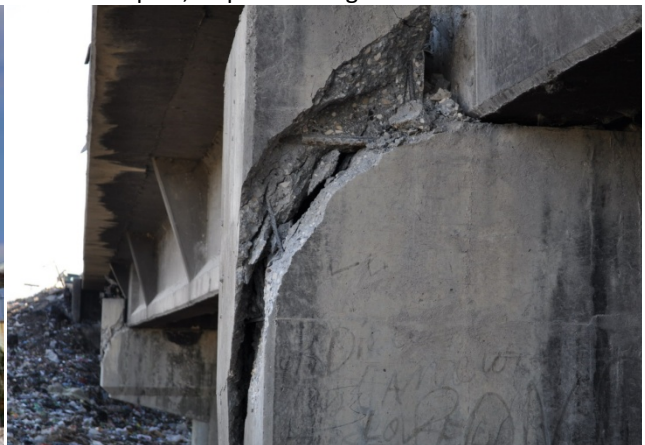
Figure 29: Bridge along main road into Port-au-Prince from the east. Damage at girder seats; all locations.

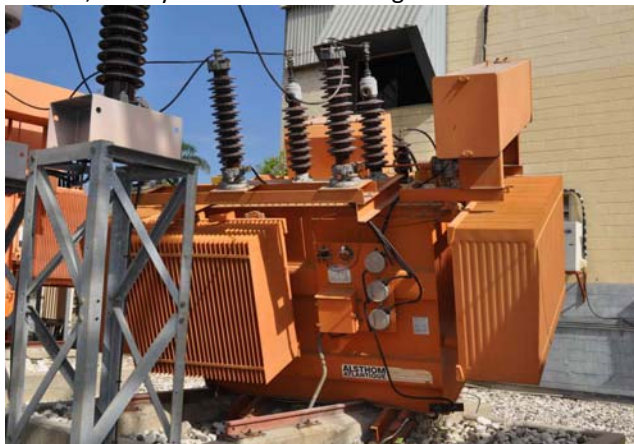
Figure 30: Electric power plant; one of six unanchored transformers jumped the rails. No damage to ceramic components.

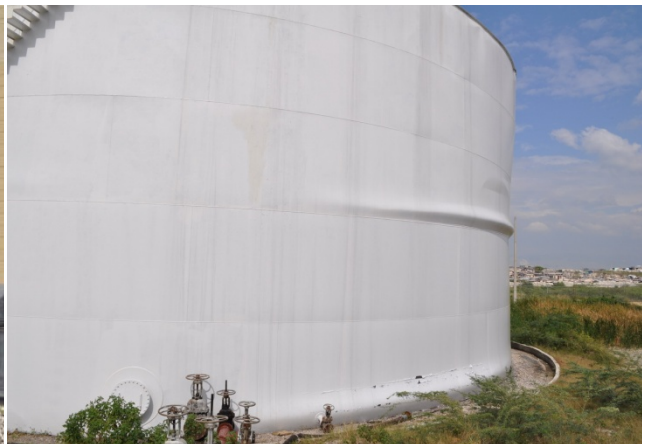
Figure 31: Tank farm at fuel port. Widespread tank damage; tank shown had "elephant foot" and "elephant knee."
