PERFORMANCE OF REINFORCED ADOBE HOUSES IN PISCO, PERU EARTHQUAKE

A. San Bartolomé¹, D. Quiun¹, L. Zegarra¹

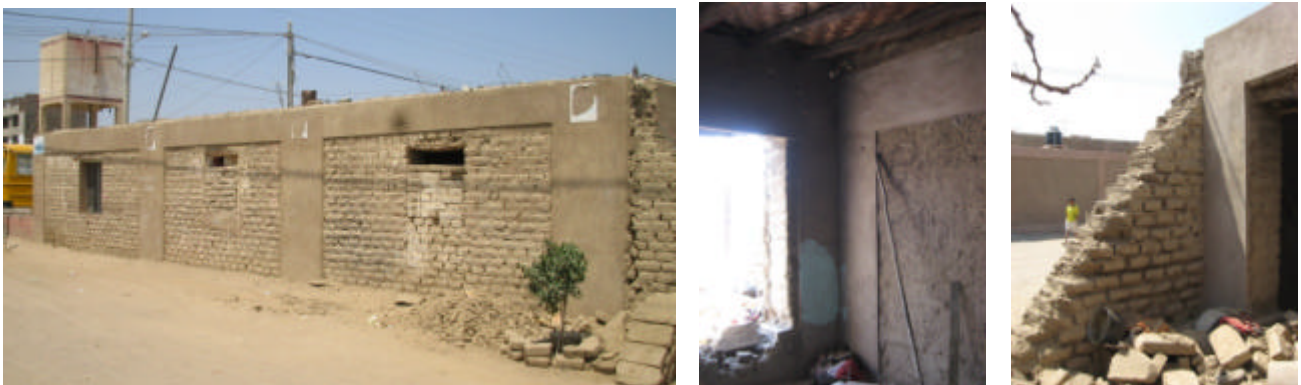
All 5 existing adobe houses retrofitted with strips of wire mesh in the affected area of Ica had an excellent seismic behavior without damage, while neighbor traditional constructions had massive failures, wall cracks and collapses. In figures 8 and 9 the reinforced adobe house of Guadalupe and unreinforced neighbor houses of traditional adobe, respectively, may be seen a few days after the event. Only the unreinforced wall of the patio, next to the reinforced area, collapsed by overturning; it was not reinforced due to lack of funds of the owner.

Figure 8. Guadalupe retrofitted adobe house without damage (except unreinforced patio wall)

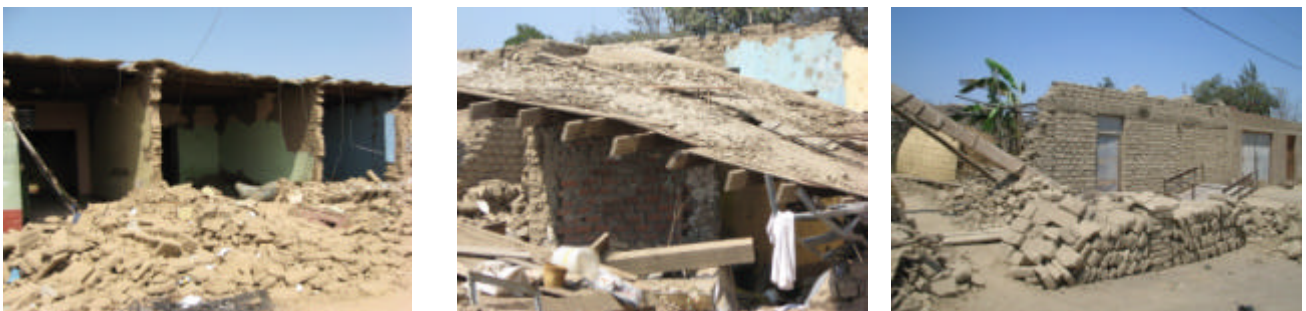
Figure 9. Other adobe houses with severe damage in Guadalupe

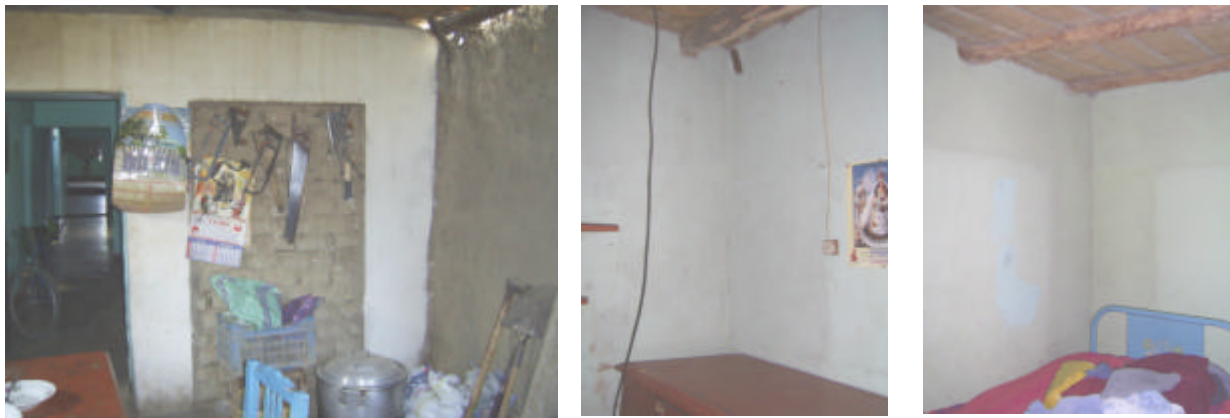
In figures 10 and 11 the reinforced adobe house of Pachacutec without damage and some unreinforced neighbor houses with damage, respectively, are shown a few days after the event.

Figure 10. Pachacutec retrofitted adobe house without damage

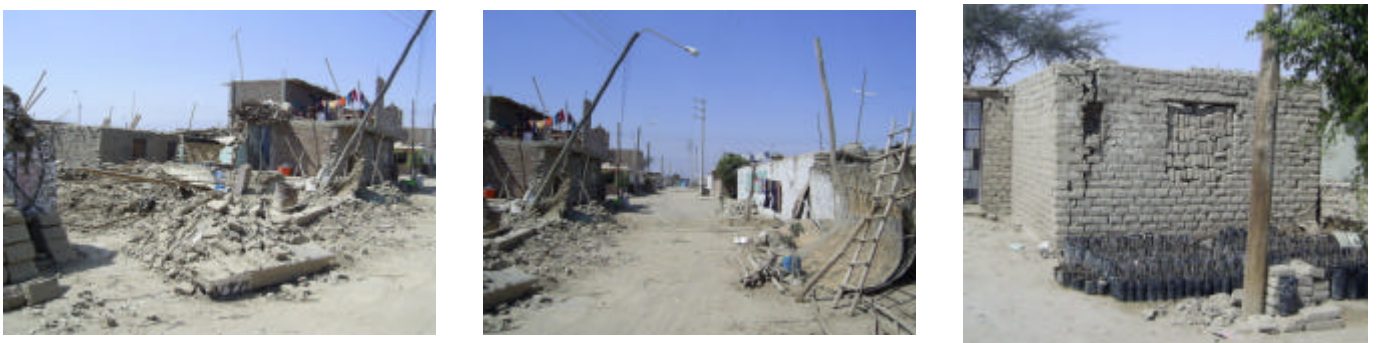
Figure 11. Traditional adobe houses with damage in Pachacutec

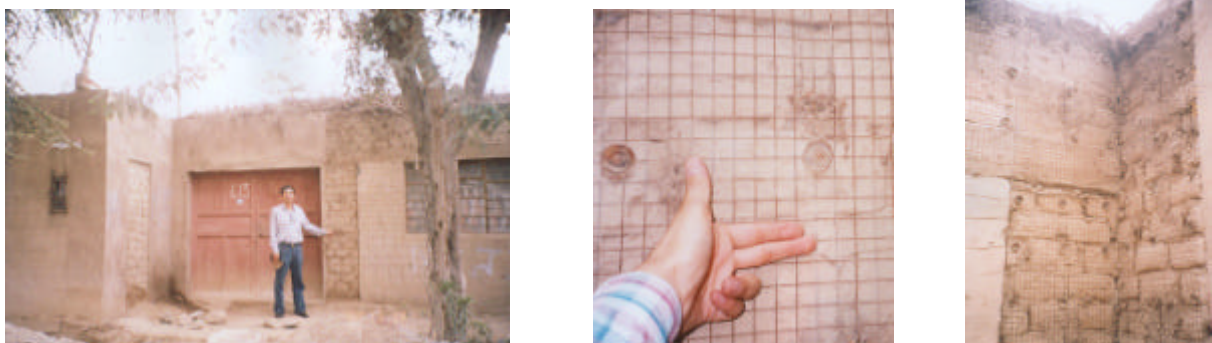
The Parcona house was partly reinforced, leaving a part of the outside mesh without covering and had no damage (fig. 12). This house is used as the station for the accelerograph, in which the foundation soil is sand lime (Tavera et. al., 2007). Other neighbor adobe houses had severe cracks and had to be demolished (fig.13).

Figure 12. Partly retrofitted Parcona house without damage

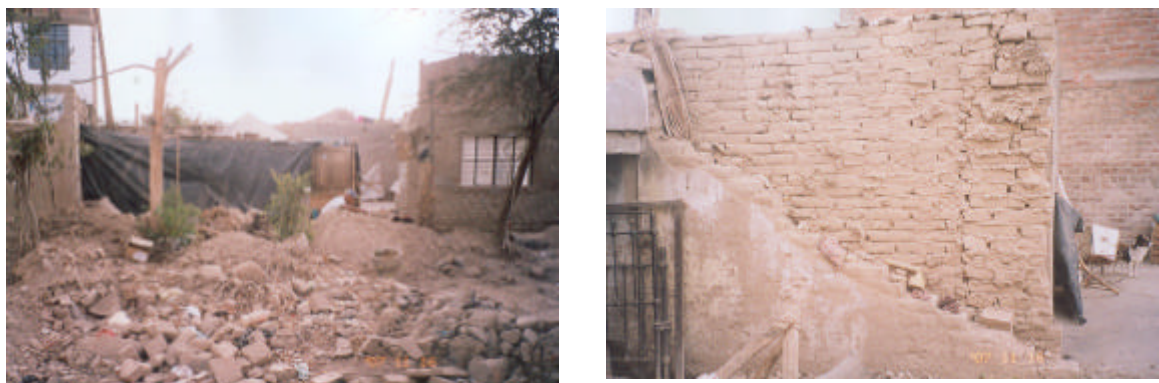
Figure 13. Demolished adobe walls in neighbor houses in Parcona

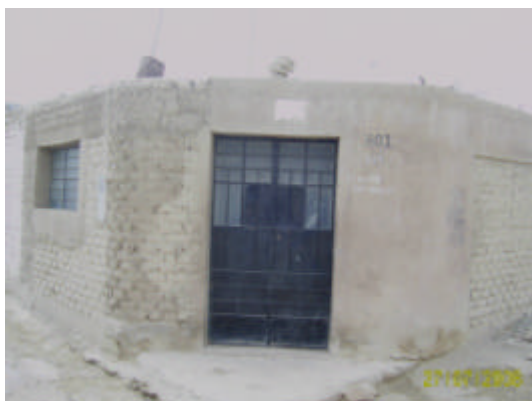
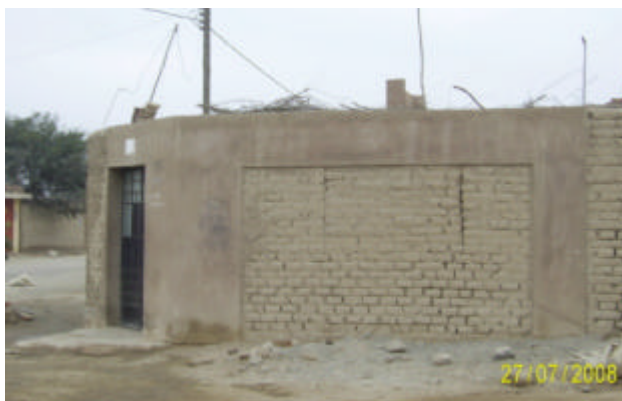
In La Tinguiña, the demonstration adobe house was partly reinforced only in the front room (fig. 14). To the left side in fig. 14 it is observed that the wire mesh has not mortar covering. The back room without any reinforcement had important cracks (fig.15). Similarly, the house in Ica Central was not affected by the earthquake (fig. 16), while other neighbor adobe houses had severe cracks.

Figure 14. Partly retrofitted house in La Tinguiña had no damage.

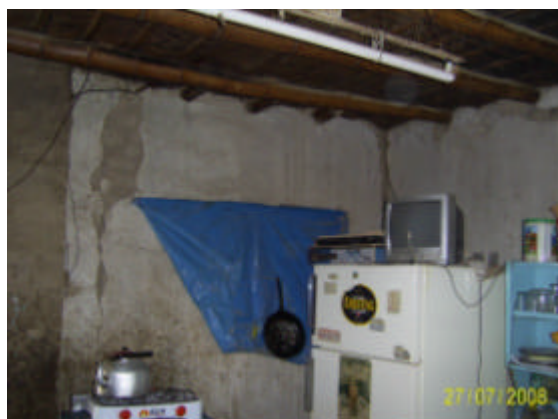
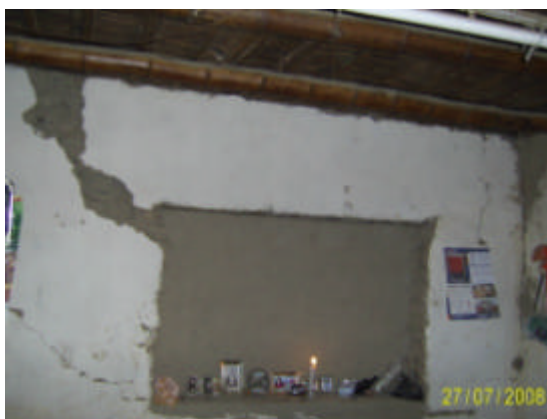
Figure 15. Non reinforced back room of the house in La Tinguiña had cracks.

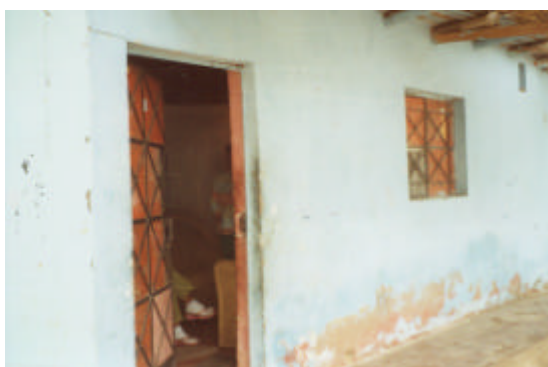
Figure 16. Partly retrofitted house in Ica Central had no damage
