Northridge-USA-17-01-1994

M = 6.7, 4:31 a.m. t = 20 seg, Foco: 20Km

Edición: A. San Bartolomé. Fuentes:

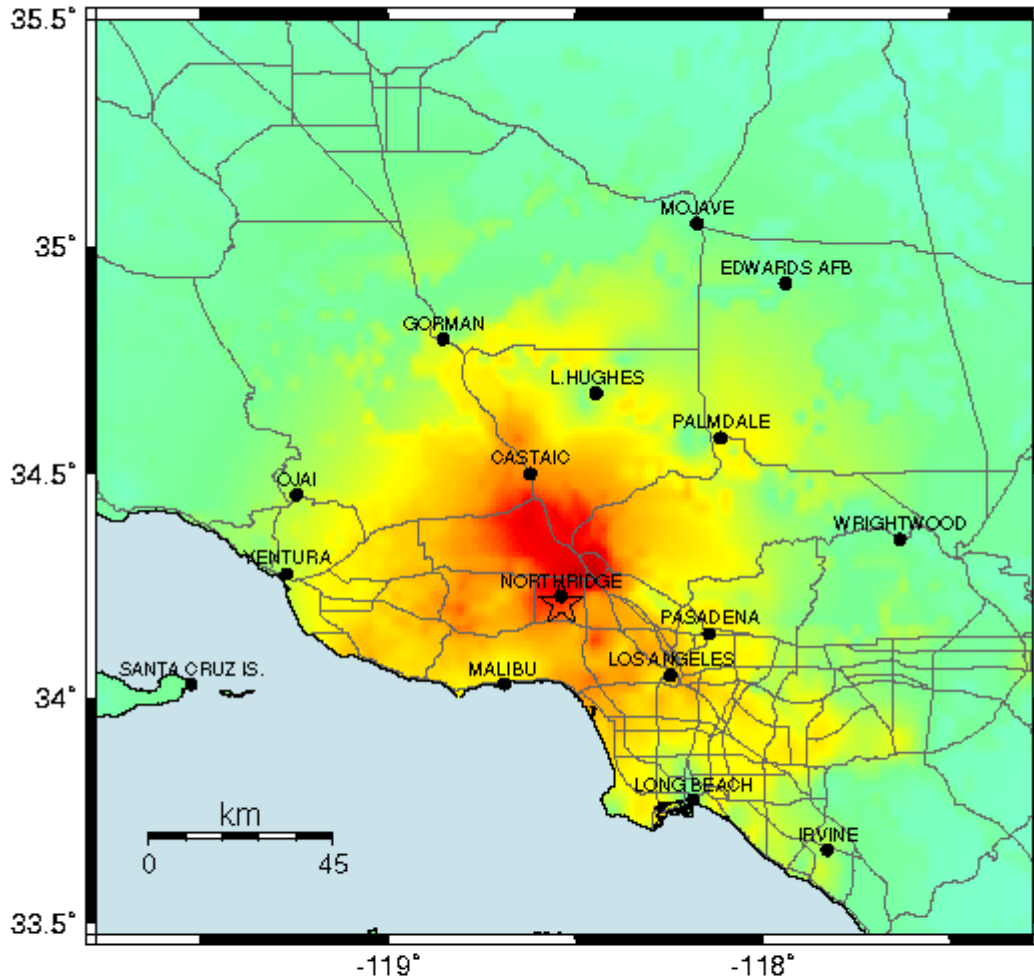
TriNet Rapid Instrumental Intensity Map for Northridge Earthquake
 Mon Jan 17, 1994 04:30:55 AM PST M 6.7 N34.21 W118.54 ID:Northridge

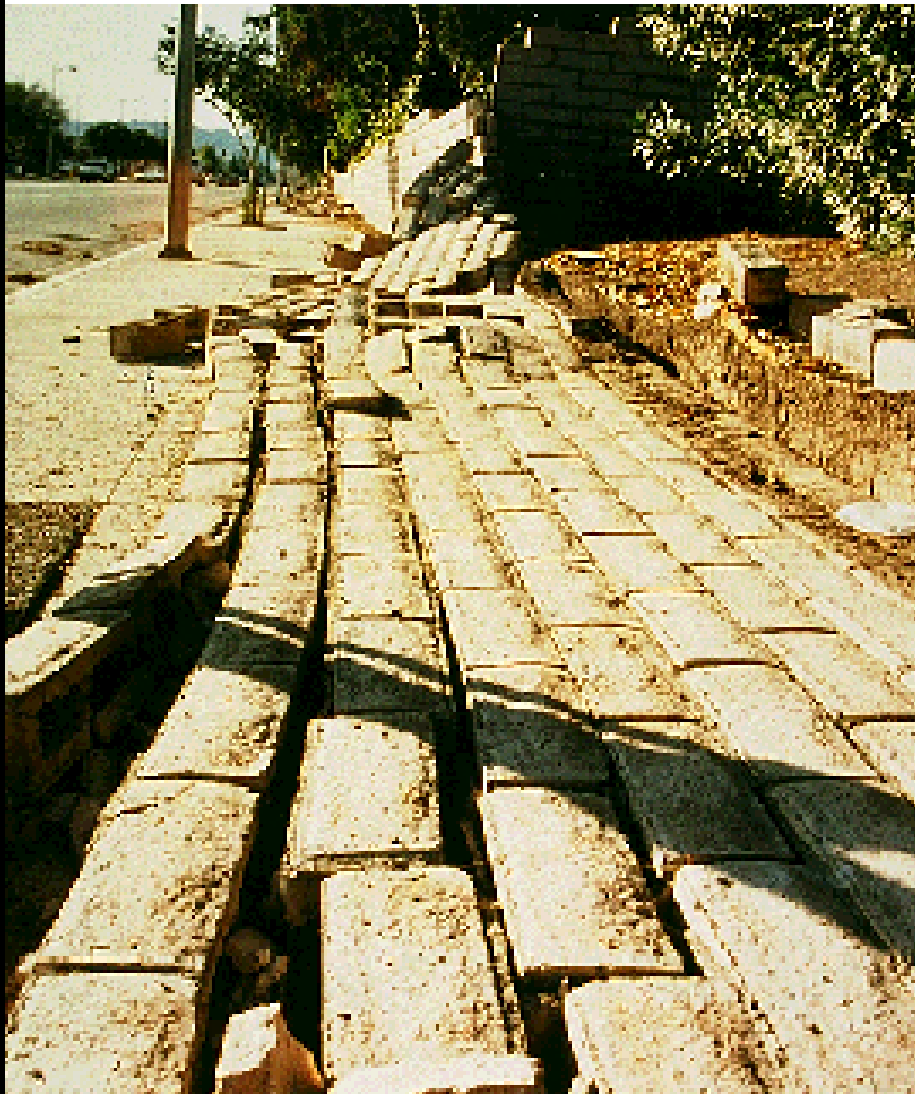
**Cercos hechos con
bloques de concreto**

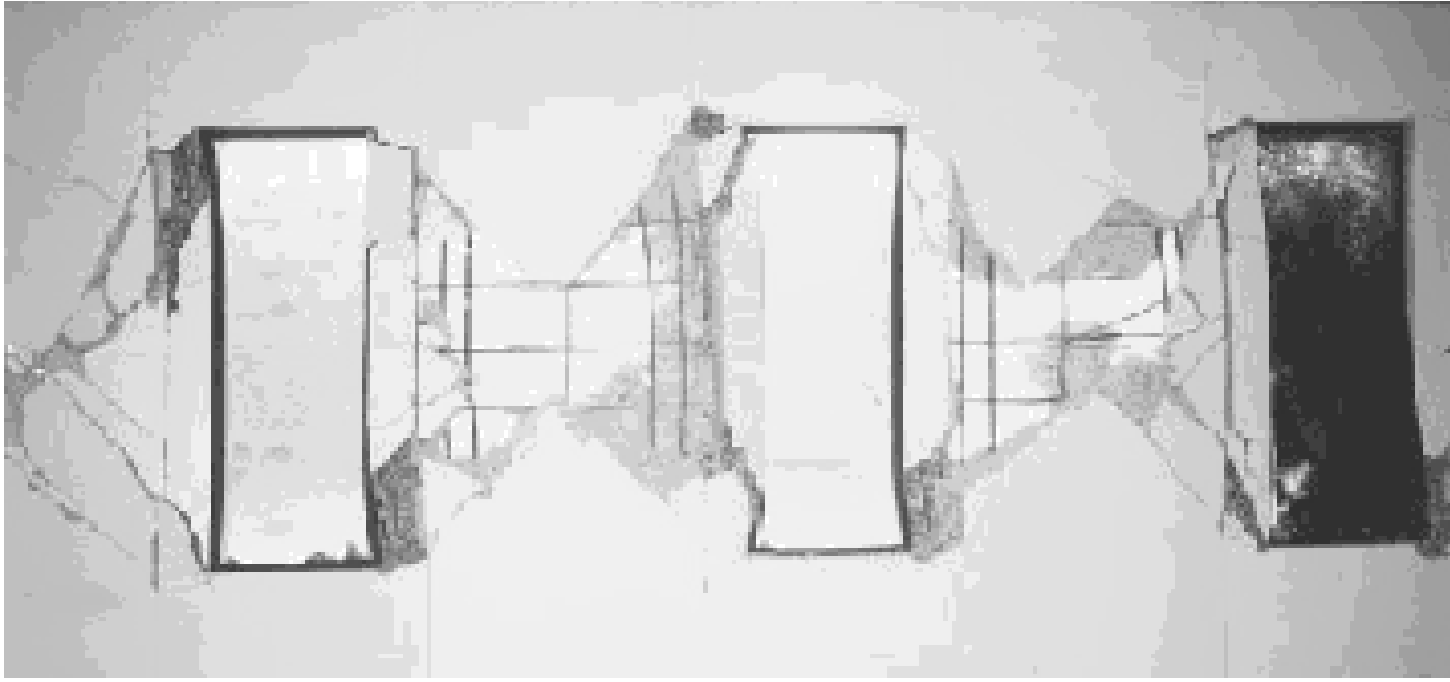
**Talón de un
muro de
albañilería
armada**

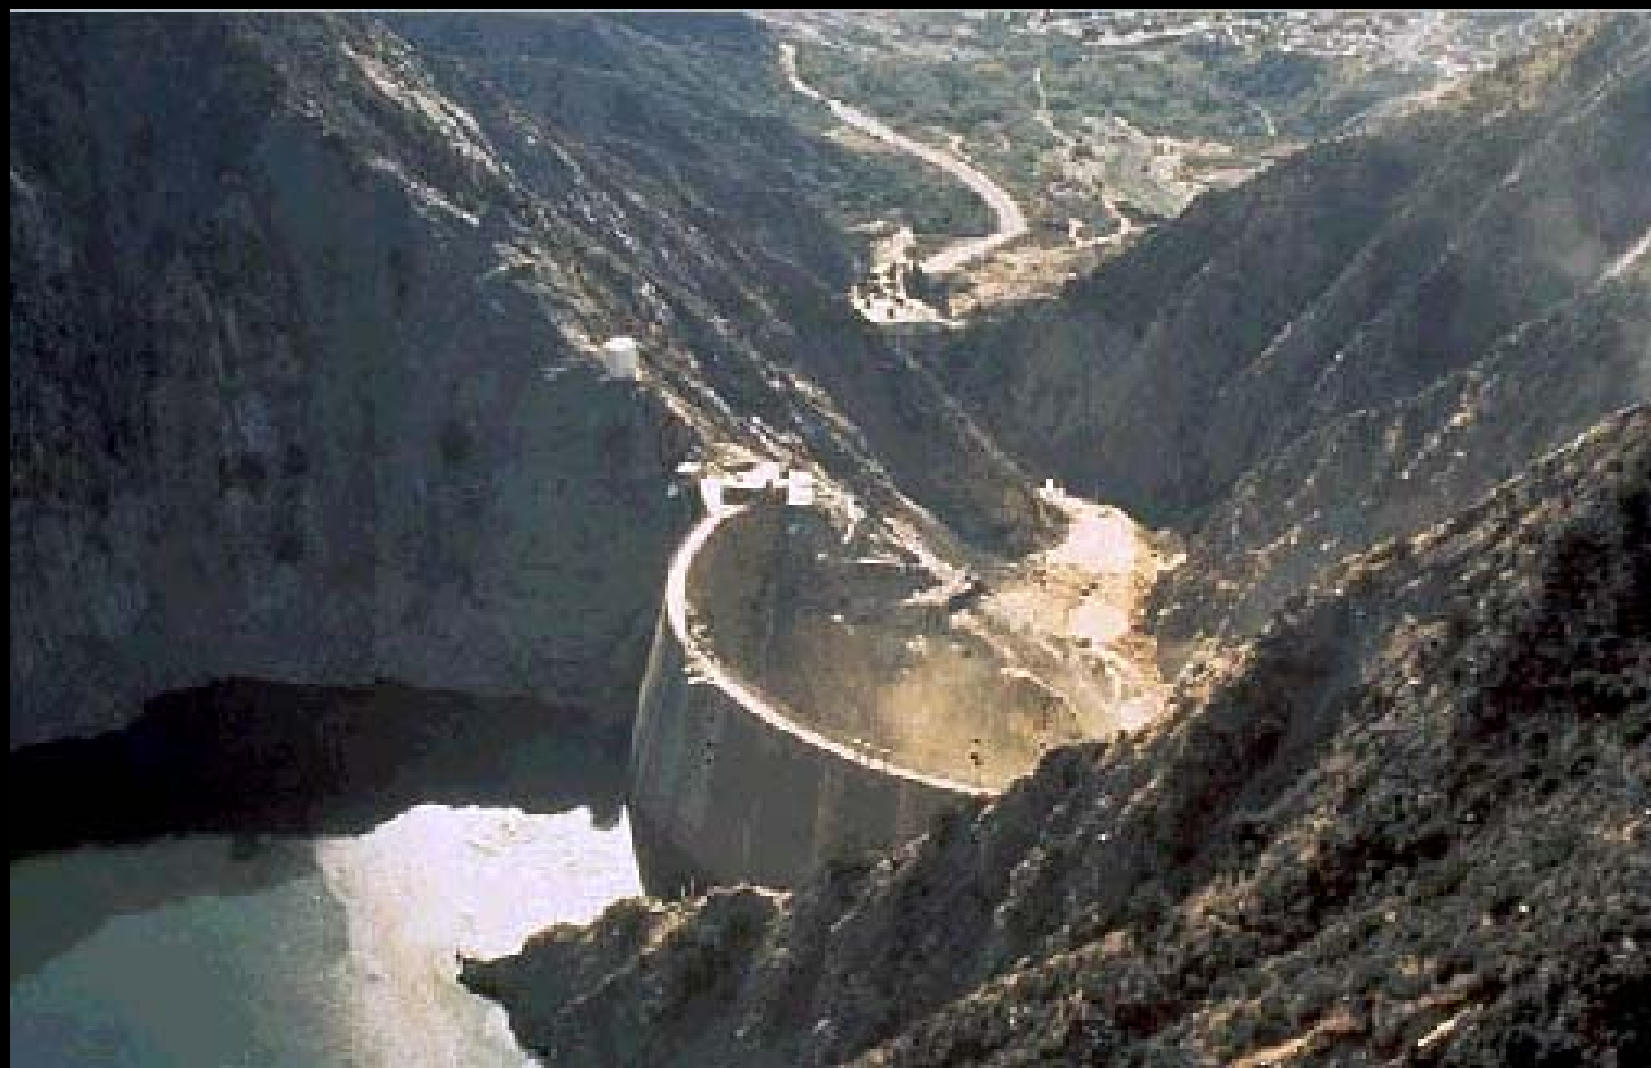
Aerial view of Pacoima Dam where strong ground shaking (over 2g measured on the abutments) caused extensive rock slides, opened a 2-inch wide gap between the dam and its thrust block on the southern abutment, and cracked the southernmost block of the dam in several places. Pacoima Dam is operated for flood control and its water level is seldom high.

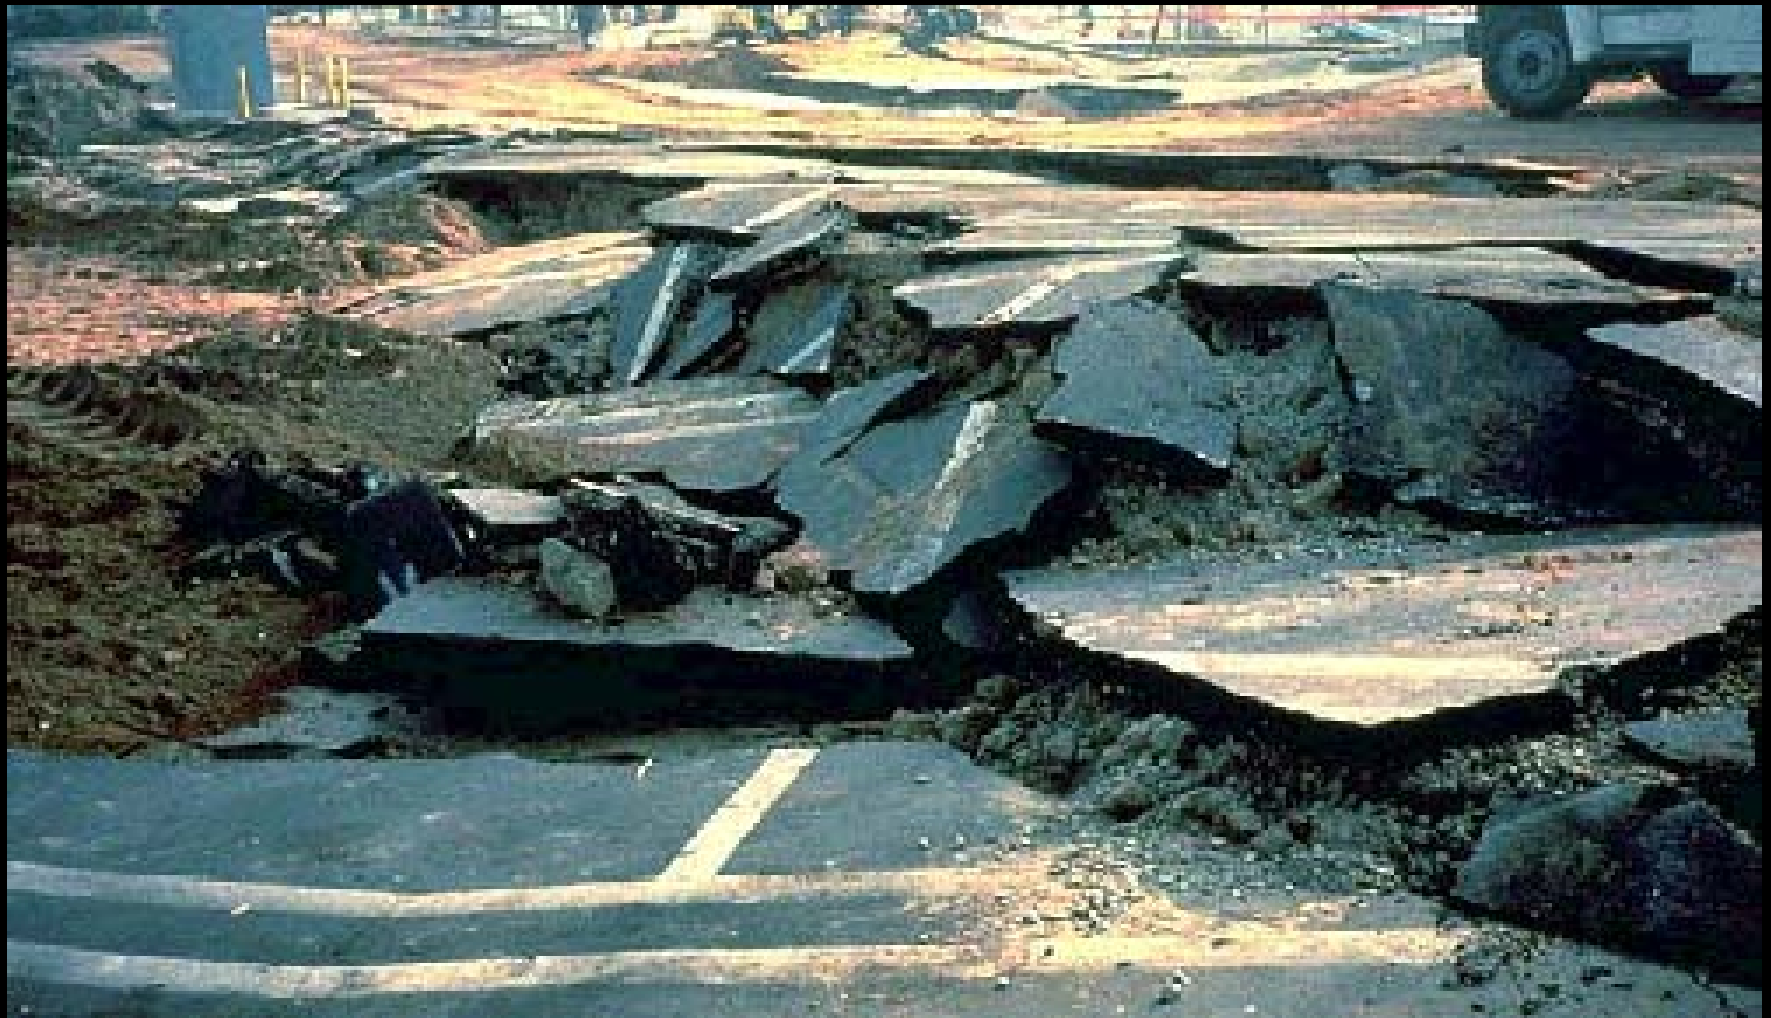
One of the few sites of ground liquefaction, and the most significant, was Kings Harbor Marina in Redondo Beach, 27 miles from the epicenter. Two reclaimed areas, each about 150 feet 1000 feet, extend into the marina. Differential subsidence of the northern fill (slide 10) occurred over a distance of 300 feet. A 500-foot long section of the southern reclamation's retaining wall bowed out, reaching a maximum offset of 20 feet (slide 11).

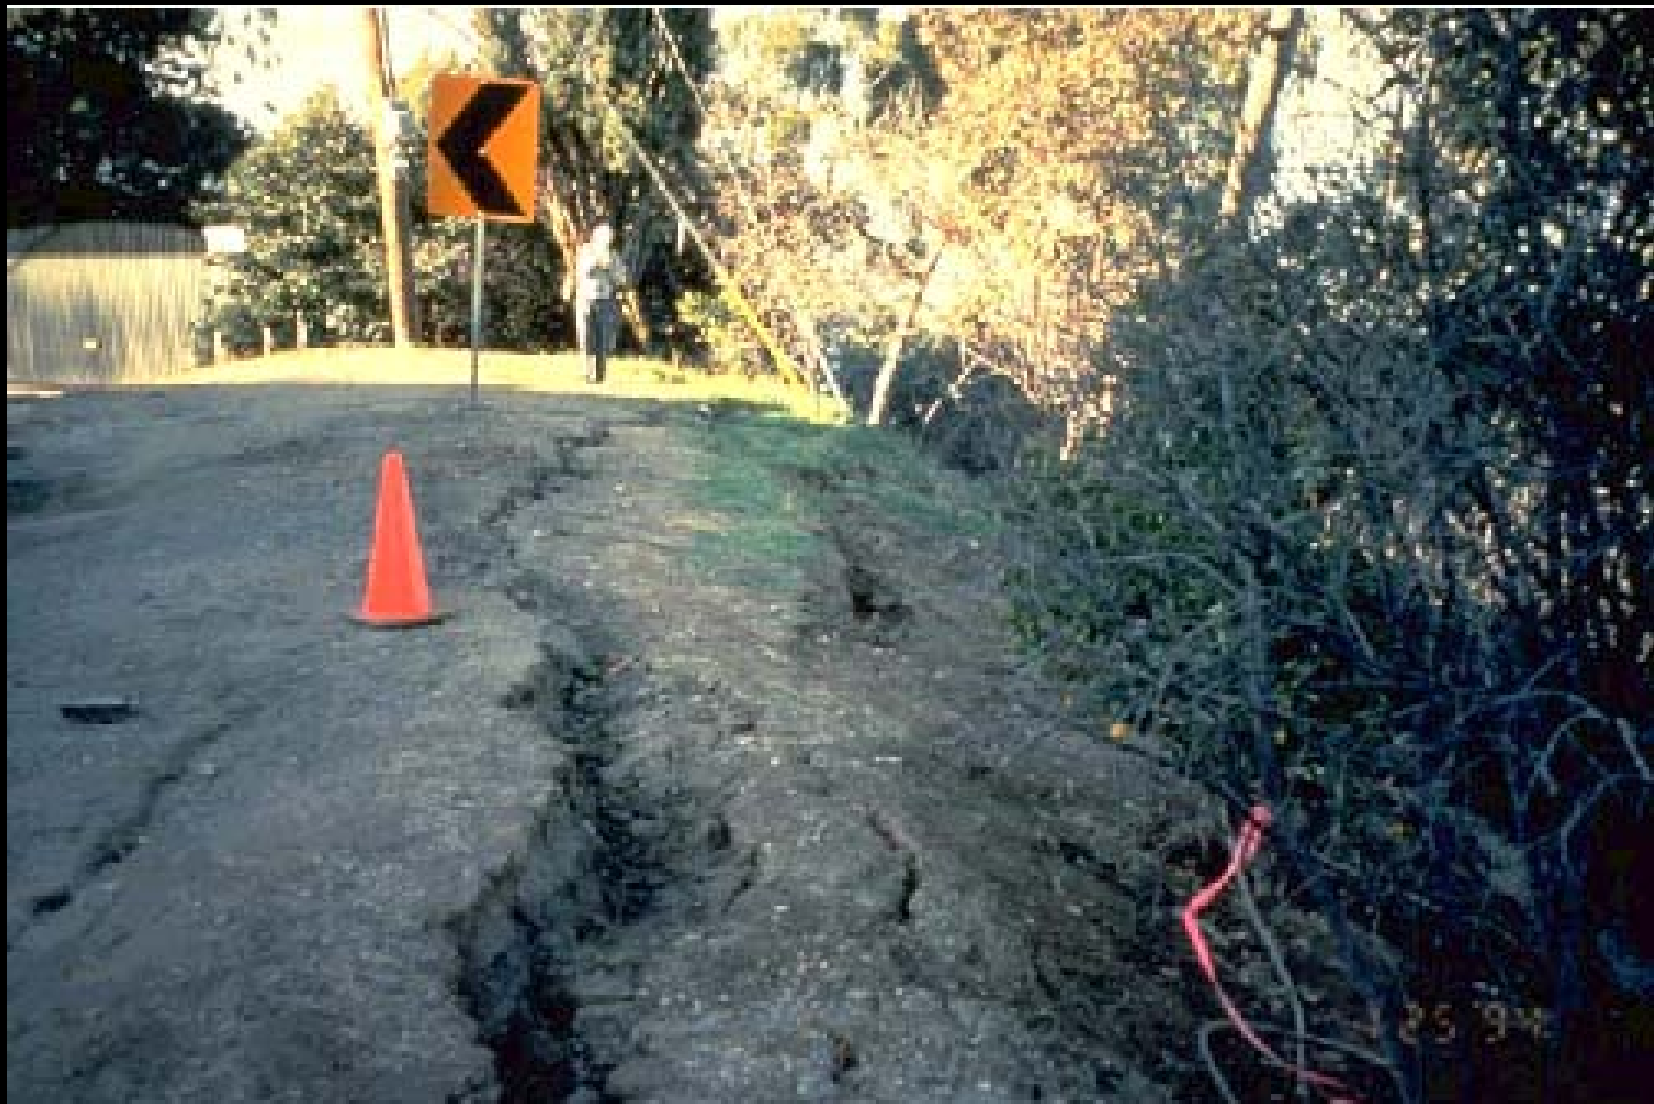
The head scarp of an incipient slope failure appeared on the northern side of Mulholland Drive in the Santa Monica Mountains. The main section of this scarp extended 400 feet and had vertical offsets up to 12 inches and crack widths up to 4 inches.

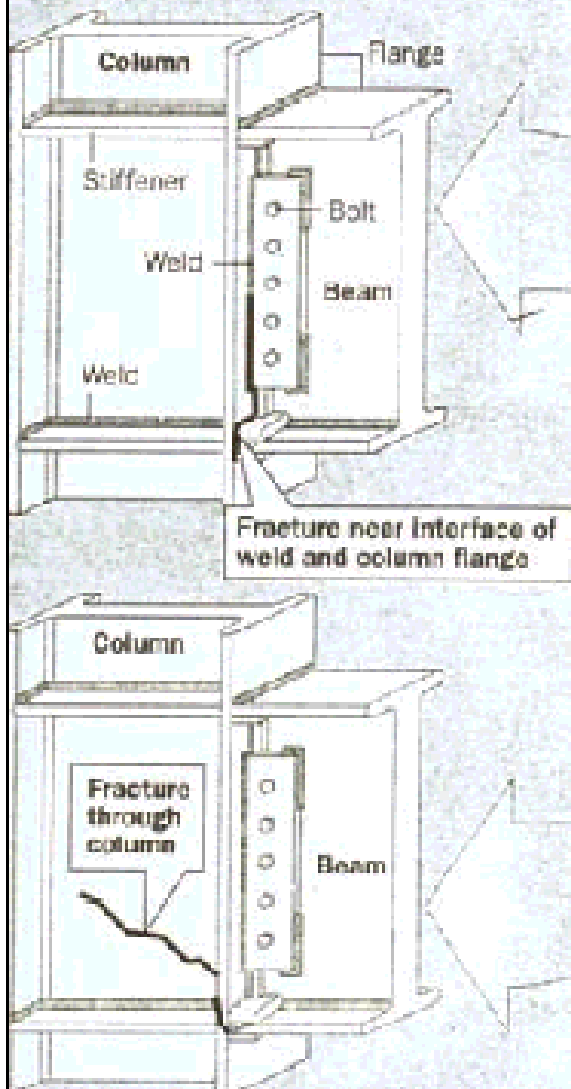
In past earthquakes, unreinforced brick and stiffly designed concrete buildings were considered more vulnerable to collapse. Buildings made of steel were deemed safer, because they tend to bend but not break. The Northridge earthquake shattered those assumptions. Engineers have identified a dozen or more steel buildings as high as 10 stories with badly cracked welds and supporting steel columns. Although they did not collapse, they were seriously weakened.

Two types of cracks

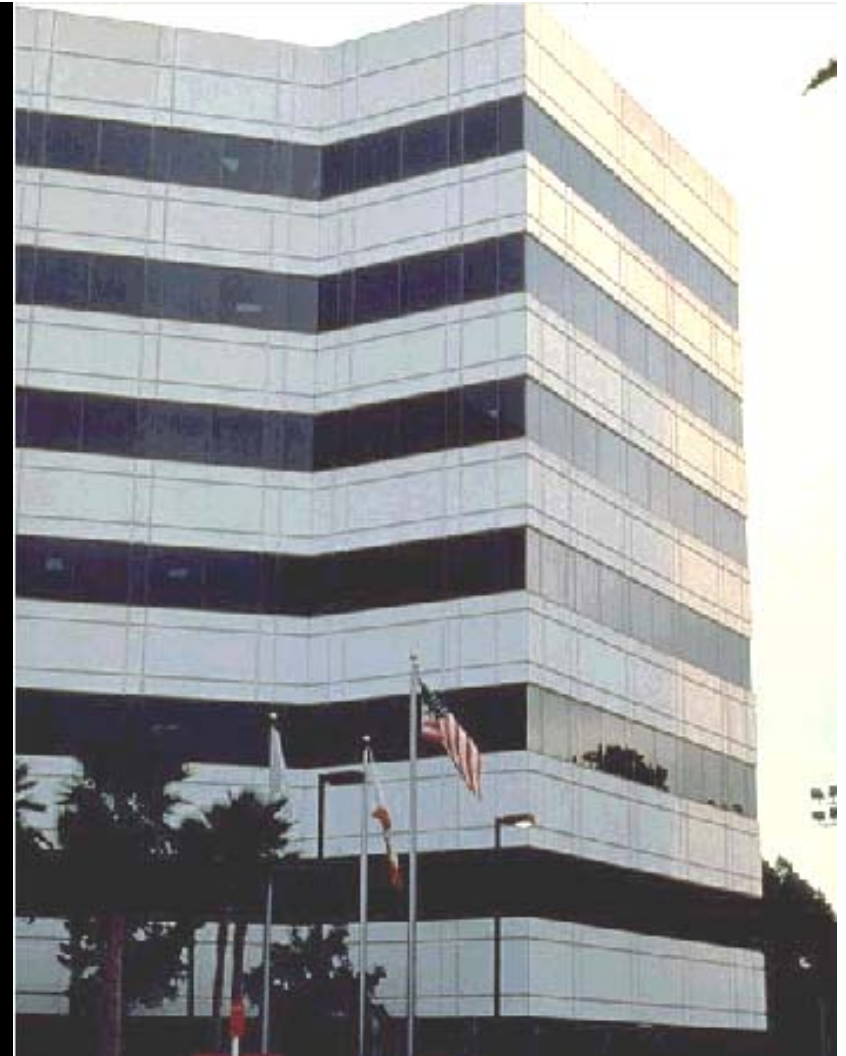
Base Isolation

The U.S.C. Hospital, a 7-story braced frame building supported on lead-rubber isolators, suffered no damage to either structure or contents. Peak horizontal ground accelerations were $.37g$ below the isolators and $.21g$ at the roof. A major benefit of base isolation is protection of building contents.

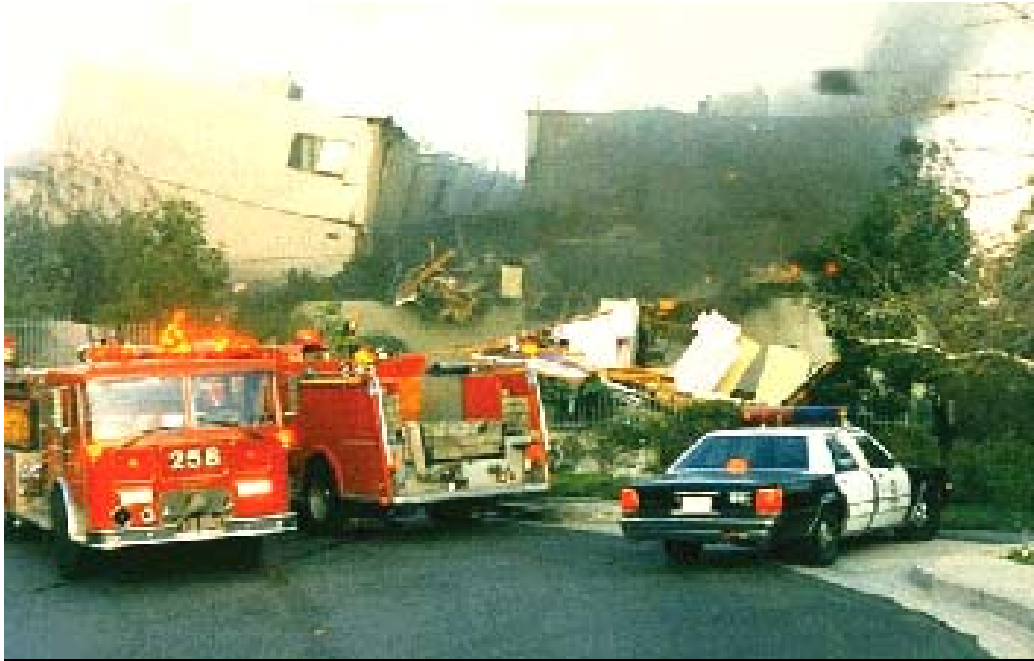
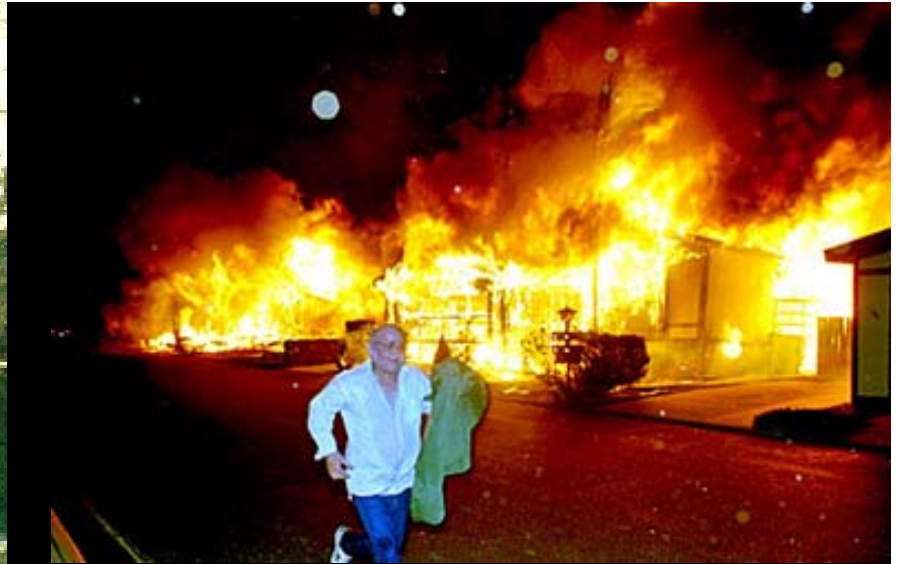
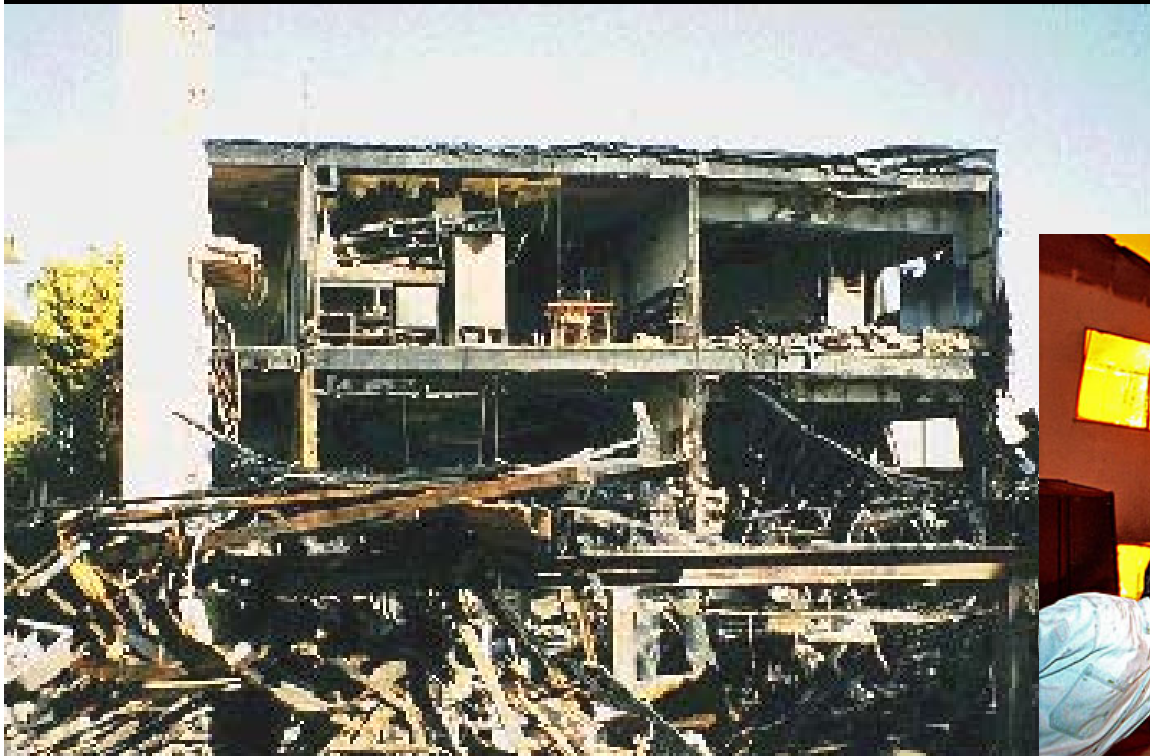
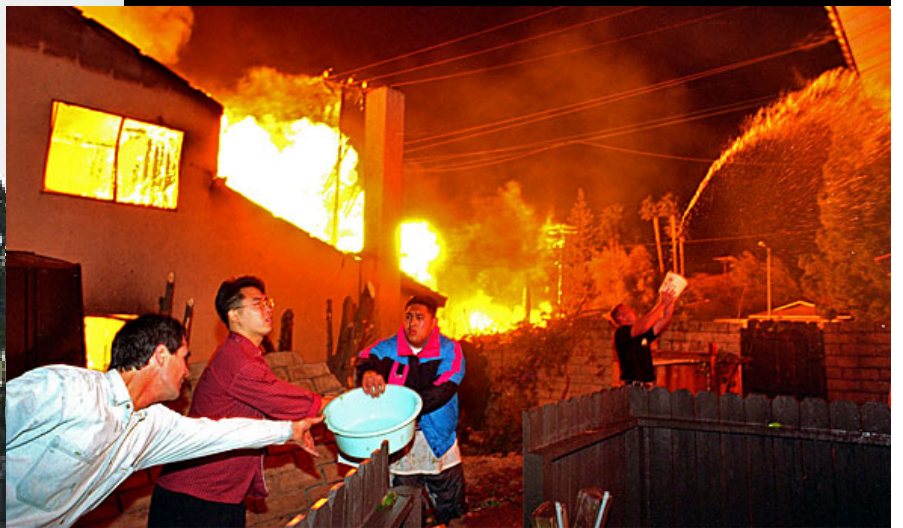
Incendios

Broken gas and water mains on Balboa Boulevard in Granada Hills created this scene of flood and fire (slide 68). The fire burned five homes, as shown in the aerial view of slide 69. In the Sylmar area, about 100 trailers burned in three mobile home parks (slide 70). These fires were attributed to breaks in gas lines, and the multiple firegrounds shown indicate more than one ignition.
