SHAKE-TABLE TESTS OF A 3-STORY, FULL-SCALE MASONRY WALL SYSTEM

Abstract

Between January 12 and February 8, 2011, a 3-story, full-scale, reinforced masonry shear wall specimen was tested on the large outdoor shake table at the University of California at San Diego. In this summary report, the characteristics of the specimen are reviewed; its development is described; its performance in the shake-table testing is summarized; and its response is compared to predictions from nonlinear finite-element modeling. The specimen was very strong and stiff, and suffered little damage when subjected to ground motions with intensities exceeding the MCE level. Its performance validates 2008 MSJC Code requirements for design and detailing of special reinforced masonry shear walls.

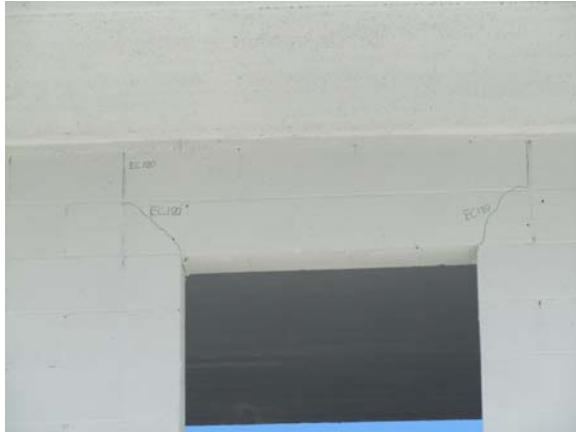
As shown in Figure 3-2 through Figure 3-5, initial response of the specimen was marked by the appearance of flexural cracks at the bases of Wall 1, Wall 2, and Wall 3, and by the appearance of lintel cracks at the control joints on both ends of the lintel connecting Wall 1 and Wall 2. Although the longitudinal reinforcement passing through the lintels had been debonded on one side of each control joint, the strong connection between the precast planks and Walls 1, 2, and 3 caused the lintels to move

with the planks rather than the walls, and caused some lintel cracking. The strut action of the lintels also tended to reduce the clear height of the walls.

Figure 3-2 Lintel cracks after 120% El Centro 1979

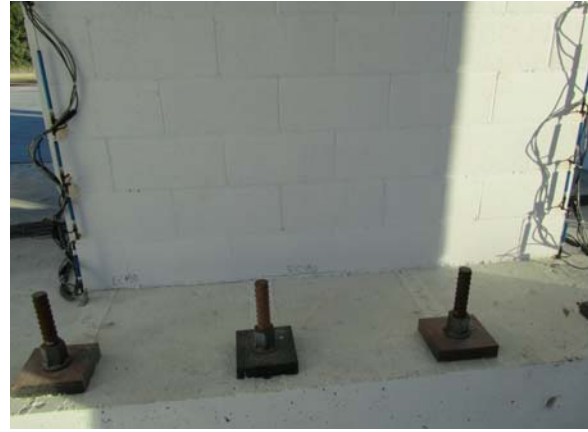
Figure 3-3 Flexural crack at base of Wall 2 after 150% El Centro 1979

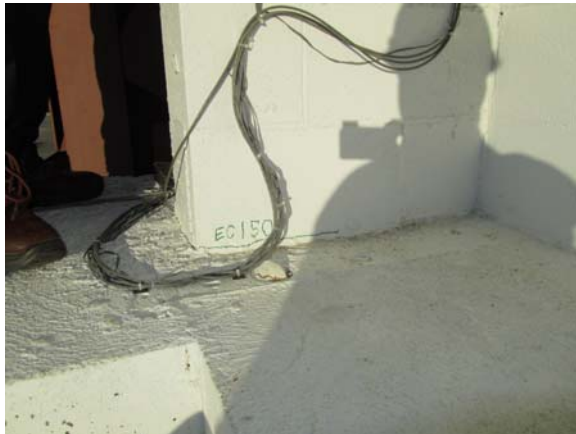
Figure 3-4 Flexural crack at base of Wall 1 flange after 150% El Centro 1979

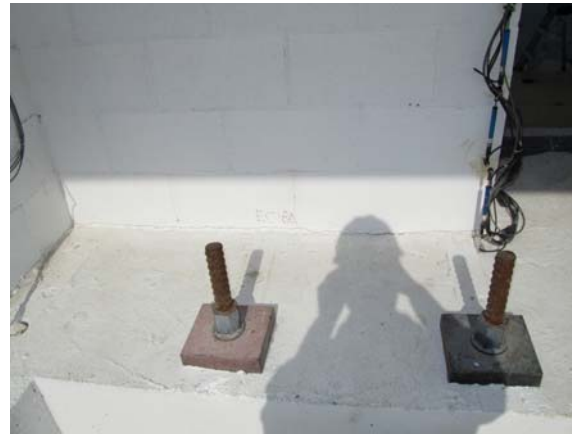
Figure 3-5 Flexural crack at base of Wall 1 web after 180% El Centro 1979

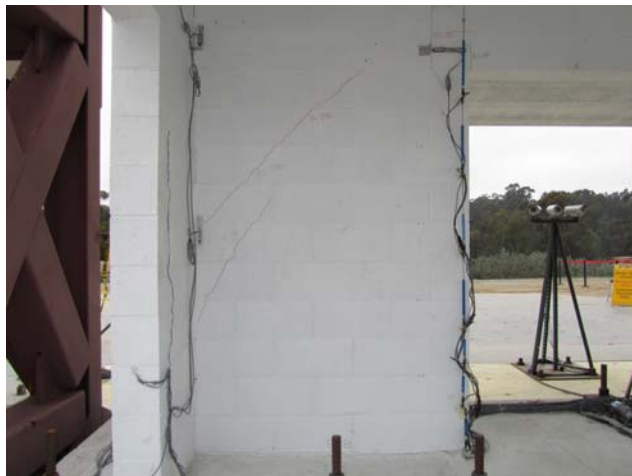
As shown in Figure 3-6 through Figure 3-9, more severe shaking caused the start of shear cracks at the bases of Wall 1 and Wall 3, and produced some minor base sliding of Wall 2.

Figure 3-6 Shear cracks on web of Wall 1 after 250% El Centro 1979

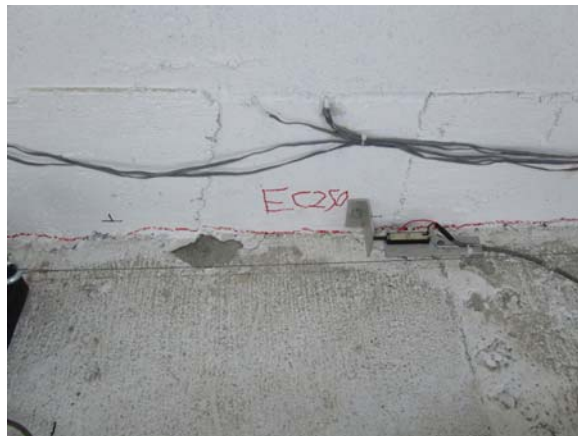
Figure 3-7 Evidence of minor base sliding of Wall 2 after 250% El Centro 1979

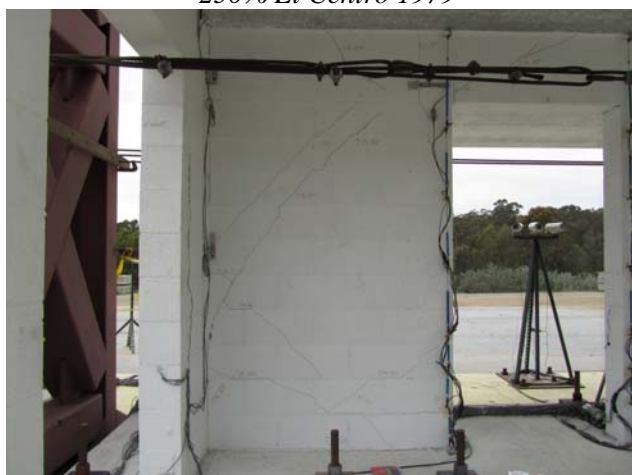
Figure 3-8 Shear cracking of Wall 1 after 100% Chi Chi

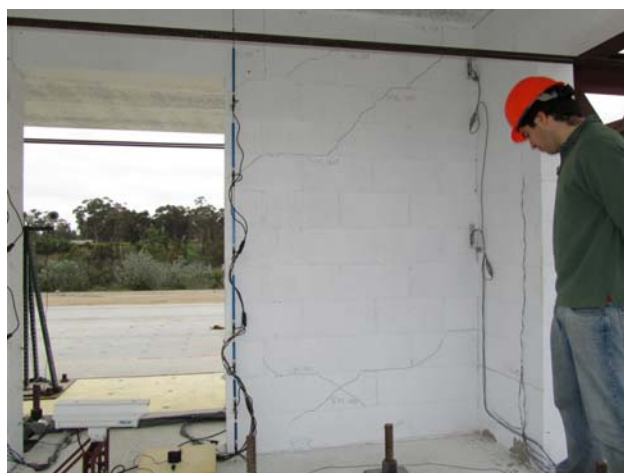
Figure 3-9 Shear cracking of Wall 3 after 100% Chi Chi

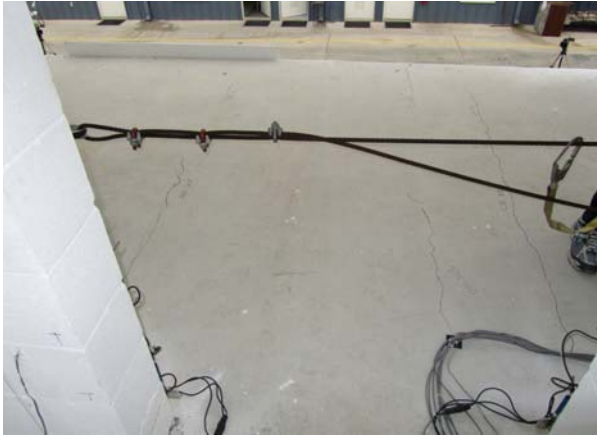
As shown in Figure 3-10 through Figure 3-14, still stronger shaking increased the observed flexural and shear cracking.

Figure 3-10 Cracks on 2nd level slab after 100% Chi Chi

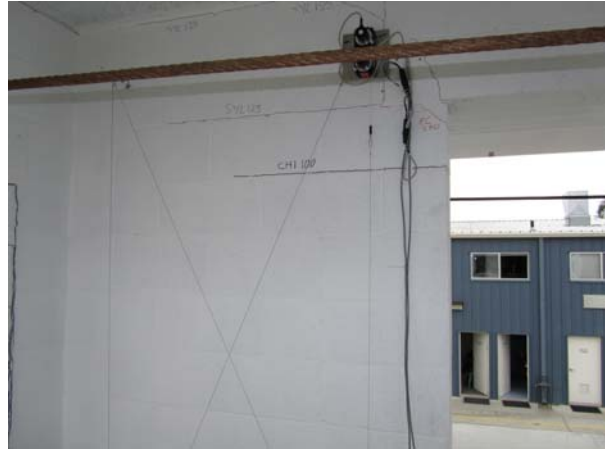
Figure 3-11 Wall 3, second story after 100% Chi Chi

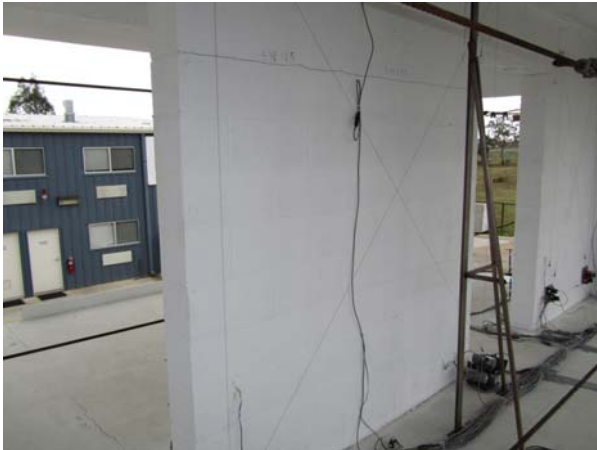
Figure 3-12 Wall 2, second story after 100% Chi Chi

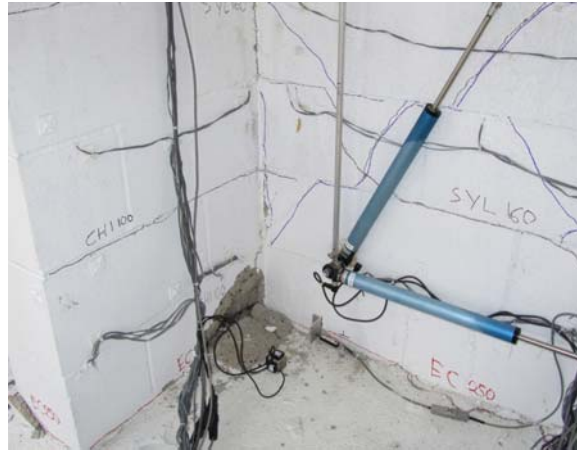
Figure 3-13 Base of Wall 3 after 100% Chi Chi

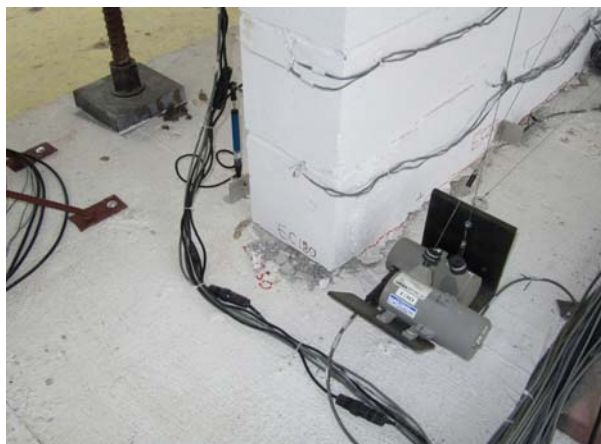
Figure 3-14 Base of Wall 2 after 100% Chi Chi

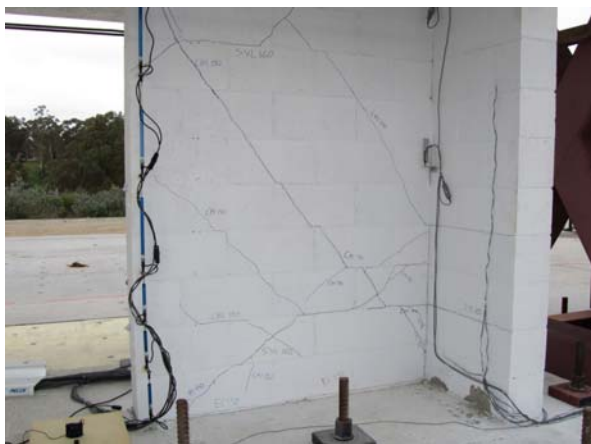
Figure 3-15 Wall 3 after first run of 150% Chi Chi

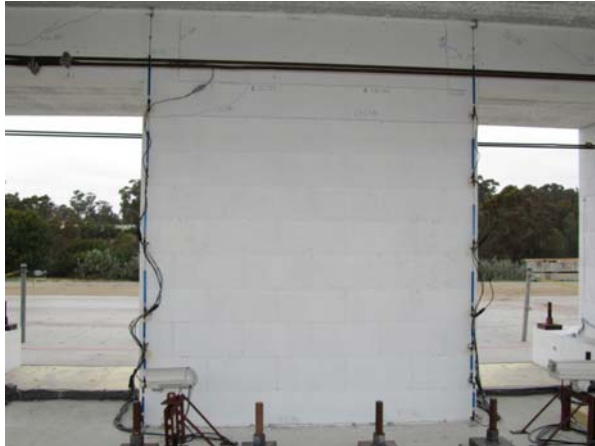
As shown in Figure 3-16 through Figure 3-21, still stronger shaking produced additional shear cracking at the base of Walls 1 and 3, and out-of-plane flexural cracking at the bases of the out-of plane walls.

Figure 3-16 Wall 2 after first run of 150% Chi Chi

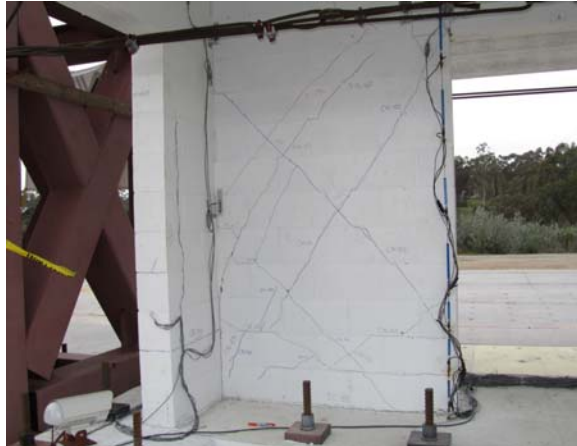
Figure 3-17 Wall 1 after first run of 150% Chi Chi

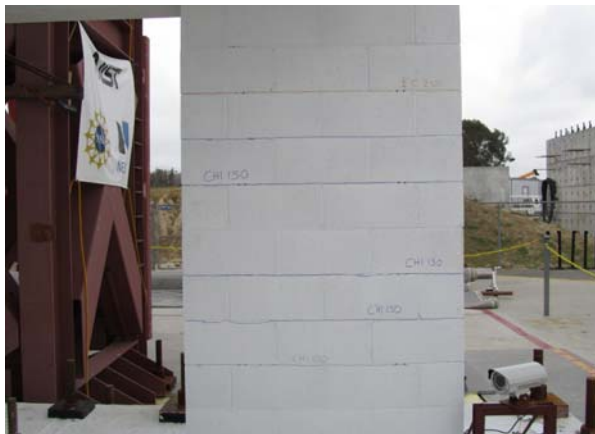
Figure 3-18 East out-of-plane wall after first run of 150% Chi Chi

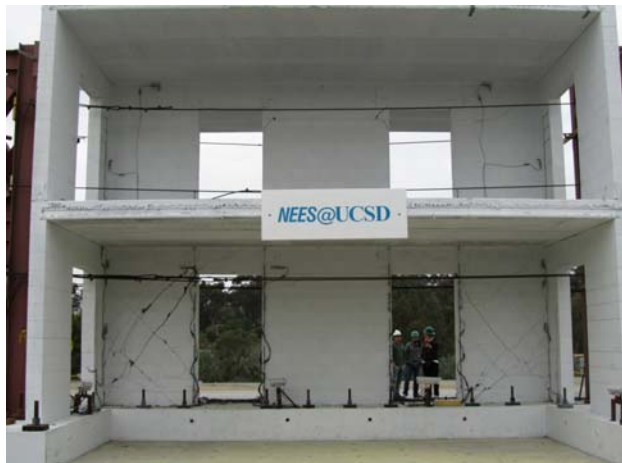
2 nd 150% Chi Chi		Structure was severely damaged; residual shear crack width of 0.38 in.; signs of toe crushing in webs of T walls; max. 1 st story drift = 1.52 %

Figure 3-19 Specimen after second run of 150% Chi Chi

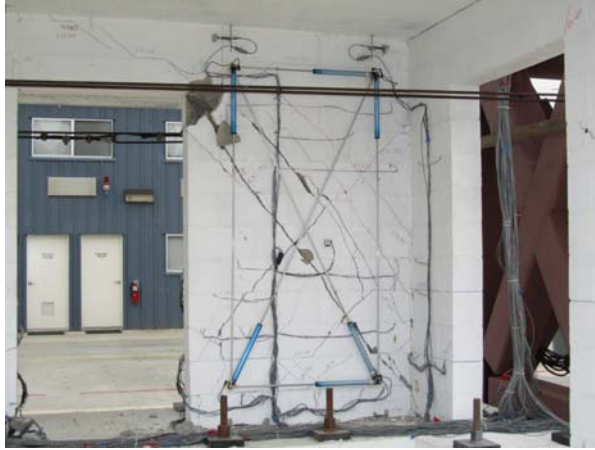
Figure 3-20 Base of Wall 1 after second run of 150% Chi Chi

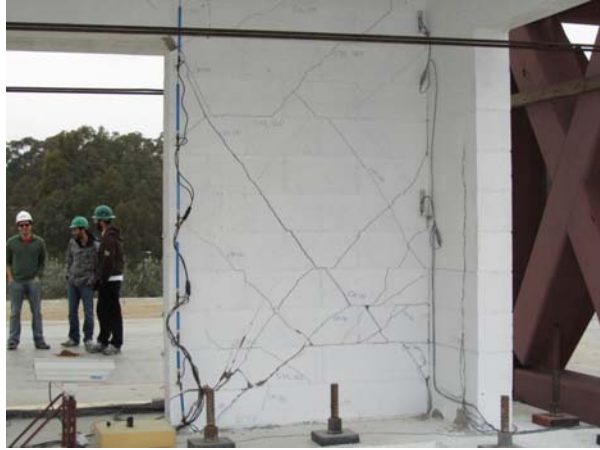
Figure 3-21 Base of Wall 3 after second run of 150% Chi Chi

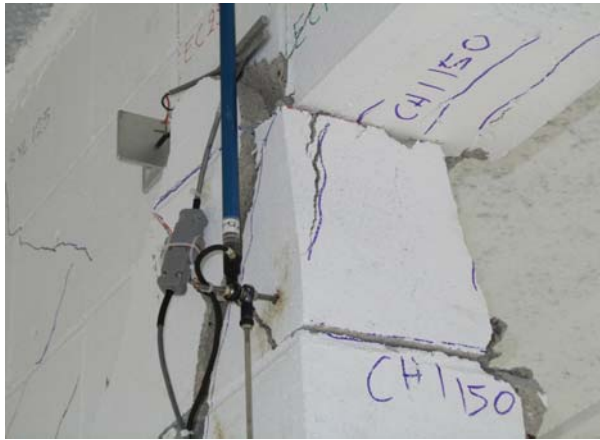
As shown in Figure 3-22 through Figure 3-25, continued shaking caused crushing at the corner of a door opening due to the rocking of the lintel beam, the widening of shear cracks at the bases of Wall 1 and Wall 3, and the crushing of the toe of Wall 3. Of particular significance is the splice region at the compression toe of base of Wall 3, shown in Figure 3-25. Note how the lowest transverse reinforcing bar, hooked around the splice, keeps the spliced bars from coming apart.

Figure 3-22 Corner of first-story lintel beam after second run of 150% Chi Chi

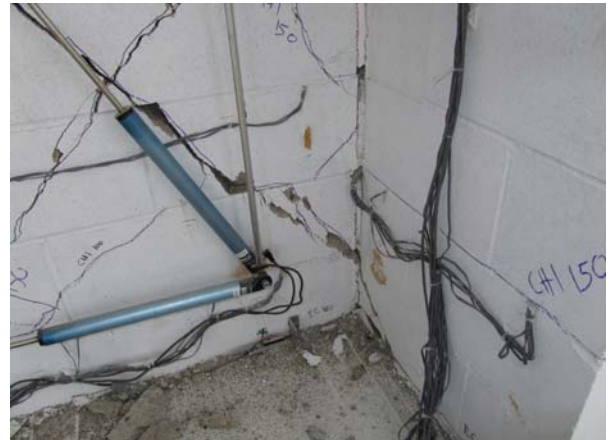
Figure 3-23 Base of Wall 1 after second run of 150% Chi Chi

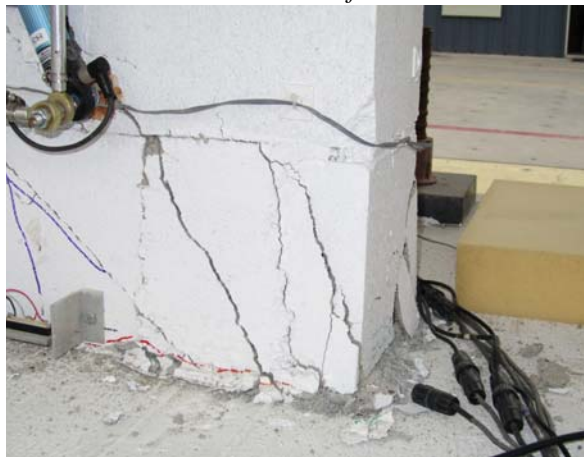
Figure 3-24 Toe at base of Wall 3 after second run of 150% Chi Chi

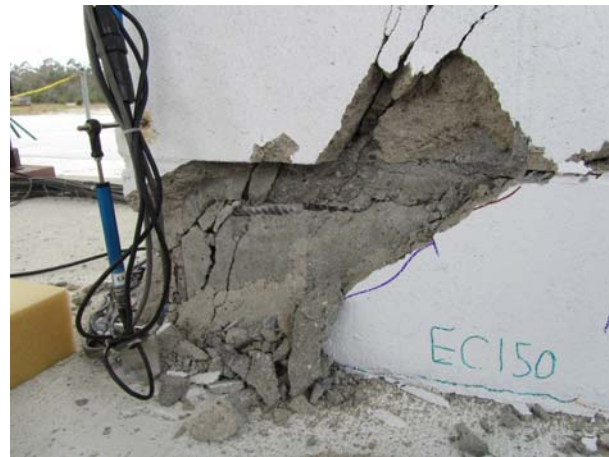
Figure 3-25 Toe at base of Wall 3 after second run of 150% Chi Chi

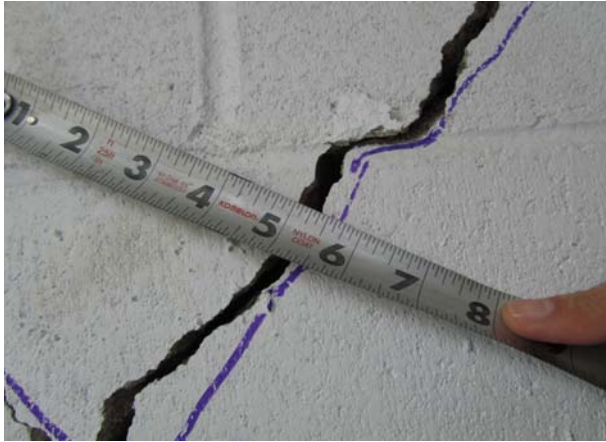
Finally, at the end of the test, Figure 3-26 shows how wide shear cracks had opened in Wall 1 and Wall 3 at the ground level. As shown in Figure 3-27, flexural cracking near the top of Wall 2 indicated that the floor planks were still acting as stiff, strong coupling elements.

Figure 3-26 Shear crack on ground story of Wall 1 after second run of 150% Chi Chi

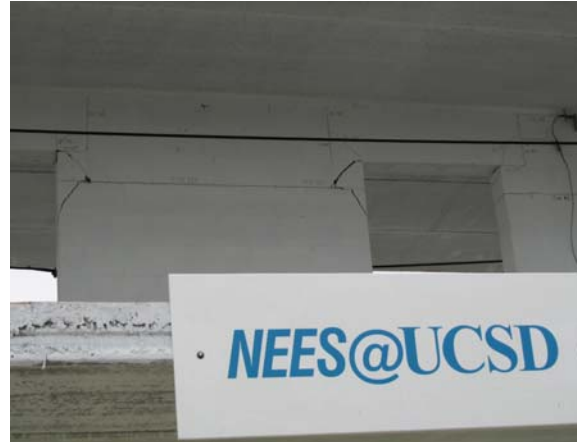
Figure 3-27 Wall 2 at second story after second run of 150% Chi Chi
