Lecciones aprendidas de terremotos recientes: Ideas para la evolución de los códigos de diseño sísmico

Lessons from recent earthquakes: thoughts for seismic design codes evolution

Humberto Varum, A. Arêde, A. Furtado, H. Rodrigues, J. Melo
 hvarum@fe.up.pt

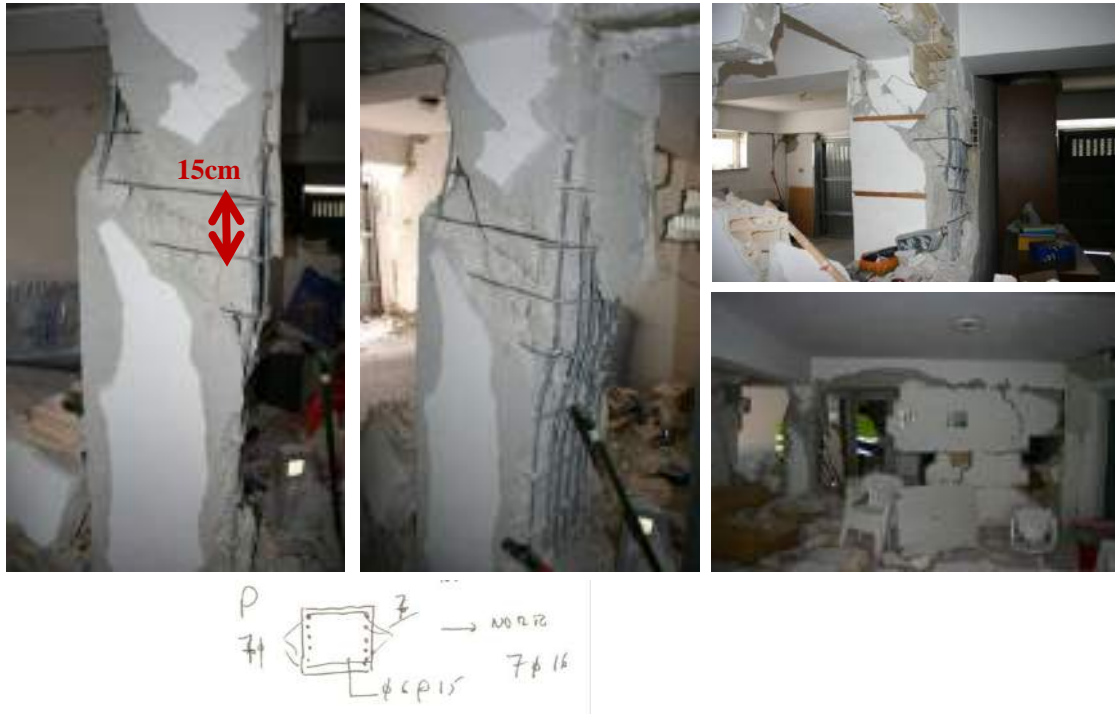
Insufficient amount of transverse reinforcement, and longitudinal reinforcement only in two column faces; excessive distance between *longitudinal bars* in two faces of the columns

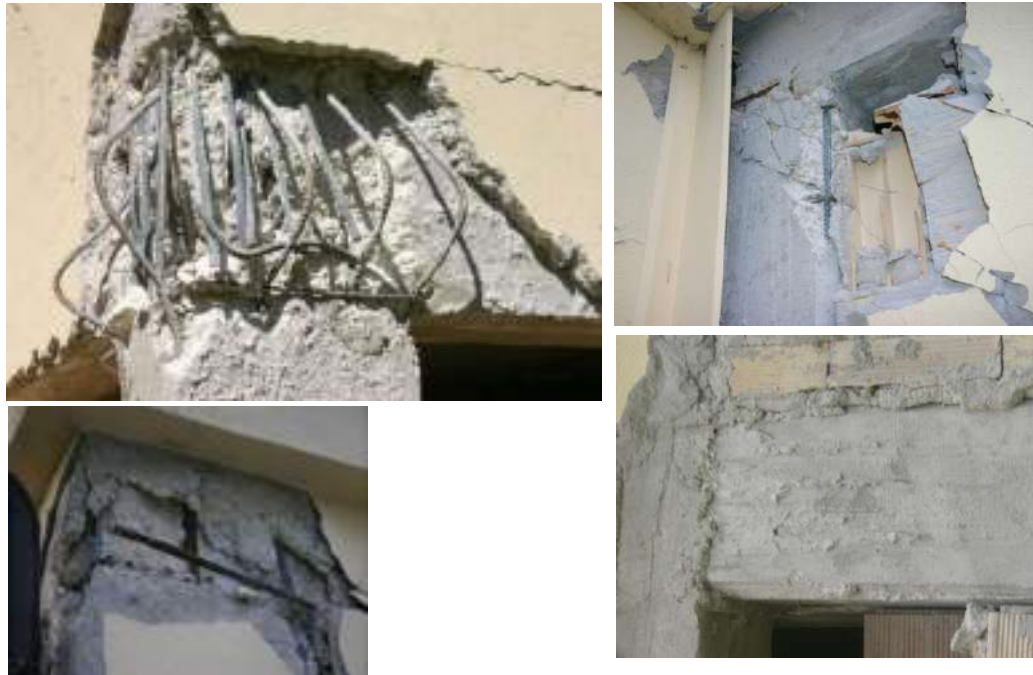
Deficiencies in the reinforcement detailing of beam-column joints

Absence of joint transverse reinforcement; inadequate anchorage of the beam longitudinal bars; shear failure of joints

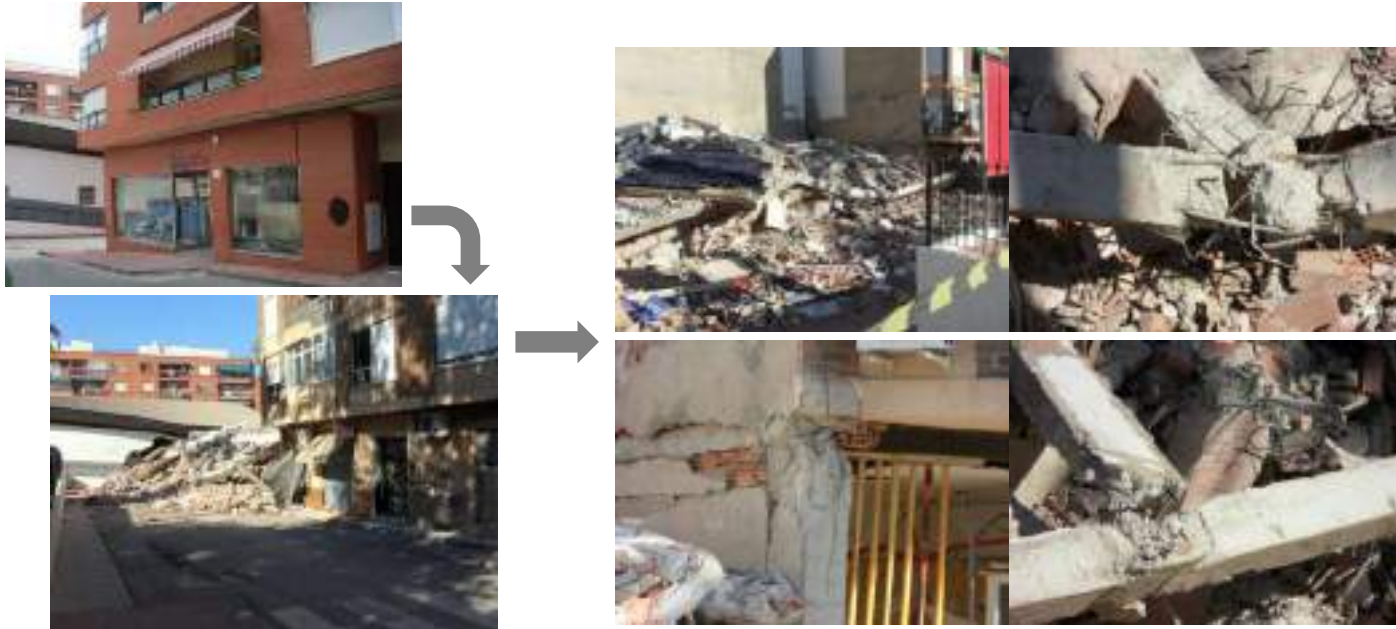
RC building collapse a few hours after the earthquake: various deficiencies in the beam-column joints (absence of hoops/stirrups; lap-splices of column reinforcing bars in the joint region; poor anchorage of longitudinal bars)

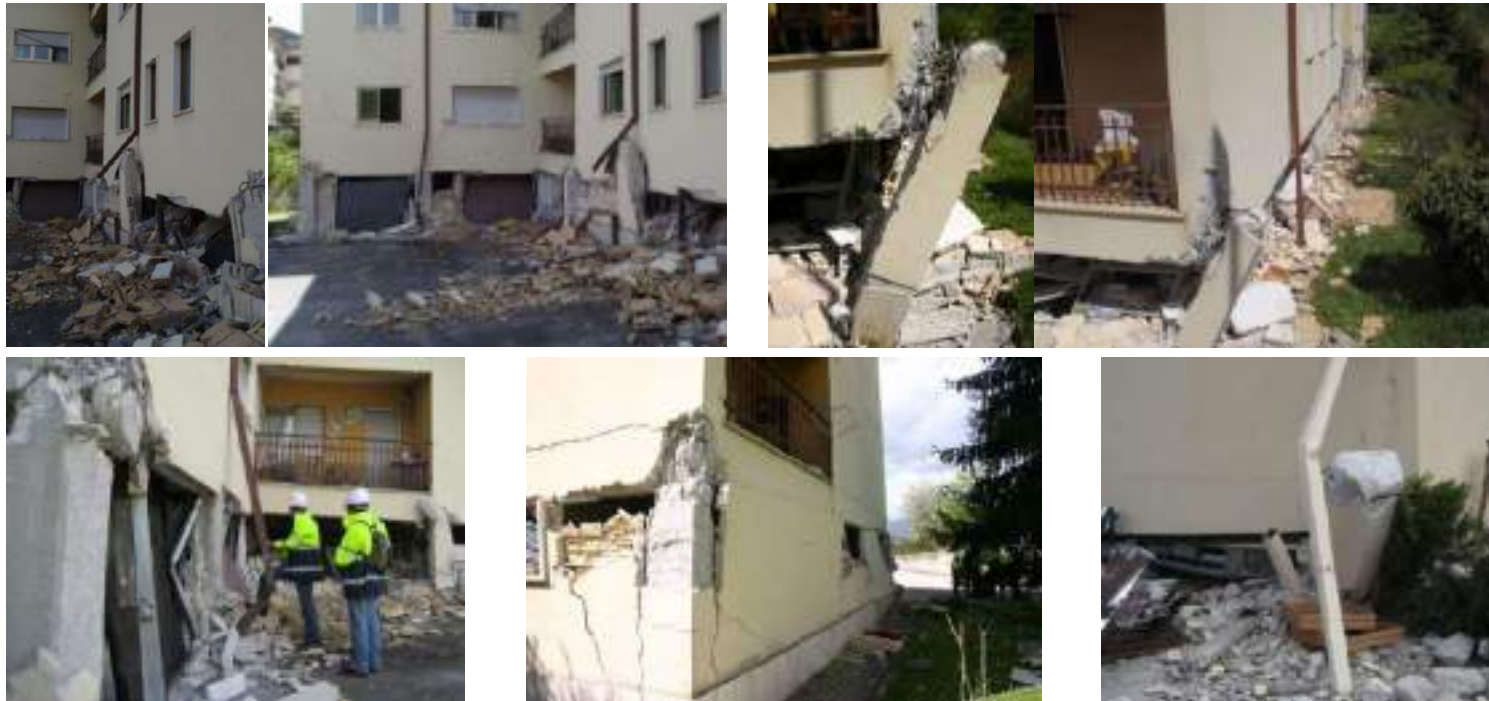
Collapse due to soft-storey mechanism: reduced number of masonry infill walls in the ground storey, causing a significant variation of stiffness and strength in elevation, creating a “soft storey” and “weak storey” + irregularities in plan (torsion)

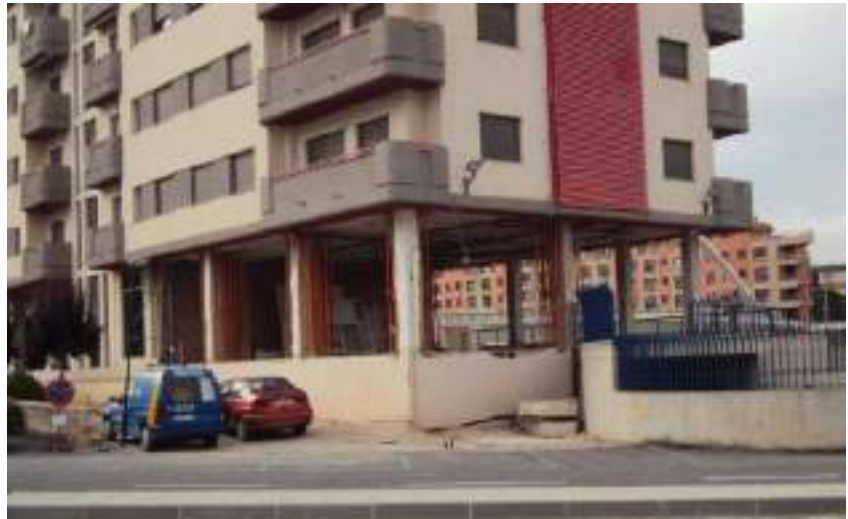
Flexible ground storey, convenient for commerce/services' use, inducing a pronounced irregularity in elevation

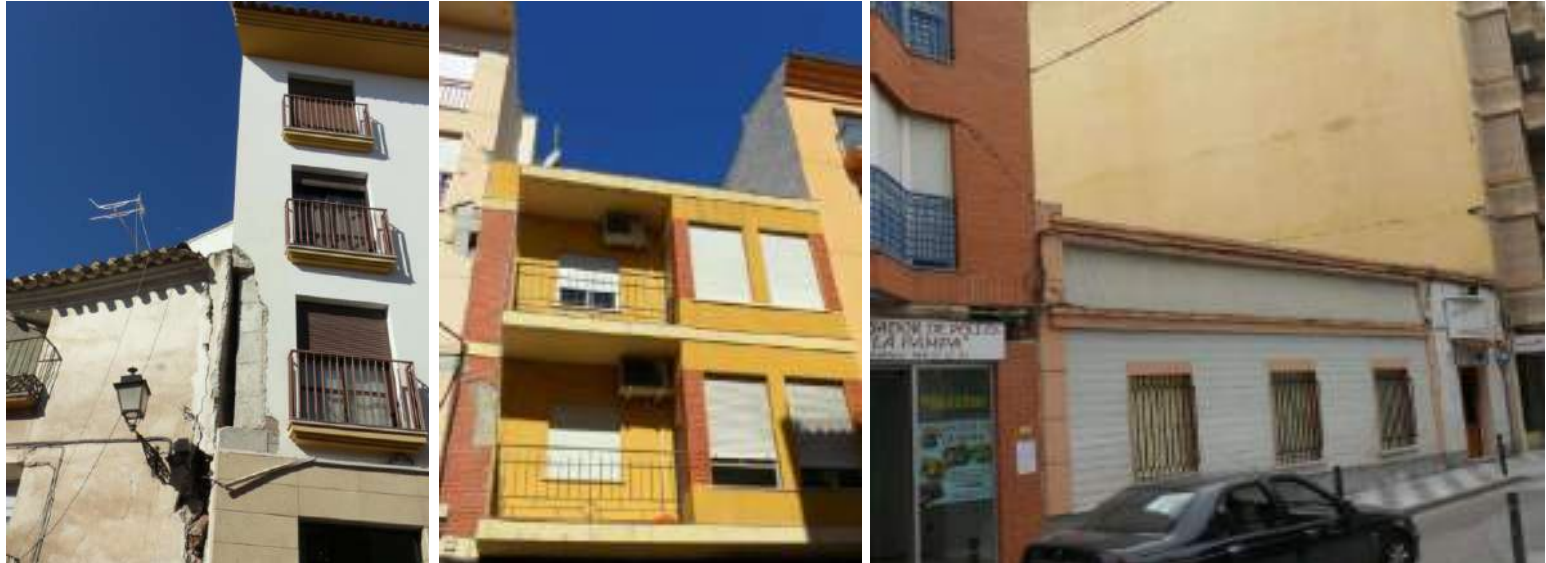
Interaction between buildings: adjacent buildings with different heights, or with different structural and/or constructive or material solutions, in the urban centre, leading to different dynamic responses, hence boosting pounding, as well as to stress and strain demands concentration in certain points

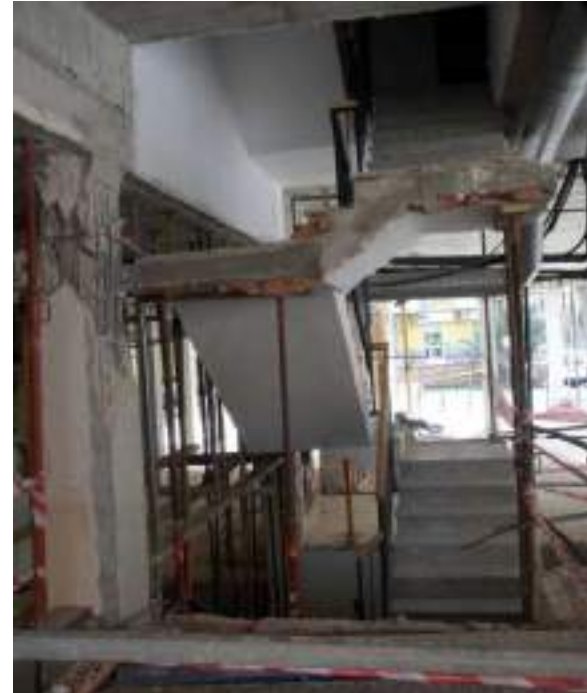
Damages associated with the stairs' elements, mainly in the lower storeys. Lack of specific design of these secondary structural elements, and/or reinforcement detailing errors (design?/construction?), and/or non specific connection to the main structural system

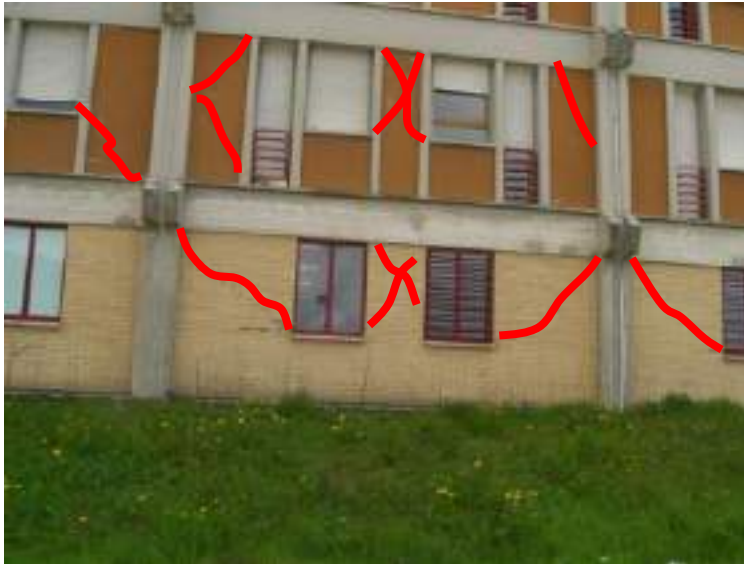
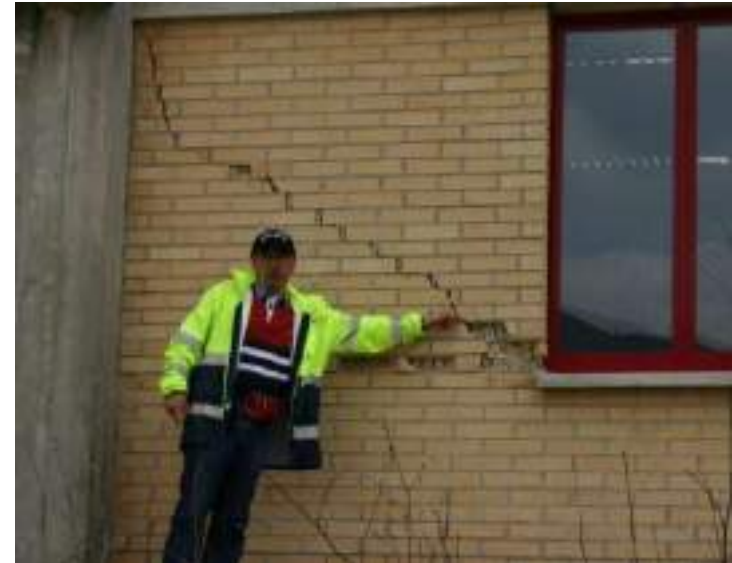
Widespread damages in the masonry infill walls in all building of Aquila Hospital

- Significant structural damages; complete buildings' collapse did not occur
- A few hours after the earthquake, the Hospital was declared inoperative in 90% of its functions

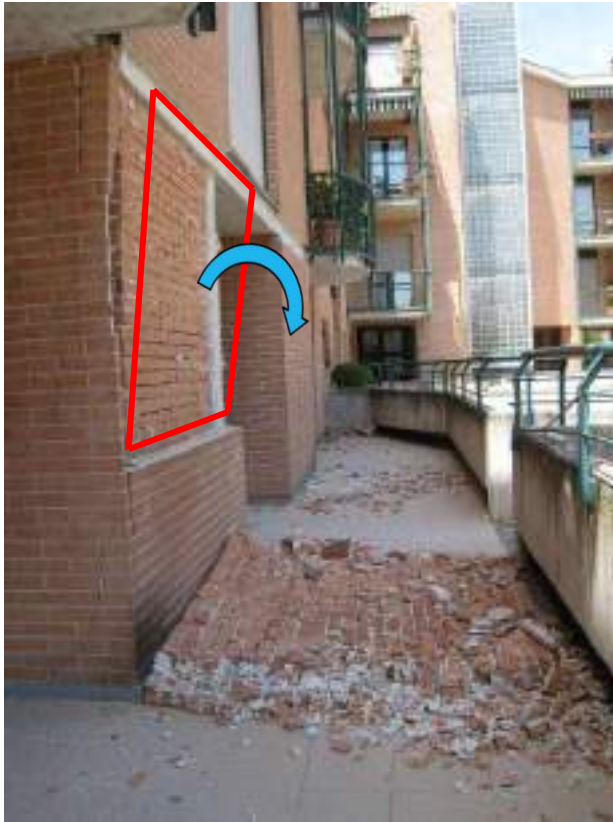
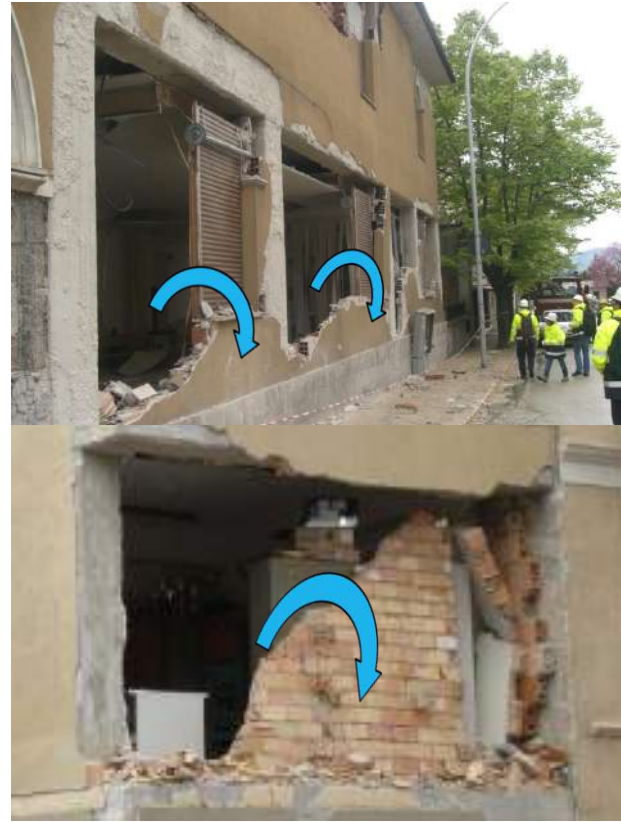
Out-of-plane failure of masonry enclosure walls

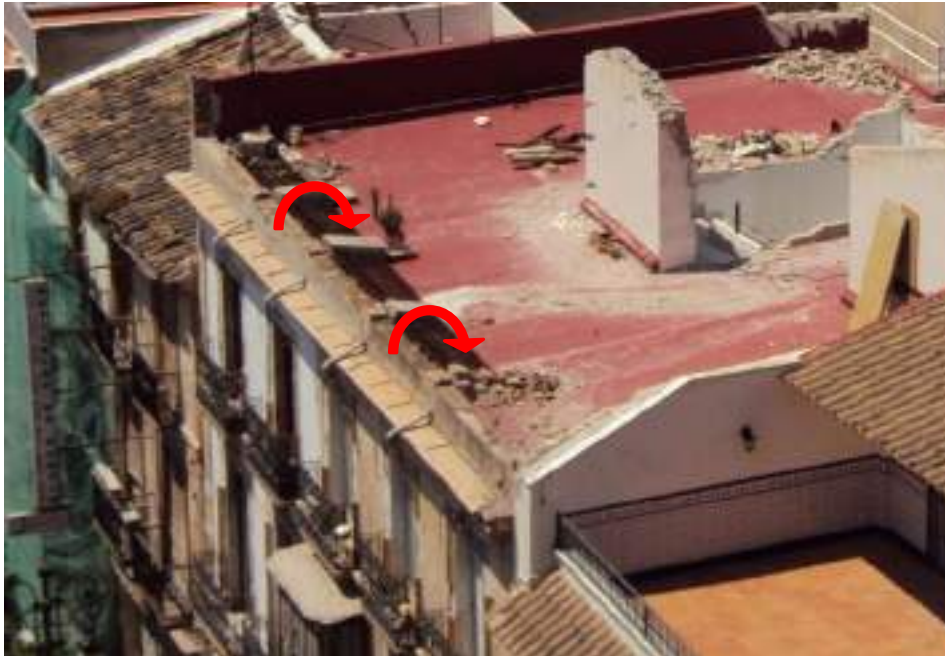
Elements not adequately connected to the structure may fall over the street

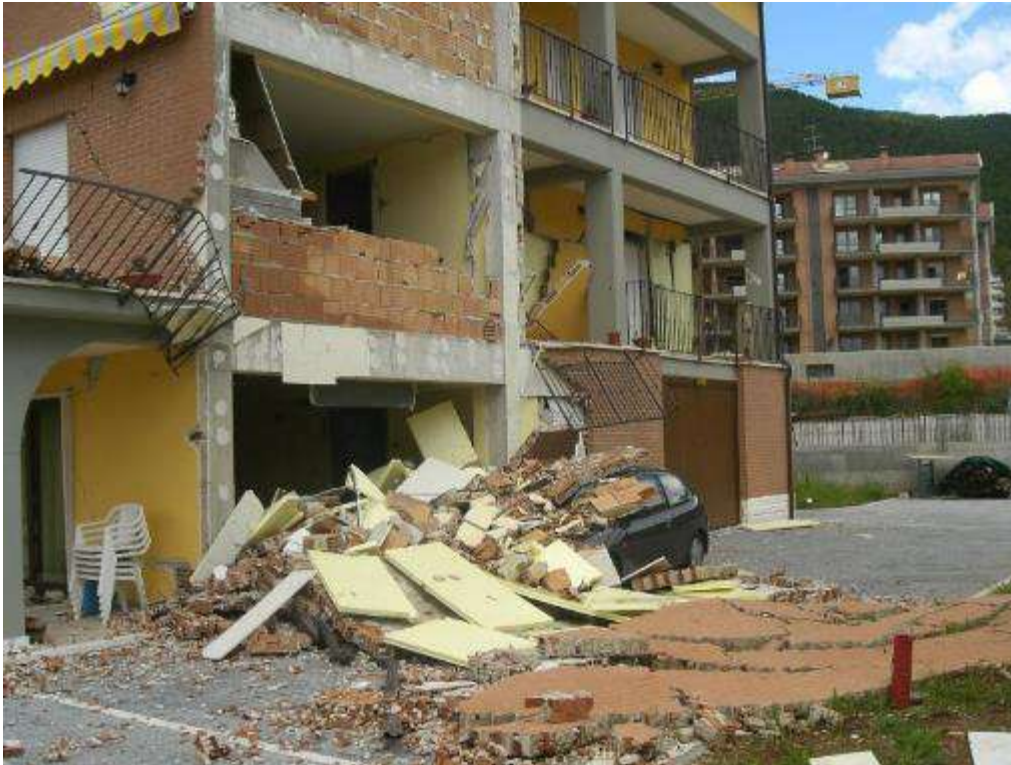
OOP collapse of masonry enclosure walls

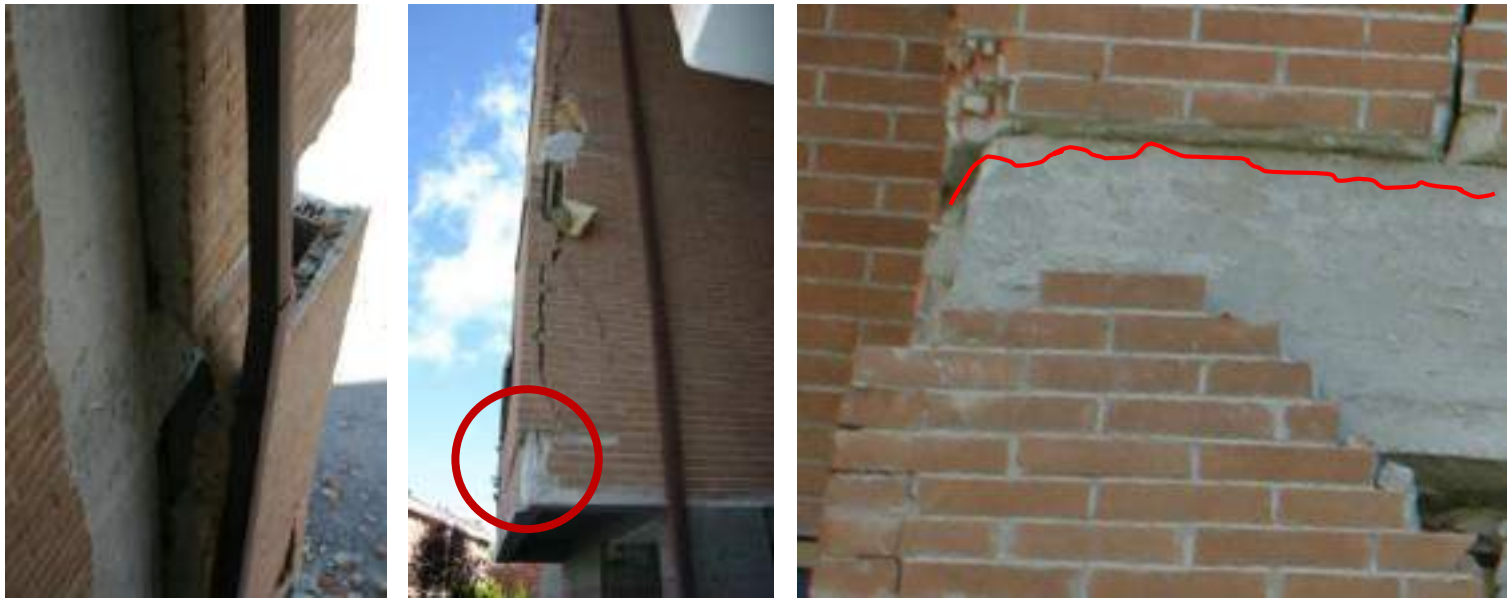
Damages in masonry exterior panels – Inadequate support

Possible causes: Poor connection between the exterior and interior panels (in double leaf walls), and between the exterior panel and the structural elements. Exterior panels supported on the beams/slabs, approximately, in only half panel thickness

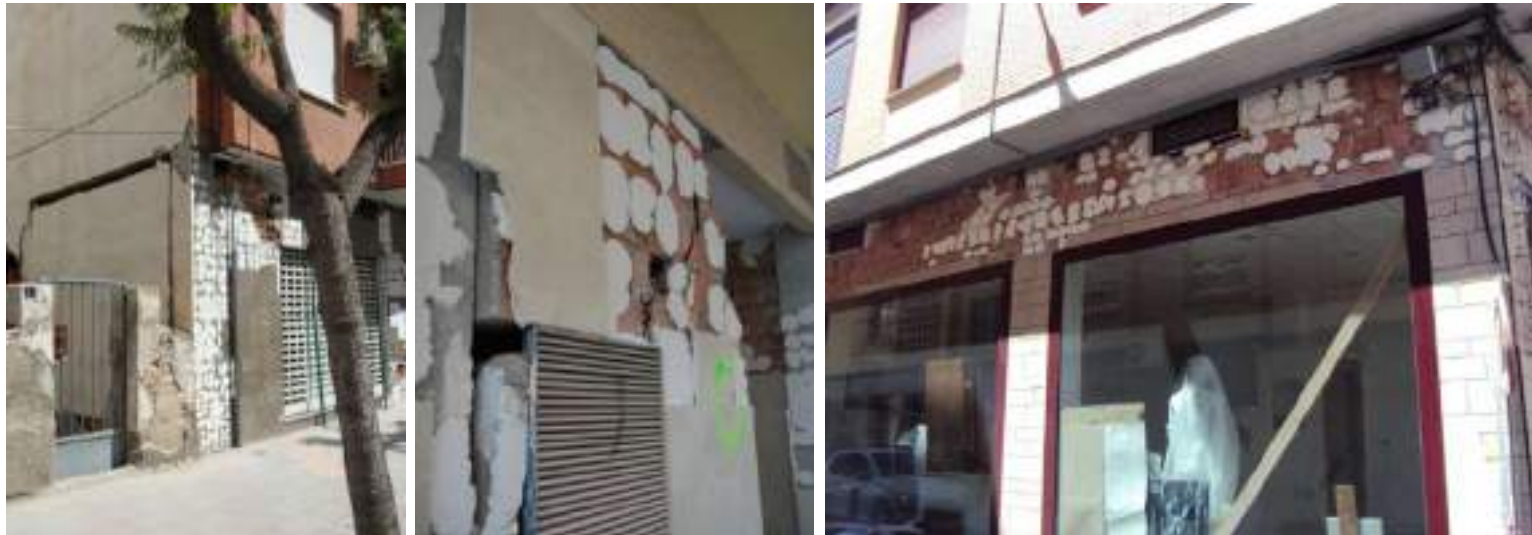
Poor connection of finishing/coverings (heavy pieces) glued in singular points with “cement glue”, without any mechanical fixing system

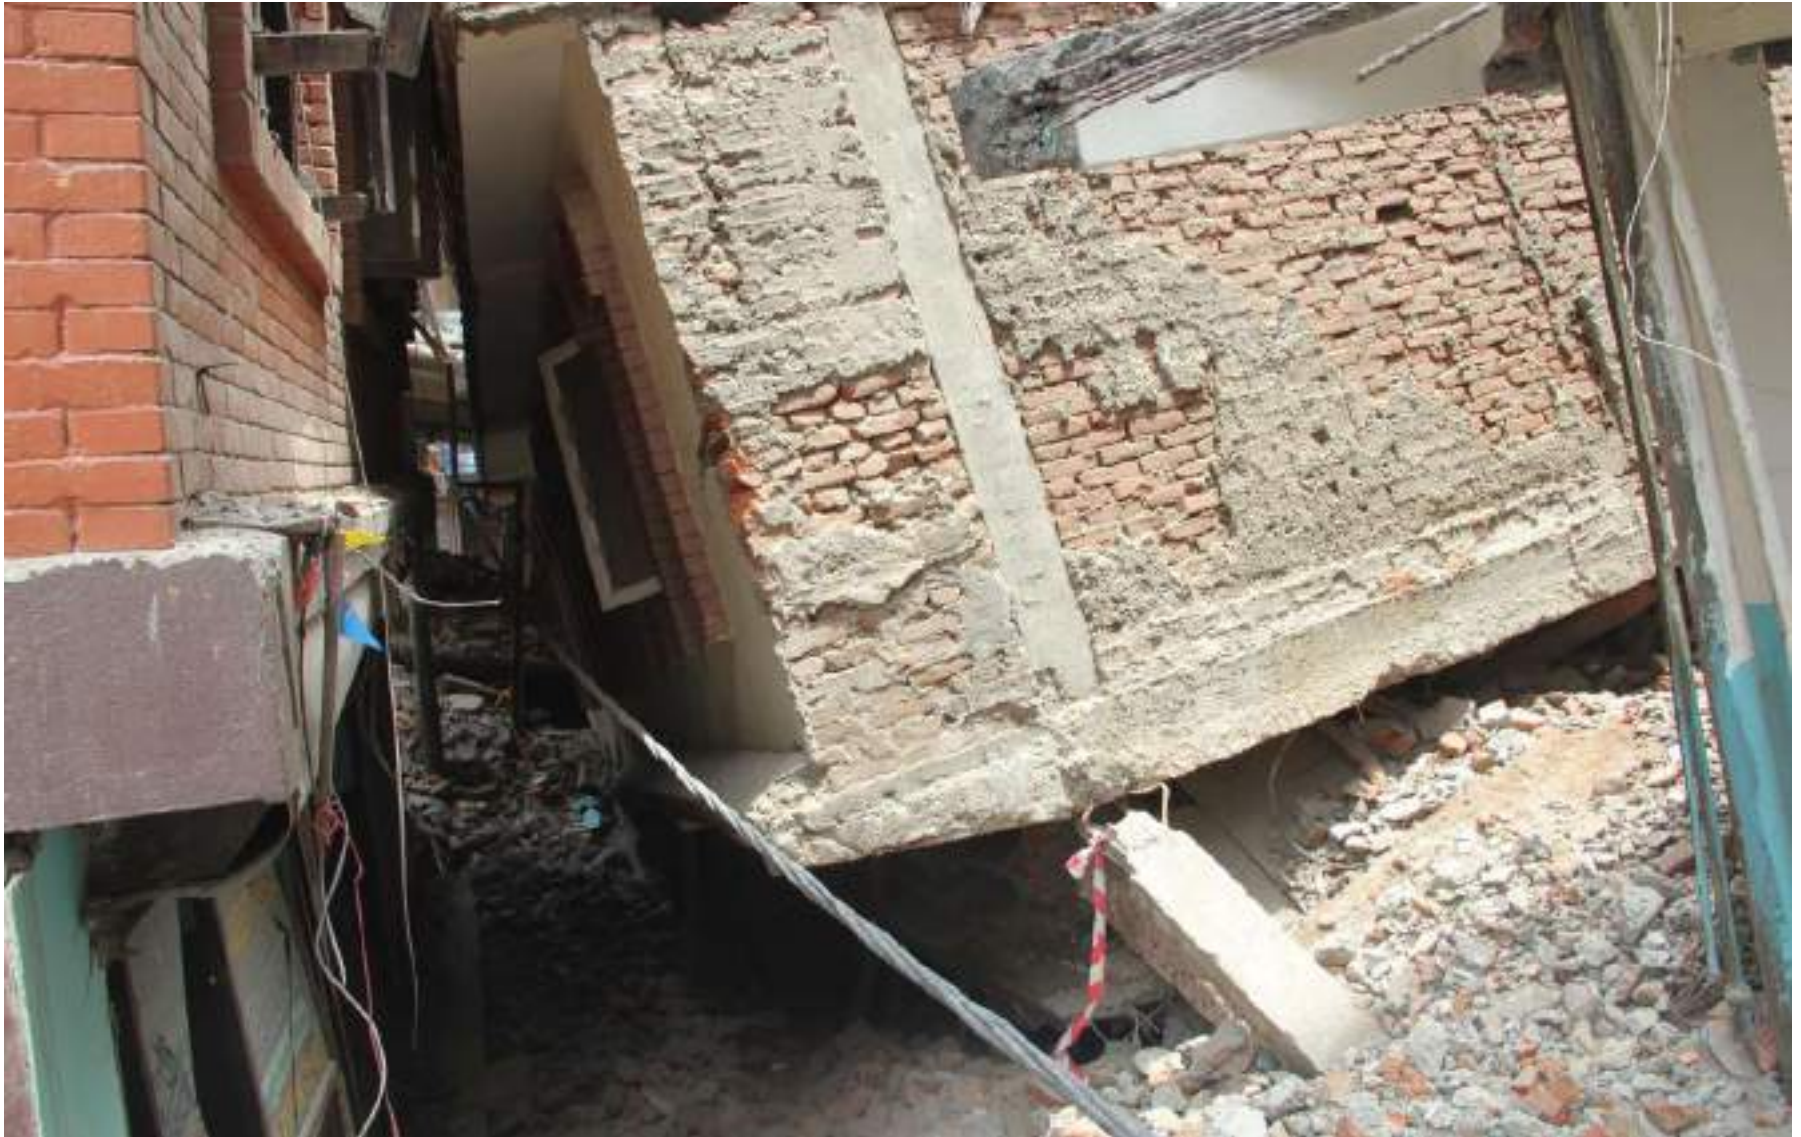
DEFICIENT RC STRUCTURAL SYSTEMS | SOLID BRICKS INFILL WALLS WITH POOR MORTAR JOINTS

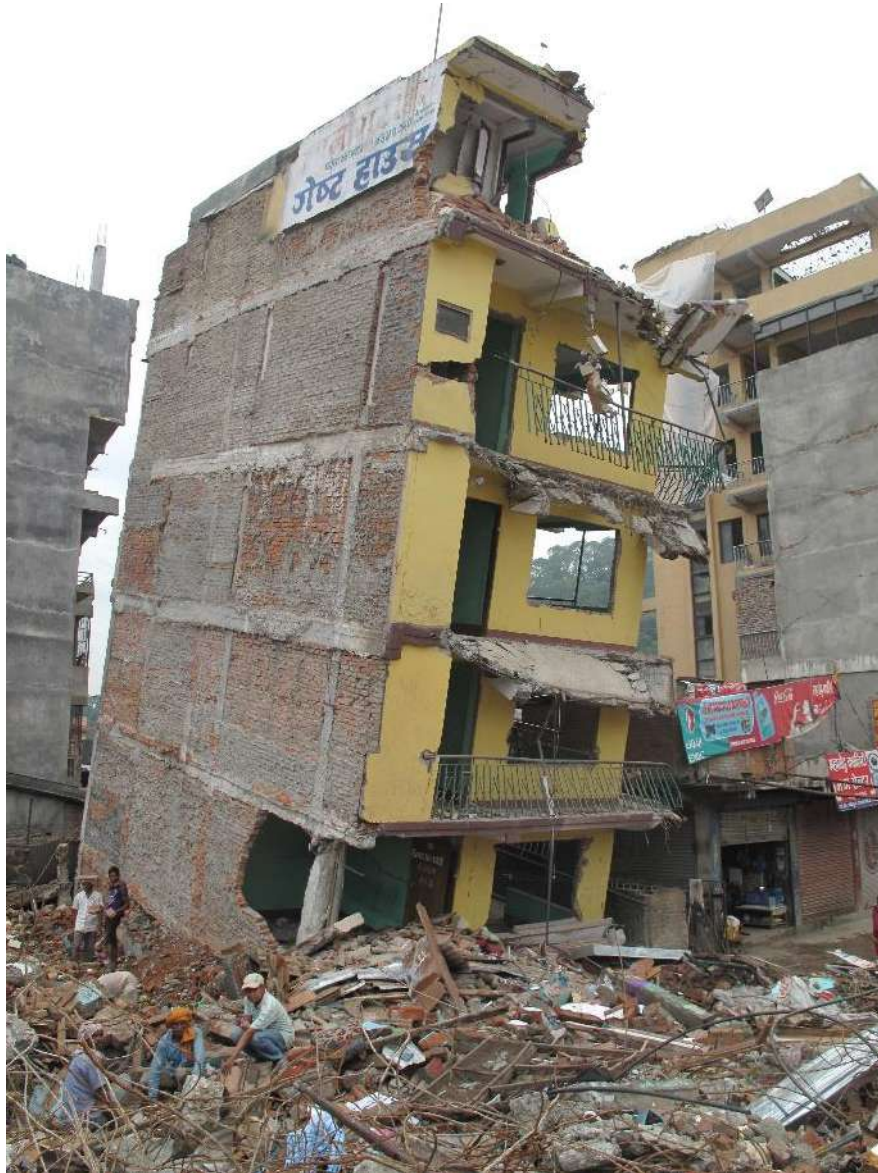
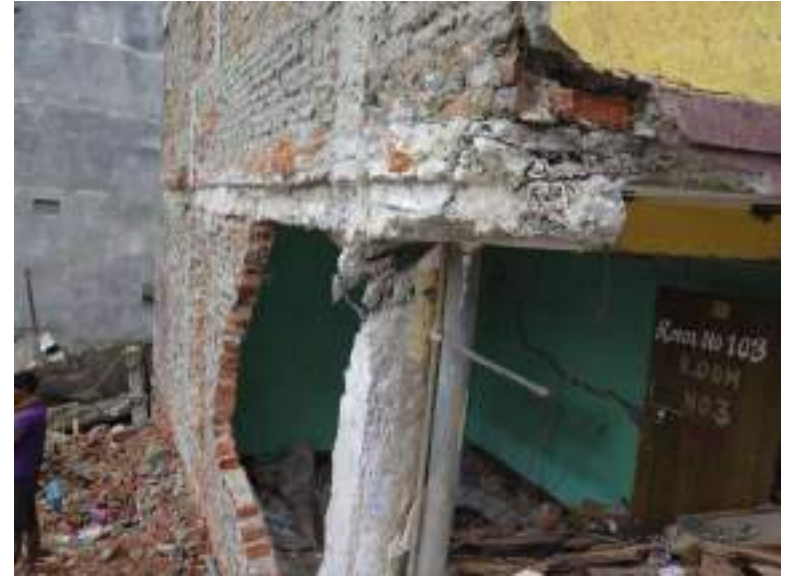
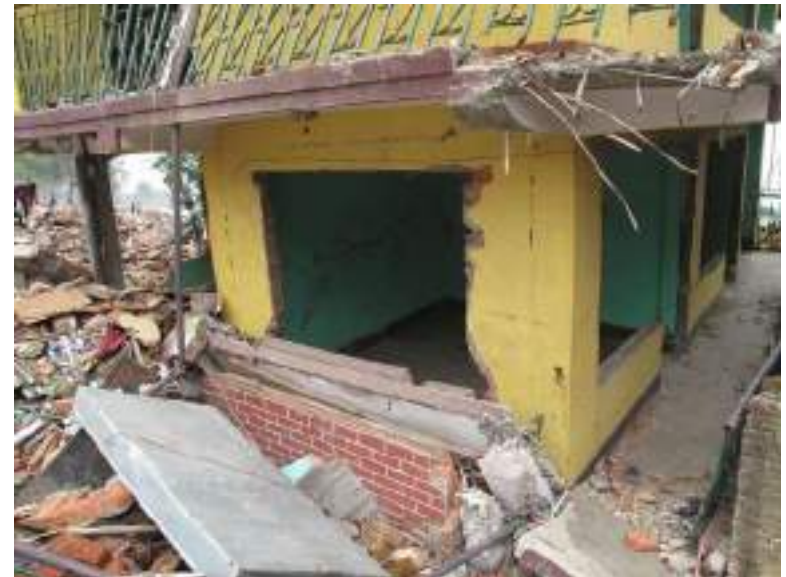
SOFT-STOREY MECHANISMS | IN-ELEVATION IRREGULARITY | FAILURE OF COLUMNS

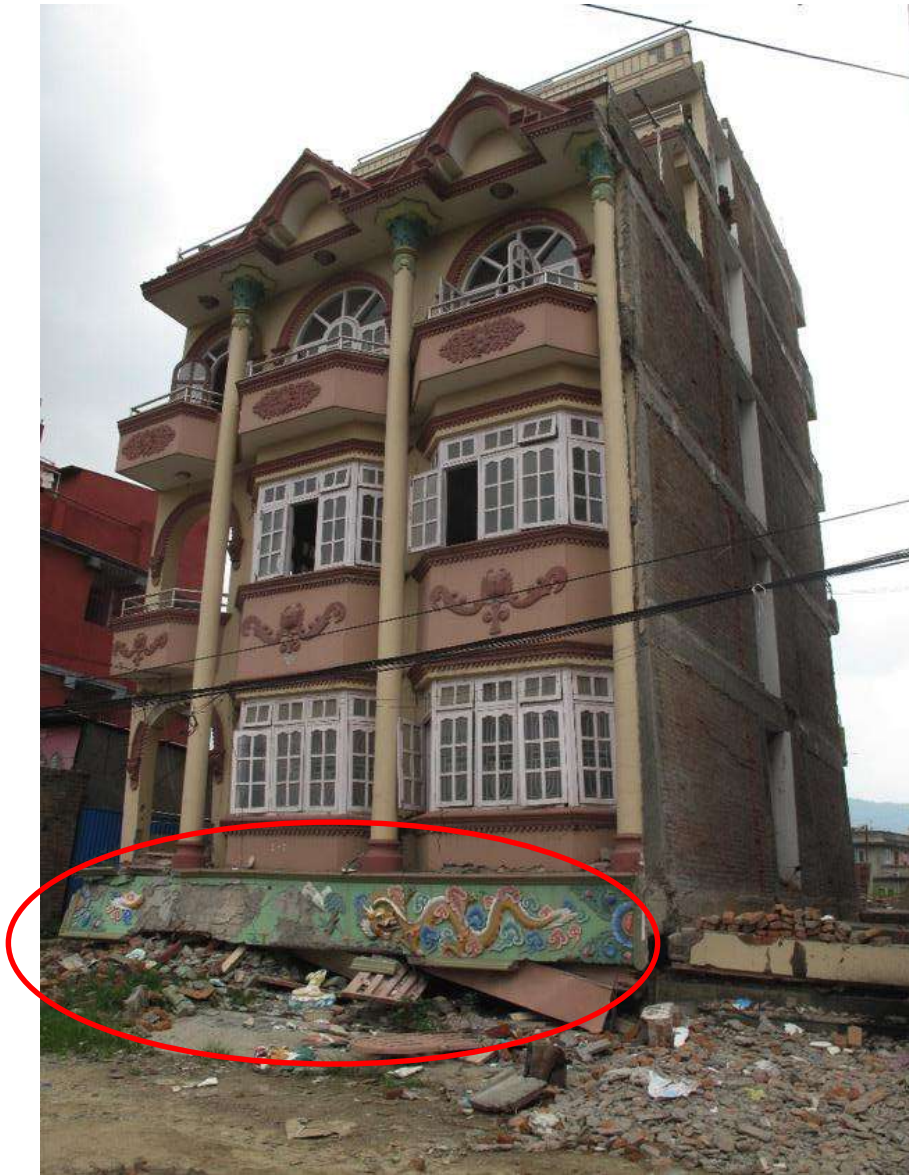
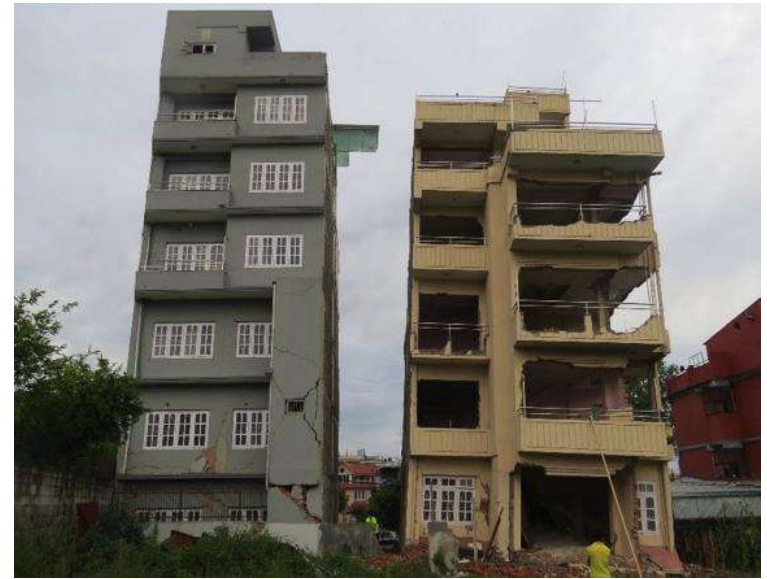
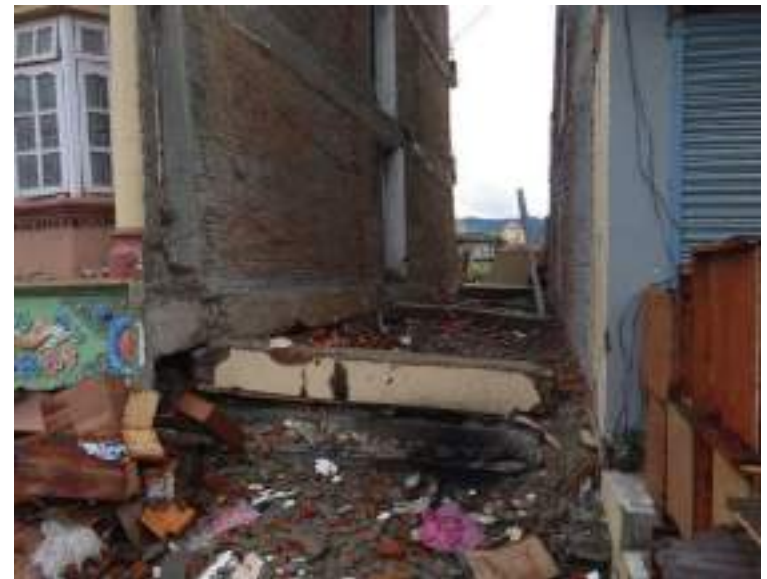
SOFT-STOREY MECHANISMS | IN-ELEVATION IRREGULARITIES | 3+ ADDED STOREYS

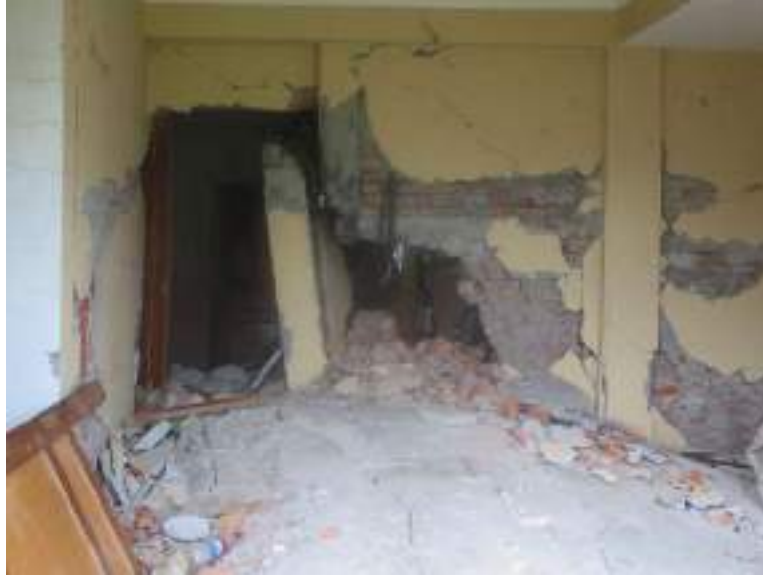
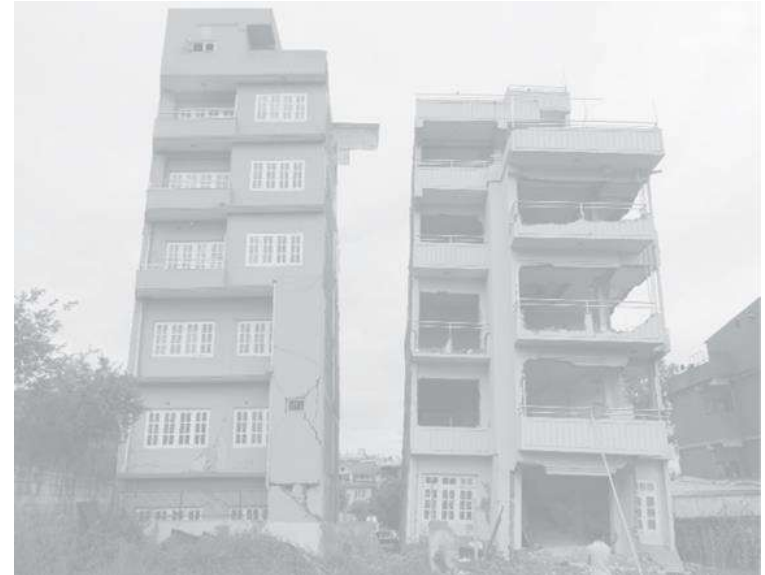
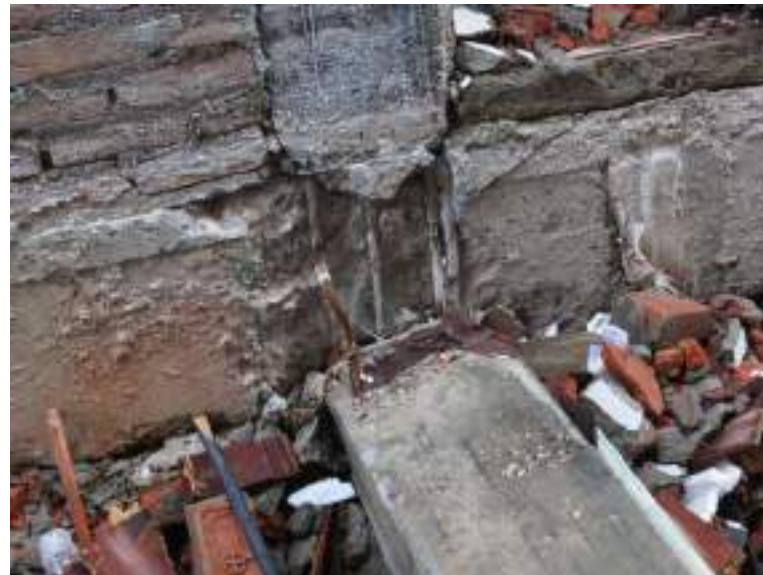
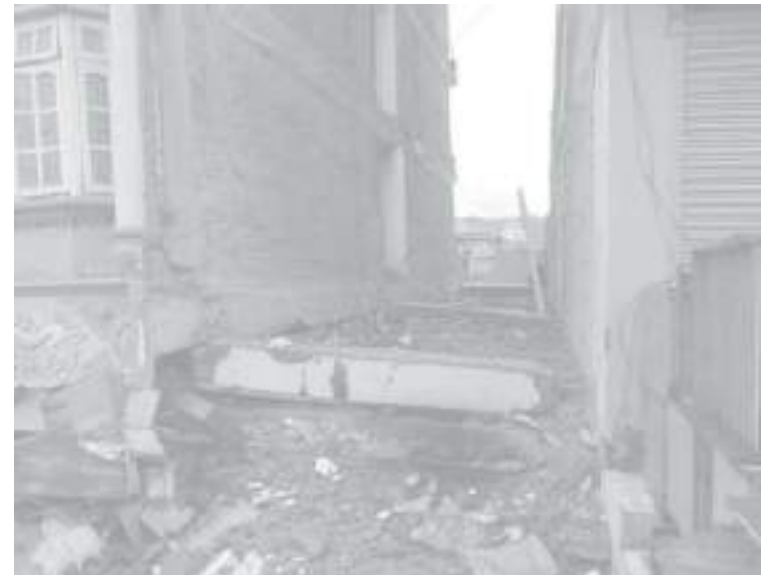
COLUMNS/JOINTS SHEAR FAILURE | POOR DETAILING | INADEQUATE BARS' ANCHORAGE AND INSUFFICIENT STIRRUPS | POOR MATERIALS QUALITY

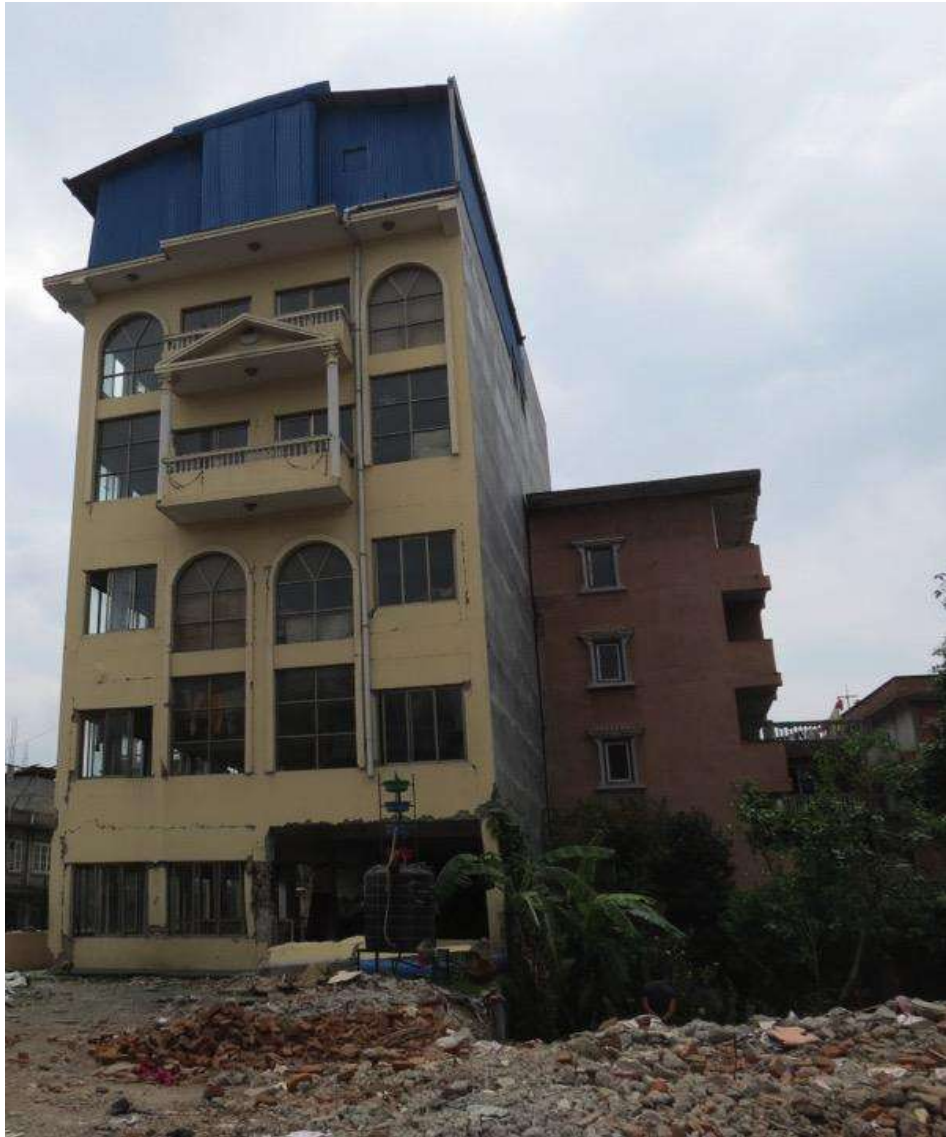
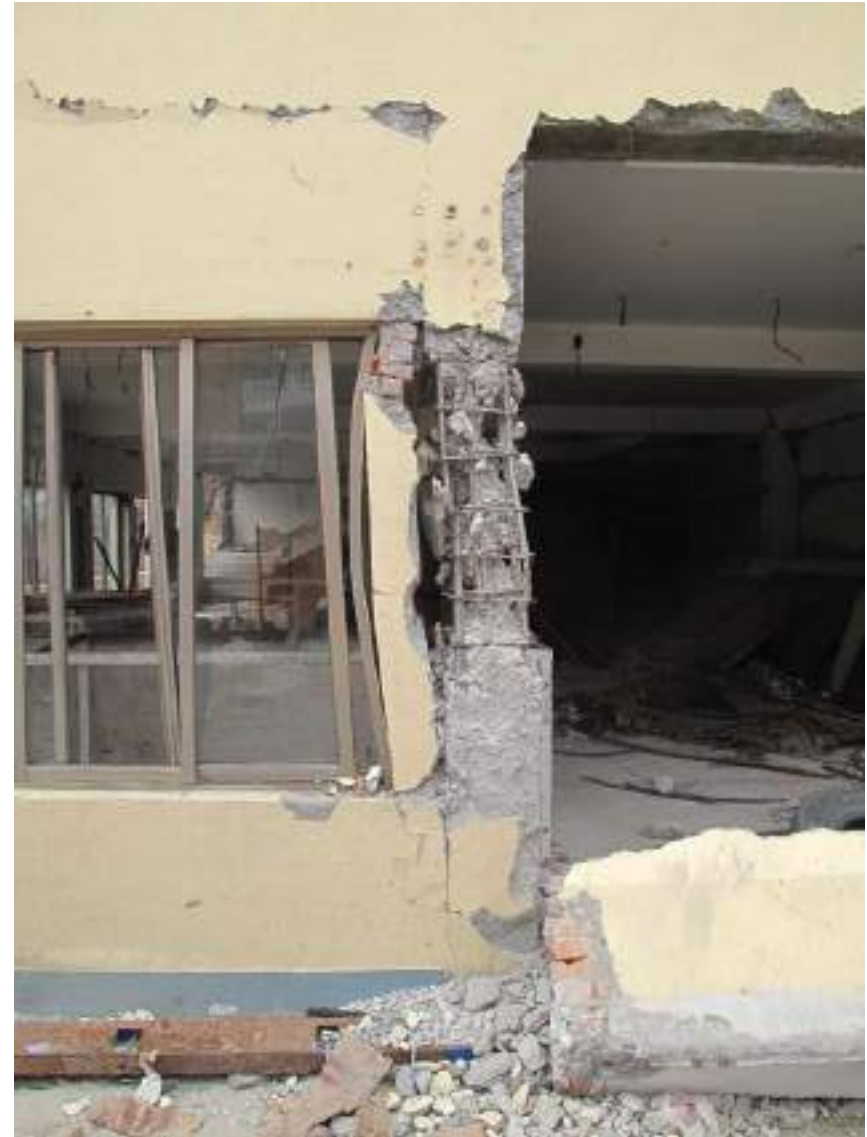
MEDIUM-RISE BUILDING | SEVERE DAMAGES CONCENTRATED IN SOME COLUMNS AT GROUND LEVEL | IN-PLAN IRREGULARITY (ONLY-ONE FULL INFILLED FAÇADE)

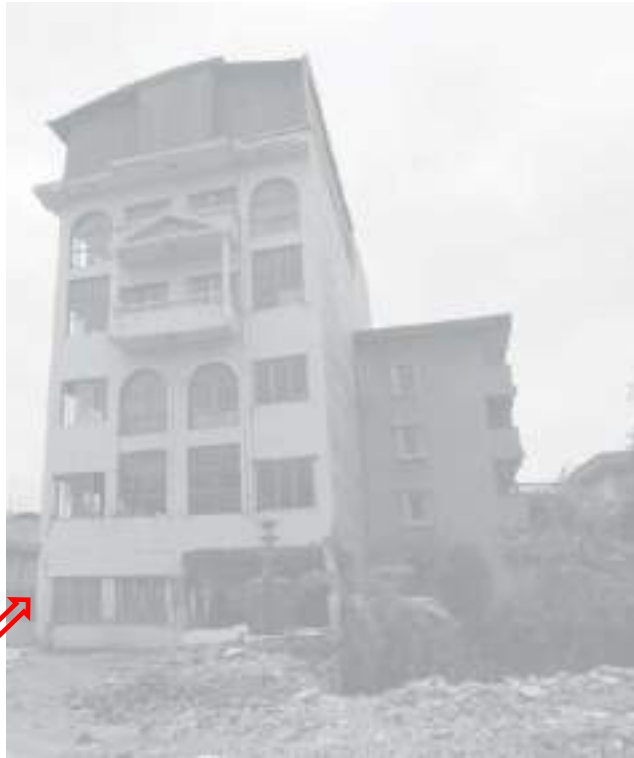
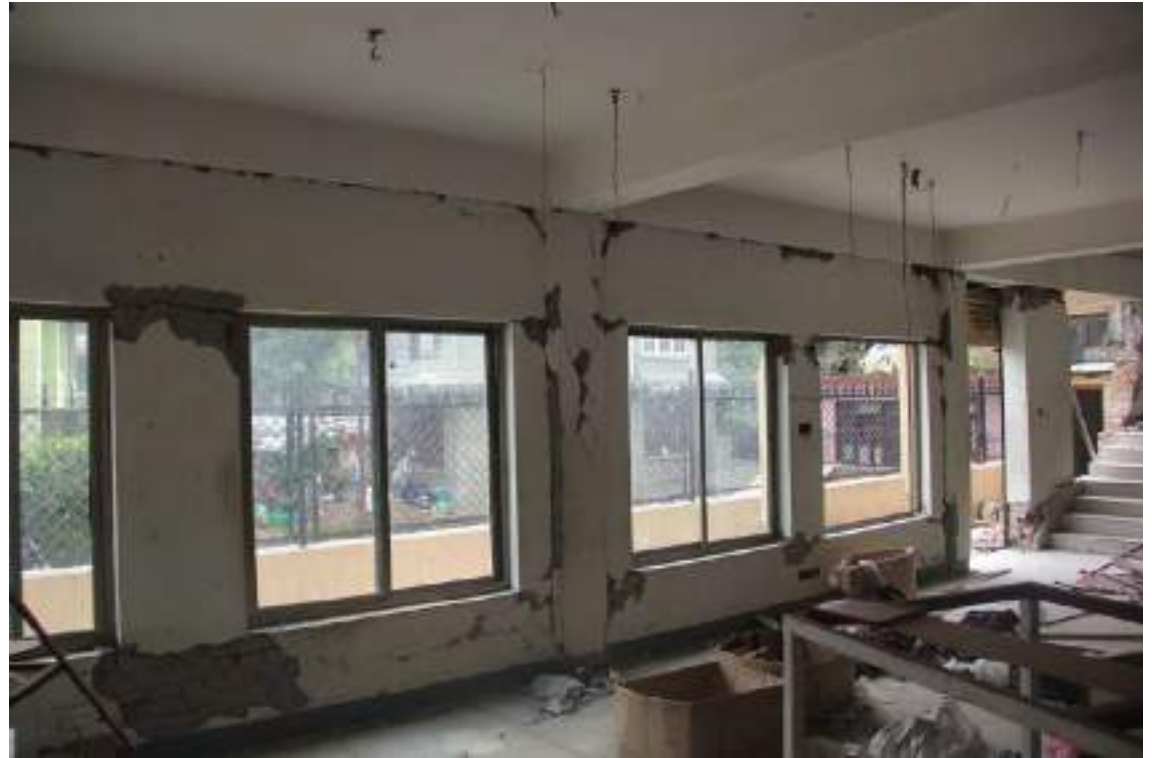
MEDIUM-RISE BUILDING | SEVERE DAMAGES CONCENTRATED IN SOME COLUMNS AT GROUND LEVEL | IN-PLAN IRREGULARITY (ONLY-ONE FULL INFILLED FAÇADE)
