Lecciones aprendidas de terremotos recientes: Ideas para la evolución de los códigos de diseño sísmico

Lessons from recent earthquakes: thoughts for seismic design codes evolution

Humberto Varum, A. Arêde, A. Furtado, H. Rodrigues, J. Melo
 hvarum@fe.up.pt

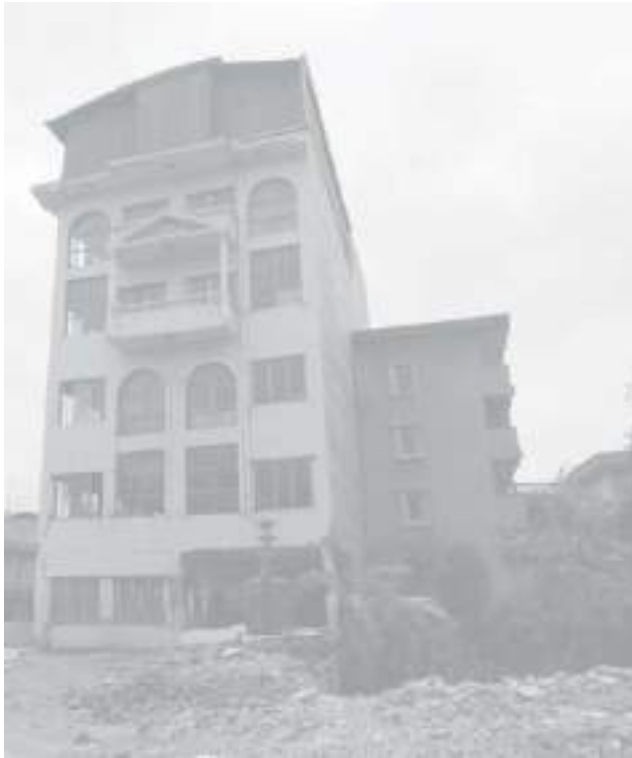
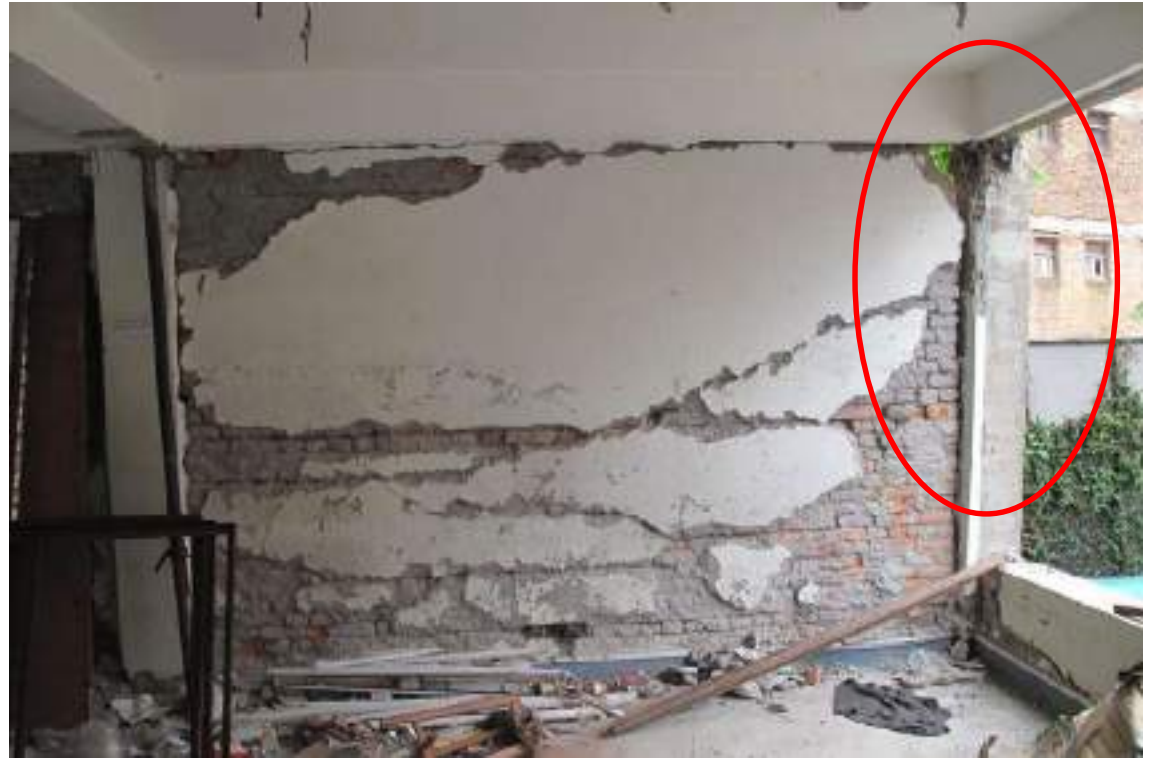
MEDIUM-RISE BUILDINGS | STRONG INFILL WALLS | SHEAR SLIDING MECHANISM AND DAMAGE IN ADJACENT COLUMNS (SHEAR-OUT)

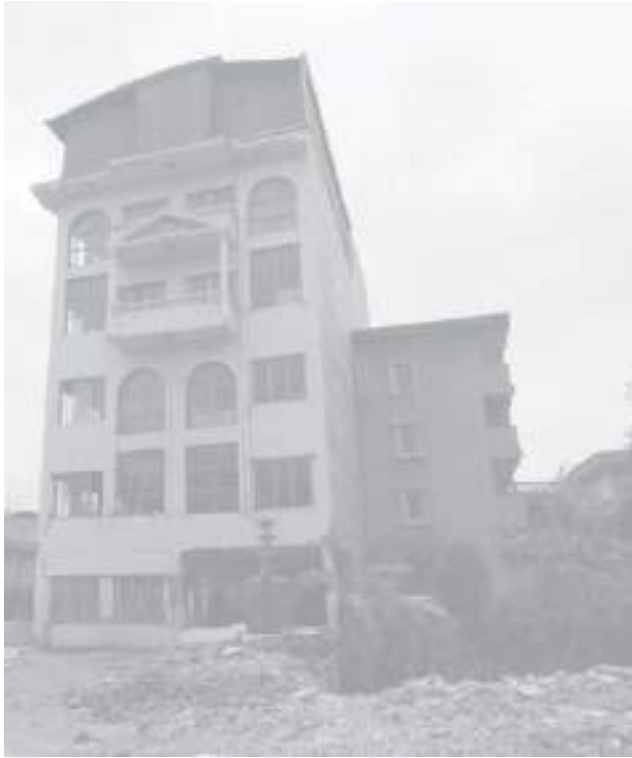
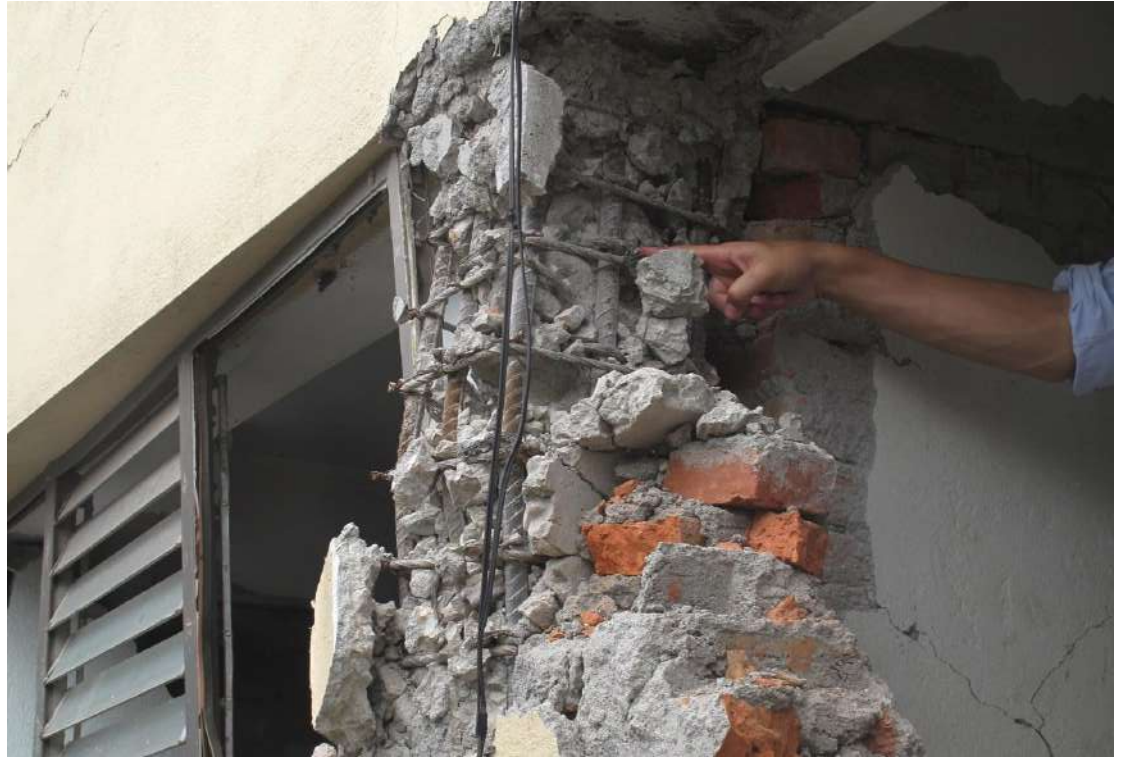
MEDIUM-RISE BUILDINGS | POOR QUALITY OF CONCRETE | SHEAR-OUT

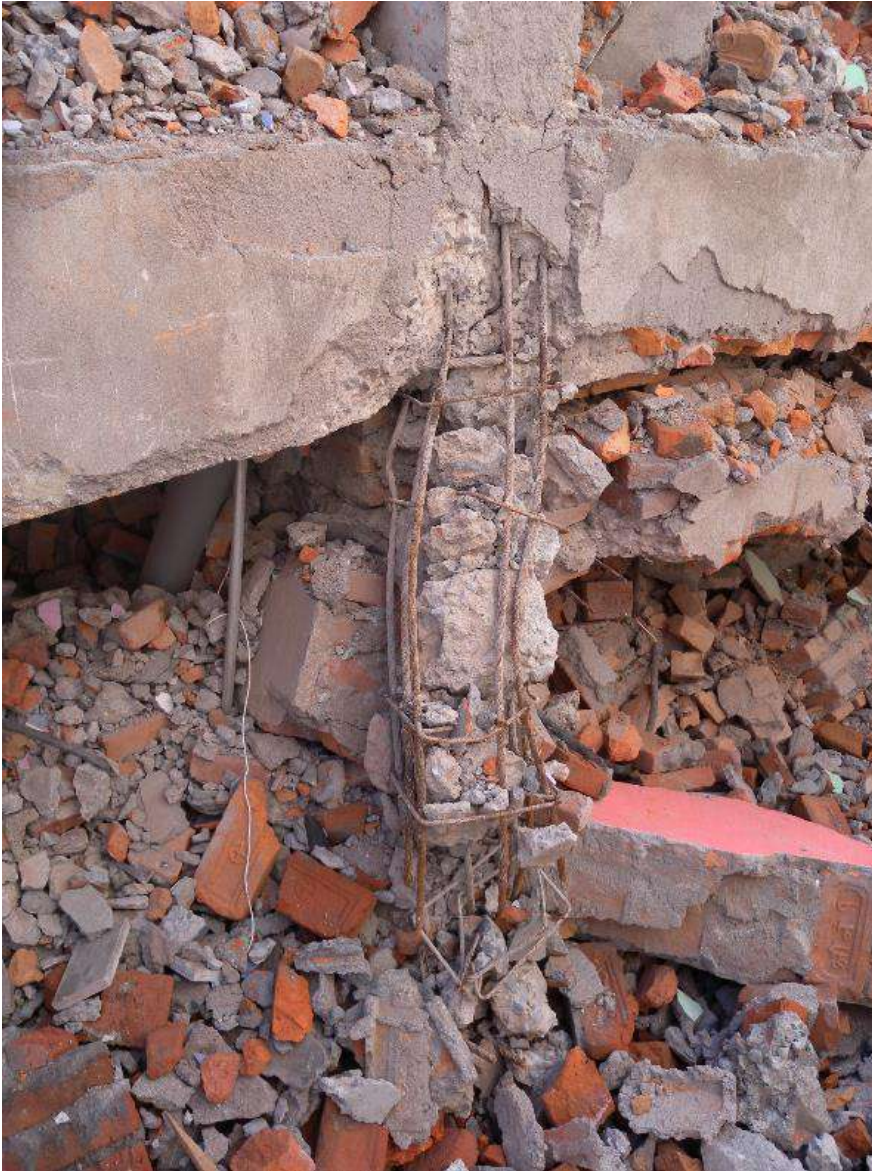
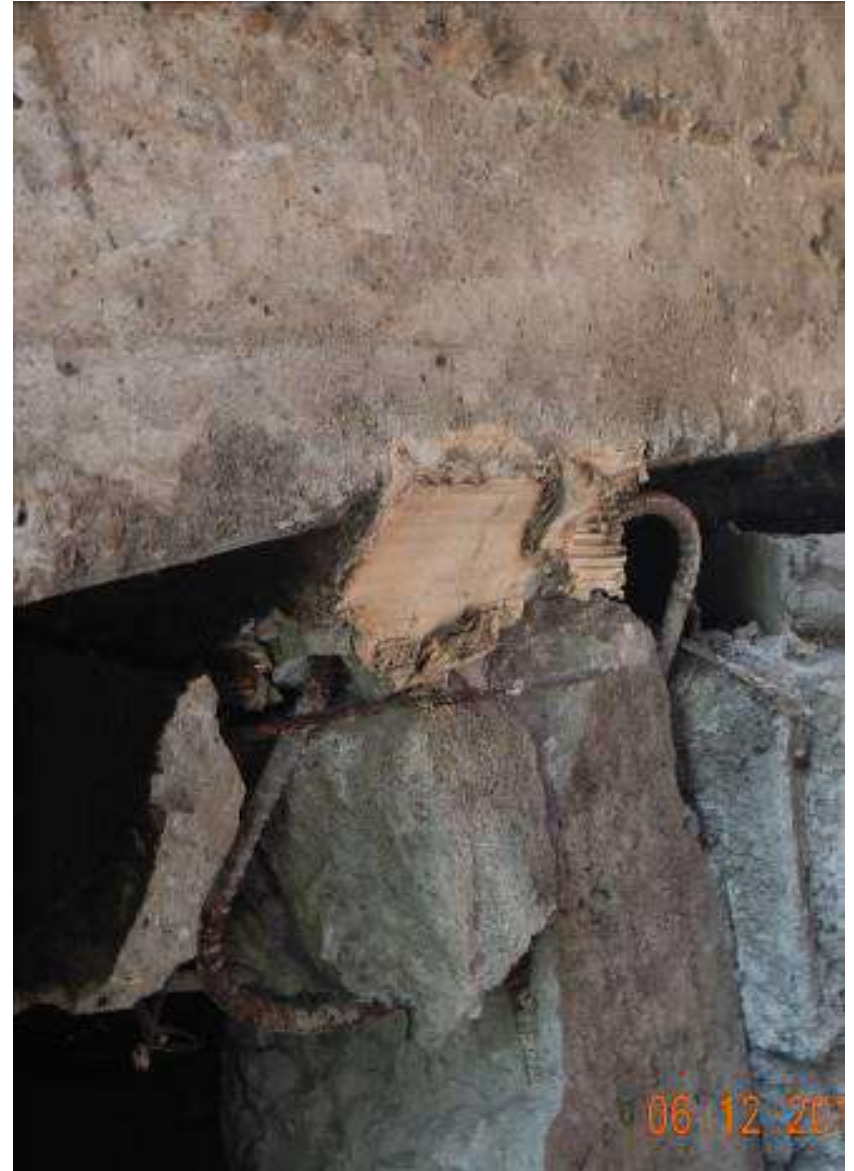
POOR QUALITY OF MATERIALS AND CONSTRUCTION DETAILING

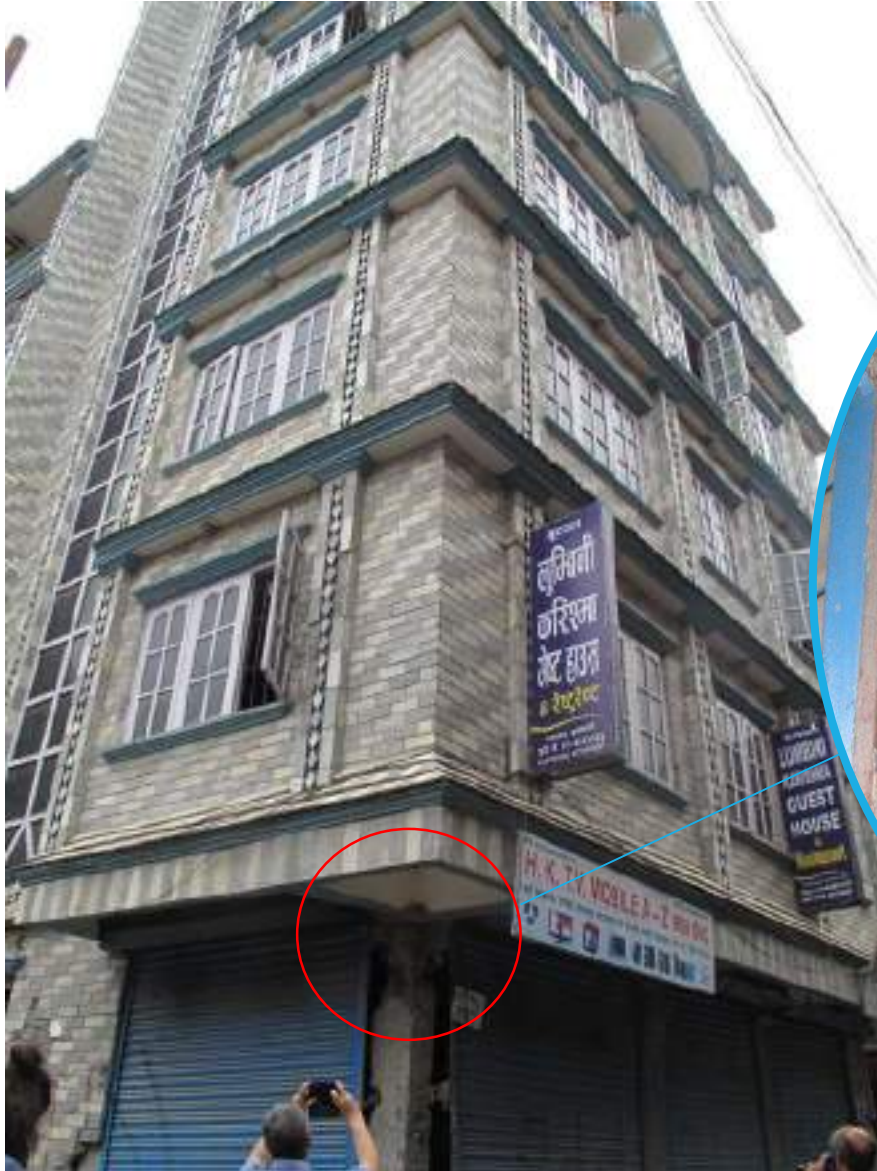
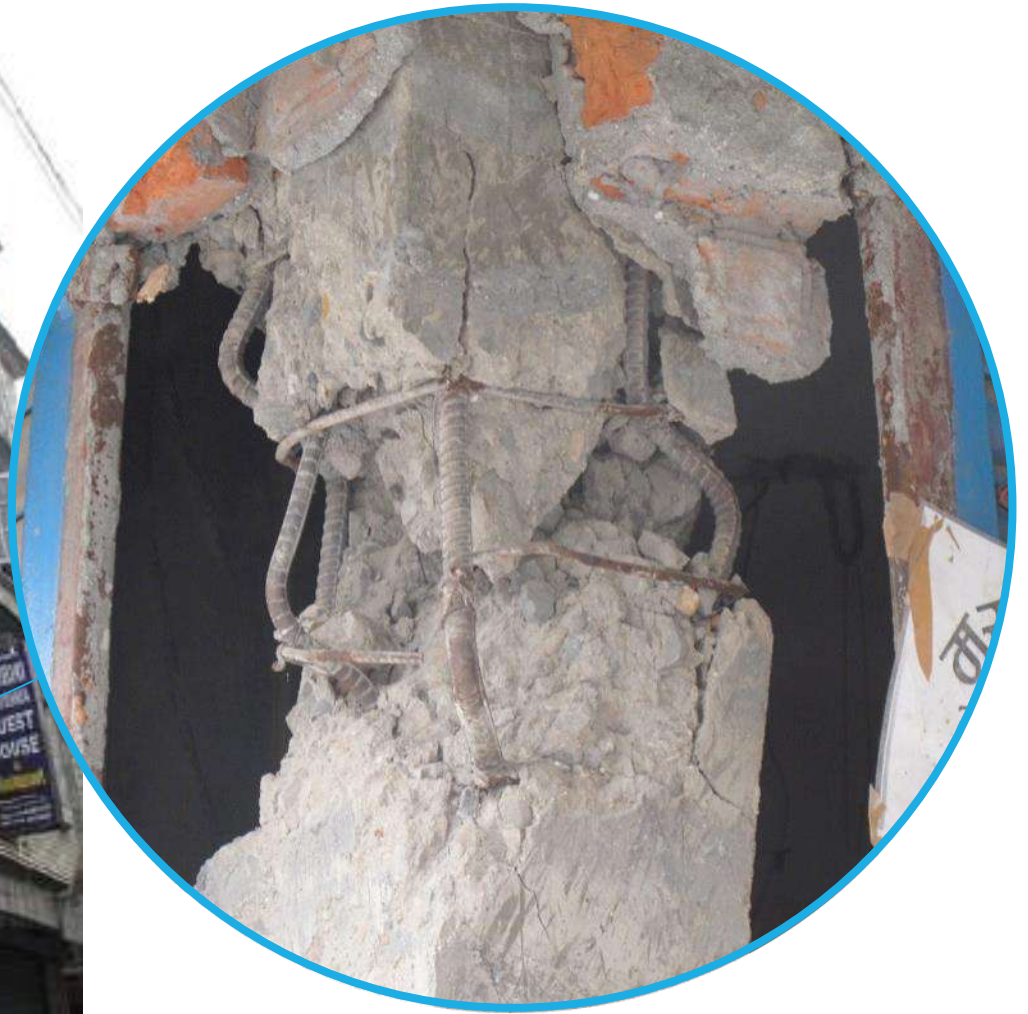
INADEQUATE CAPACITY OF COLUMNS | DIMENSIONS AND DETAILING | SOFT-STOREY

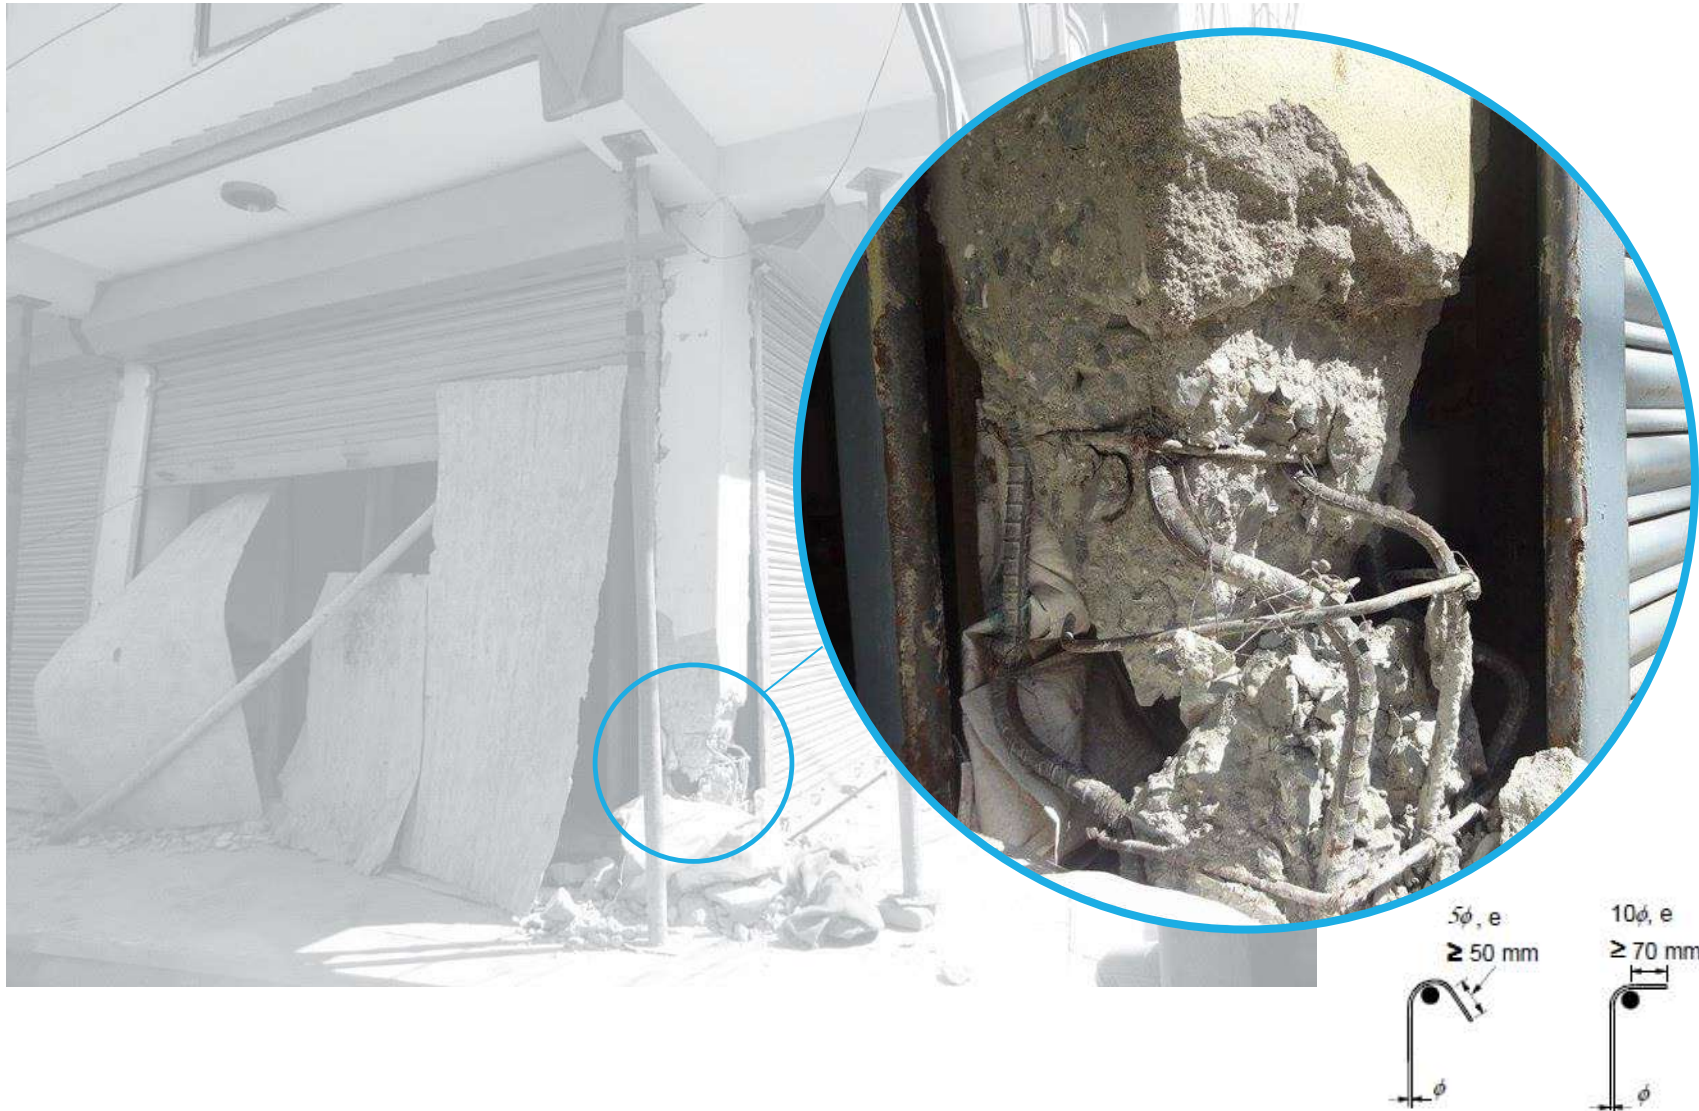
INSUFFICIENT CAPACITY OF RC ELEMENTS | DIMENSIONS AND DETAILING | SOFT-STOREY | STIRRUPS FAILURE

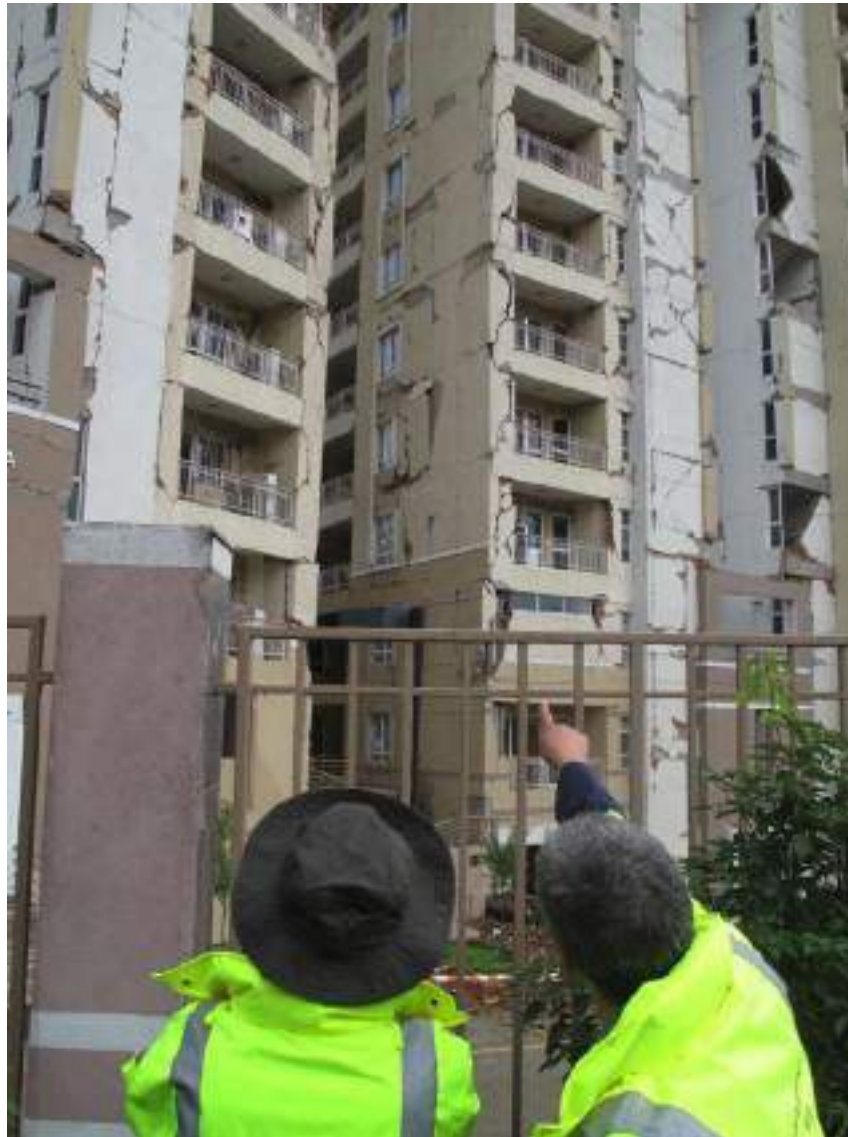
HIGH-RISE WDS BUILDINGS

DAMAGES ESSENTIALLY AT NON-STRUCTURAL ELEMENTS

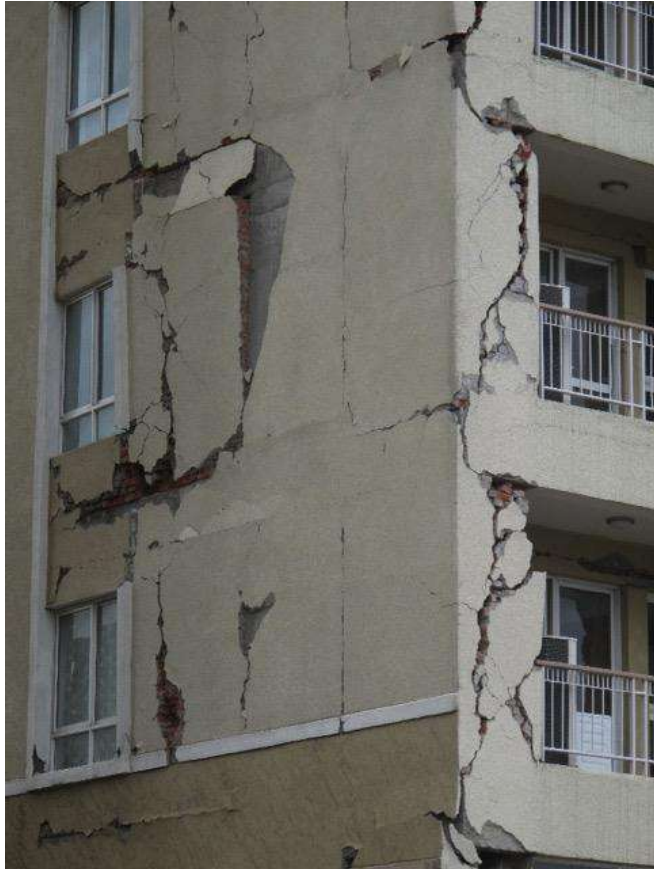
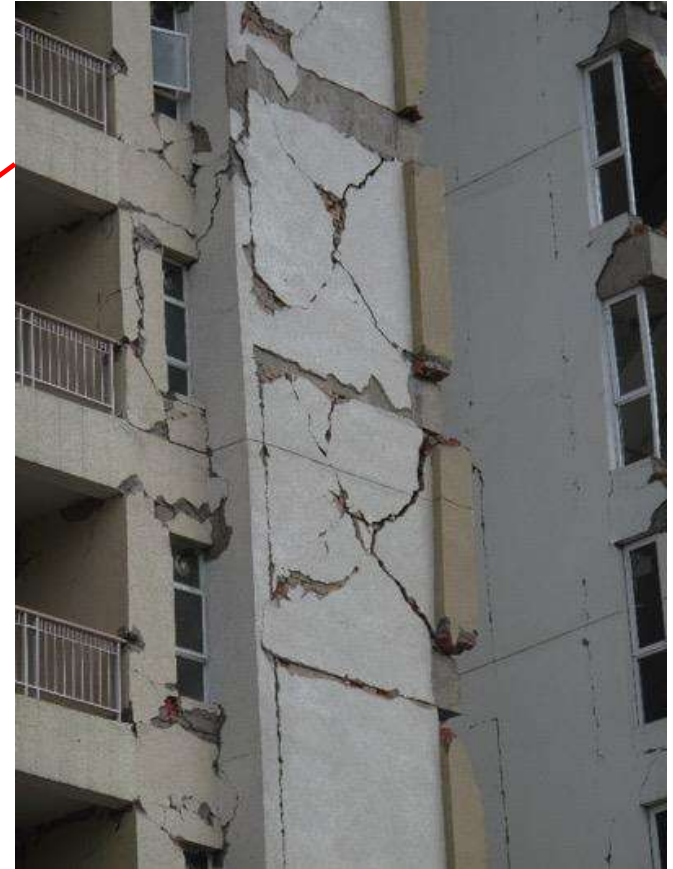
PRONOUNCED IN-PLANE CRACKING | OUT-OF-PLANE COLLAPSE OF WALLS

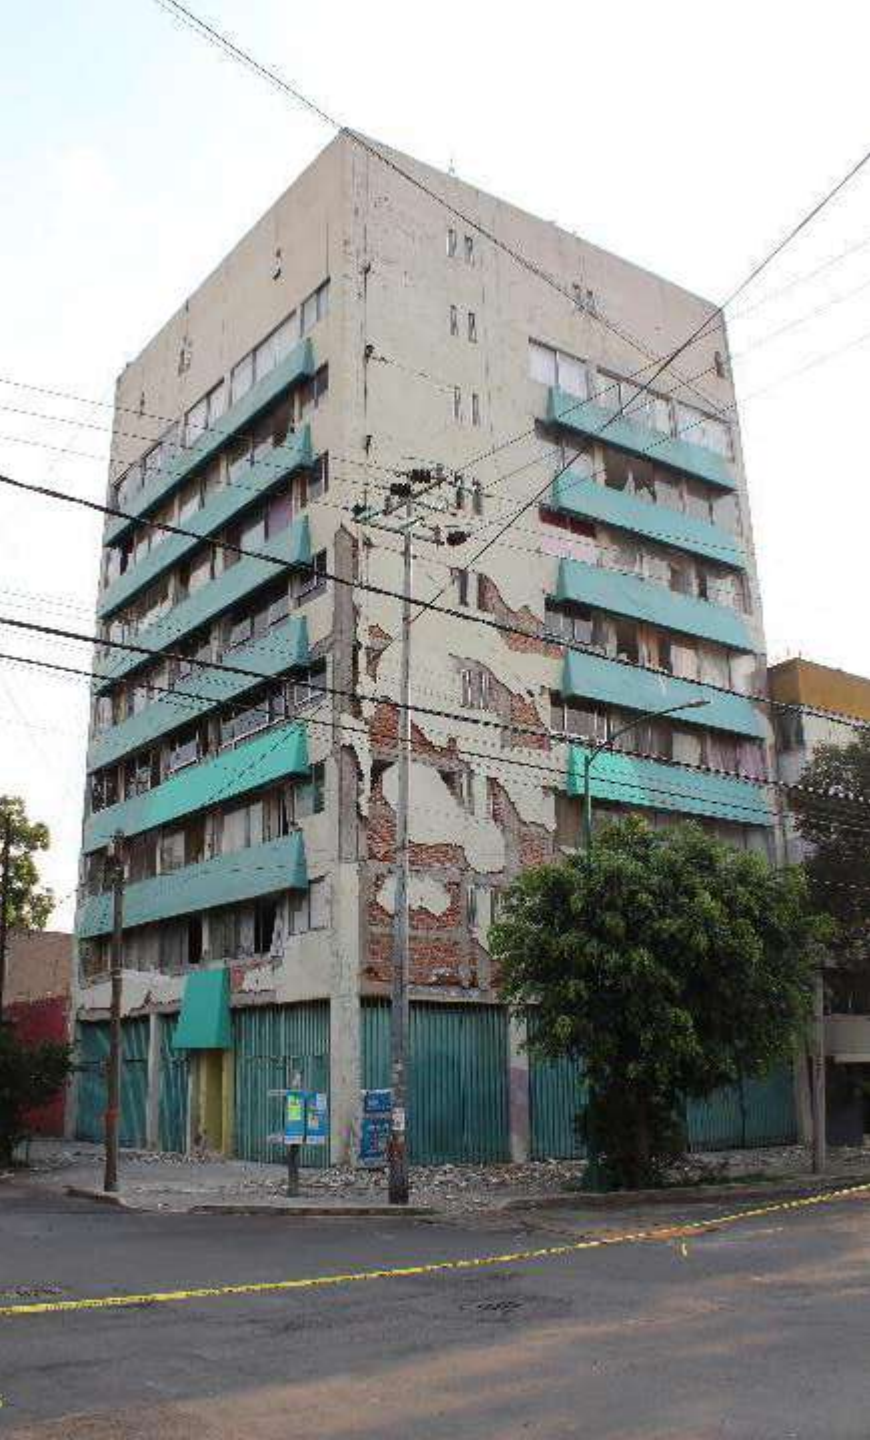
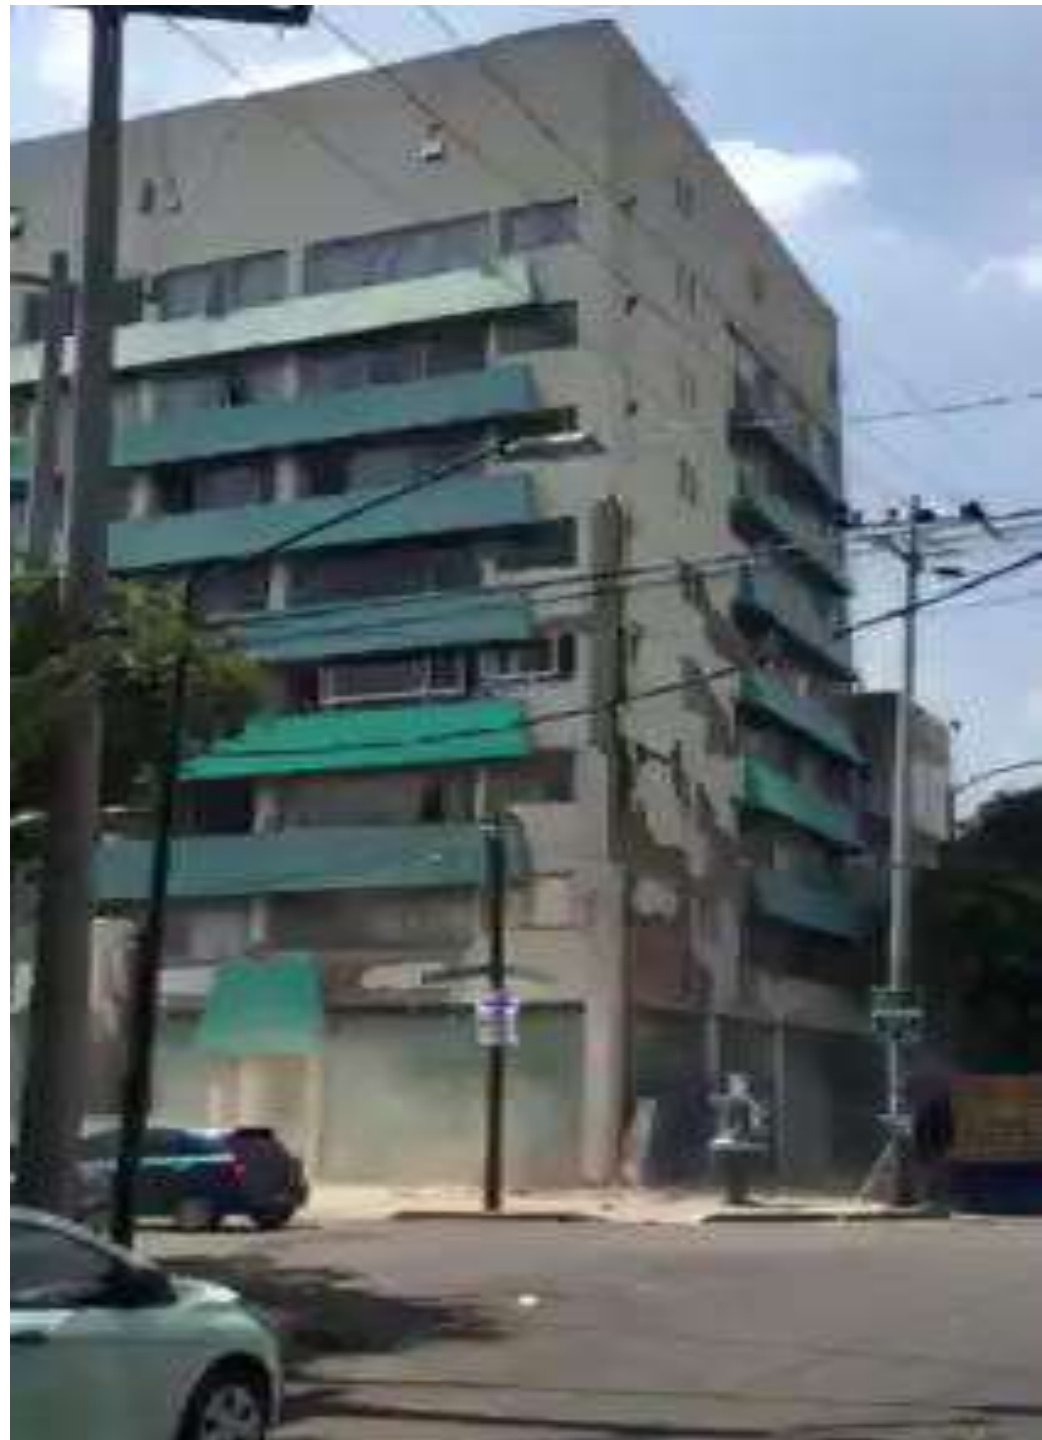
Structural configuration problems were a major cause of failure, or severe damage. Most configuration problems were associated with the contribution of non-structural elements to the building response, especially in corner buildings where two perpendicular facades were fully infilled with masonry walls, and the facades facing the street were left open.
