MAN = RECONDITIONING OF EXISTING ADOBE HOUSES  
TO MITIGATE EARTHQUAKE EFFECTS

An advance of the present research project, that corresponds to the celebrated Agreement between the Regional Center of Seismology for South America (CERESIS) and the Deutsche Gesellschaft für Technische Zusammenarbeit (GTZ), the same that is under execution at the Structures Laboratory of the Catholic University of the Peru (PUCP), is presented in this paper.

The main objective of the project is to evaluate and decide on simple and economic strengthening procedures that will enable existing adobe houses to resist strong earthquakes without collapse, letting their occupants enough time to get out and save their lives. This project was selected by UNDRRO under the International Decade for Natural Disaster Reduction.

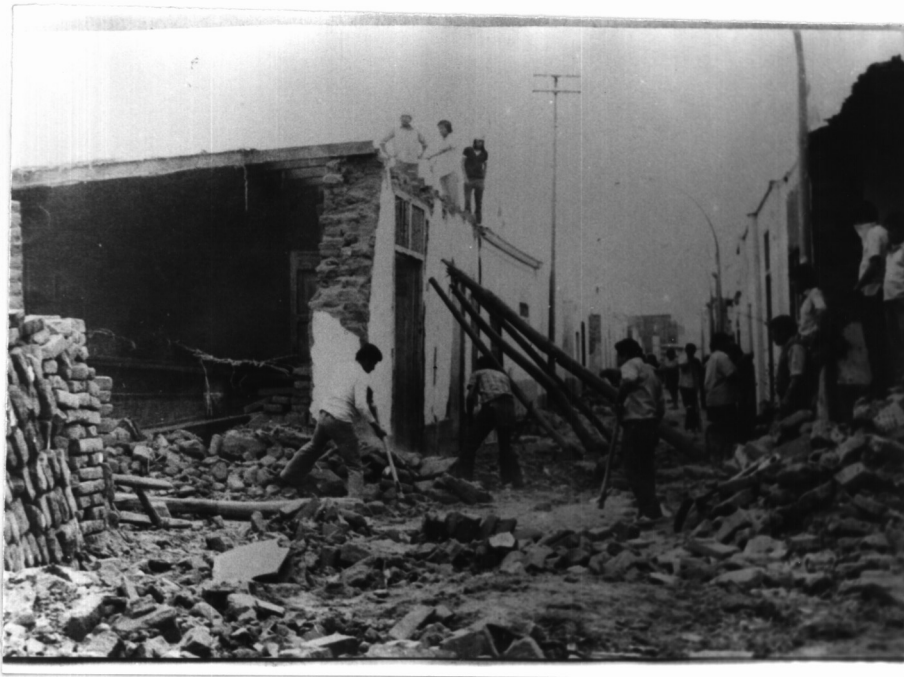
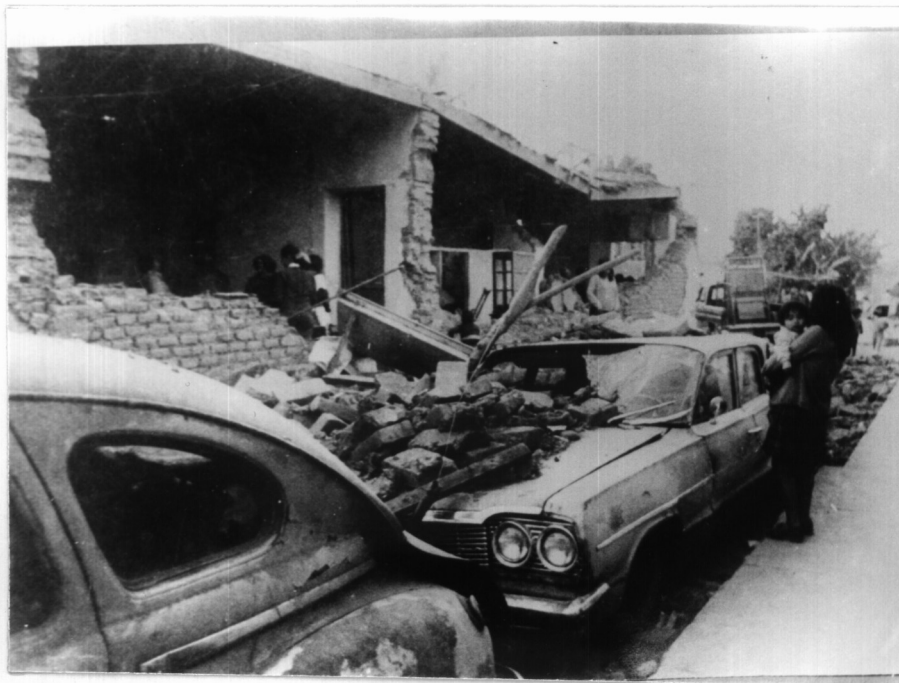
Fig. 7 Collapse of Adobe Houses in Ancash, Peru, after the May 31, 1970 earthquake.

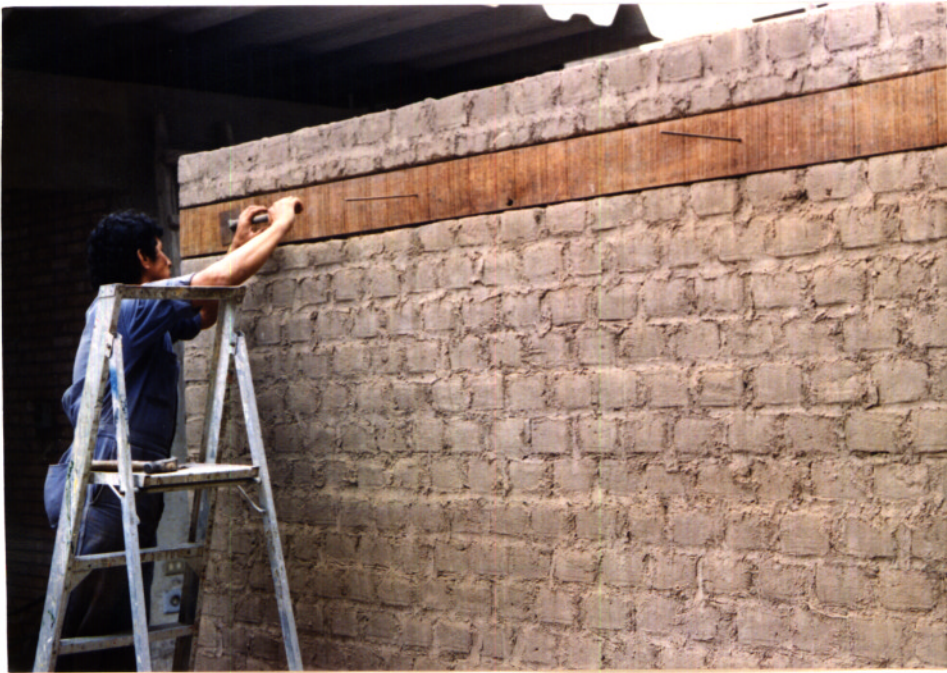
Fig. 8 Type 1 Reinforcement

- b. - Construction and seismic simulation tests in shaking table (Figs. 11 and 12) of four preliminary specimens, whose geometric characteristics are shown in Fig. 1. These specimens were: Wall 1, traditional unreinforced; Wall 2, reinforced with wood board and steel rod ties (Figs. 2 and 8); Wall 3, reinforced with rope (Figs. 3 and 9); and, Wall 4, reinforced with wire mesh covered with mortar (Figs. 4 and 10). The seismic record used was the corresponding to the Peru earthquake of May 31, 1970, with 30 seconds long.

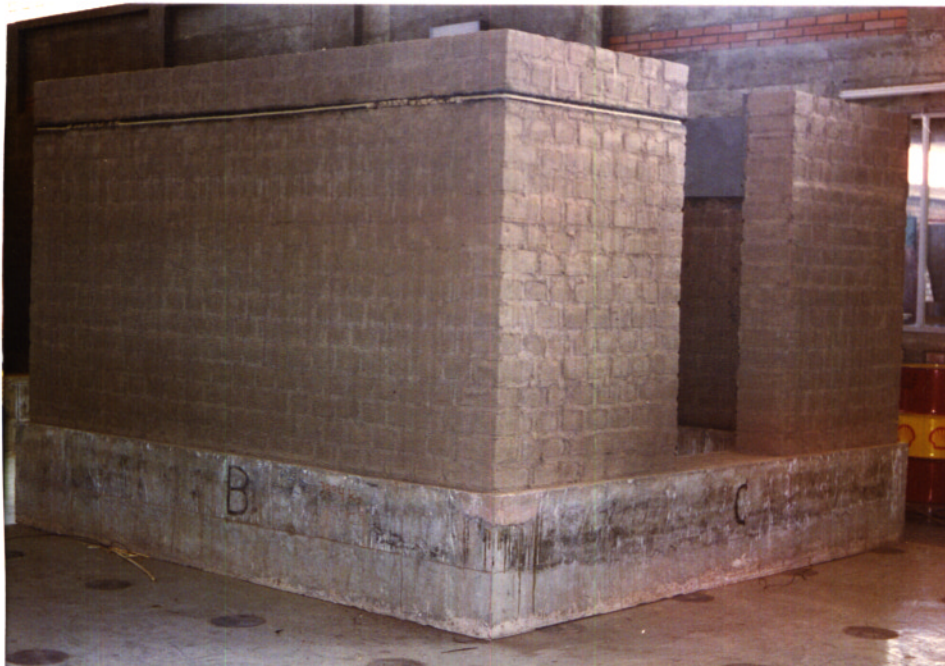
Fig. 9 Type 2 Reinforcement

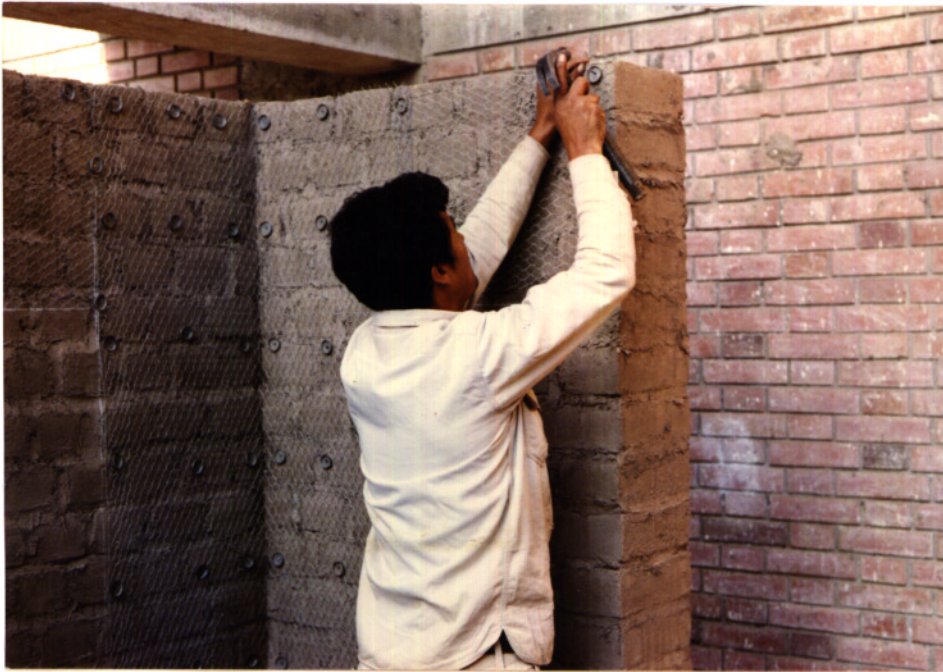
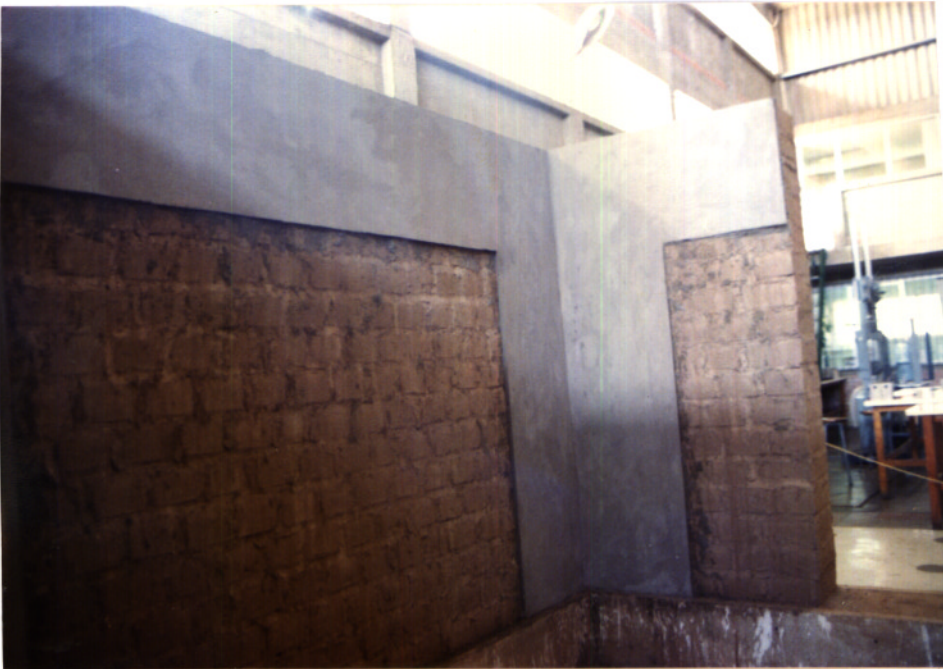
Fig. 10 Type 3 Reinforcement

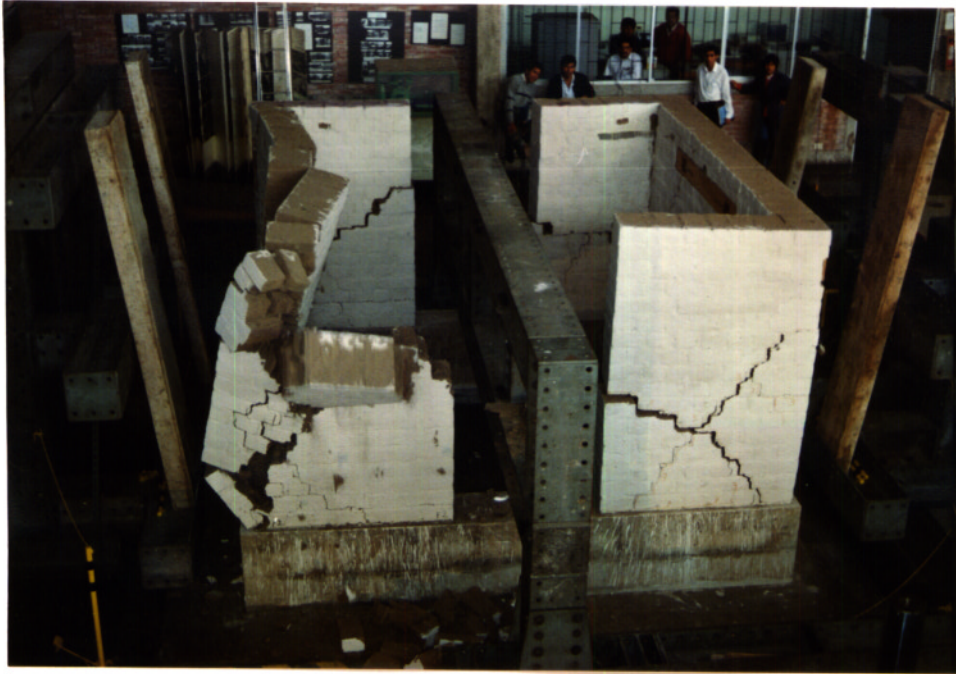
Fig. 11 Shaking table test on unreinforced wall (left) and wall with type 1 reinforcement (right)

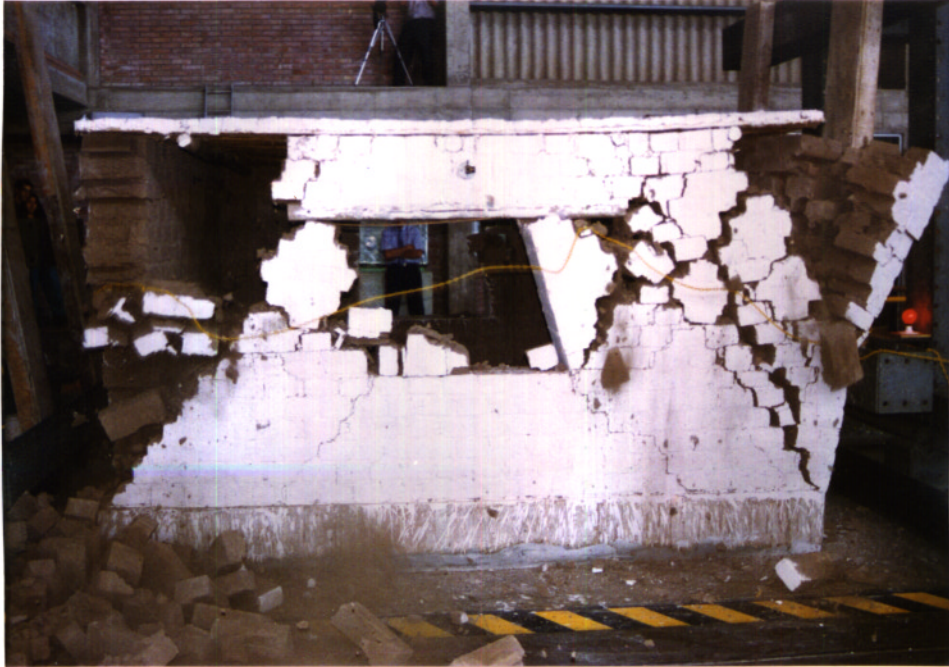
Fig. 13 Collapse of unreinforced adobe house specimen (typical of the Coastal Zone), tested on shaking table

The advance accomplished during this period, demonstrates that it is possible to reach the main objective of the Project. The next step is to investigate the seismic behavior of the described reinforcement, using it in specimens that actually represent the type of existing adobe houses in Peru (figs. 5, 6, 13 and 14).

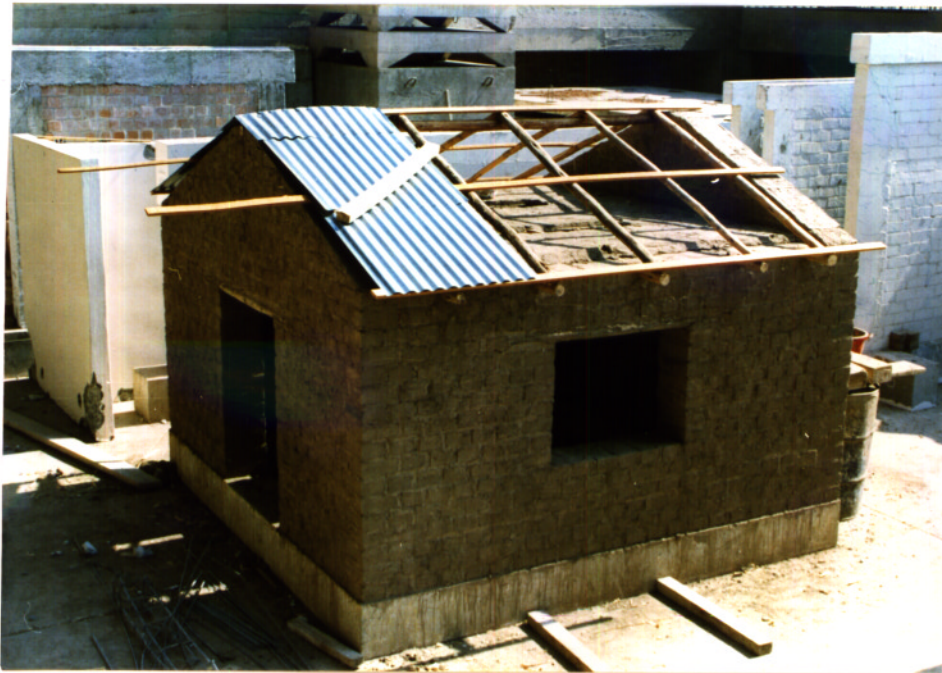
Fig. 14 Unreinforced adobe house specimen (typical of the Andes) under construction
