SEISMIC BEHAVIOR OF A TWO STORY MODEL OF CONFINED ADOBE MASONRY

ABSTRACT

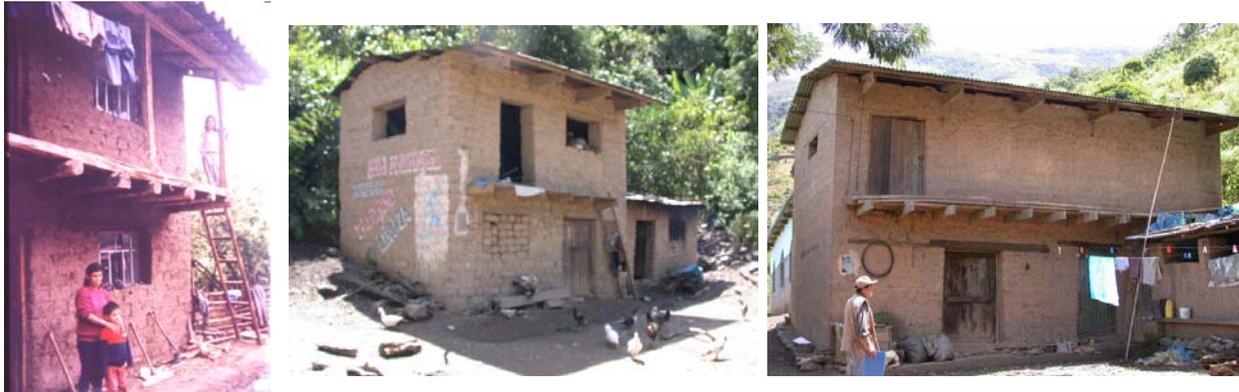
In the Andean highlands, especially in Peru, many traditional adobe houses have two or more stories (Figure 1). These constructions usually have no reinforcement, and when they have been hit by an earthquake, they had collapsed causing injuries or even death of their occupants. However, adobe is still the best solution for poor people housing in highland areas, due to economic reasons; also, earth units are the only available material suitable for walls due to their thermal properties. This project was thought on how to reinforce such two story houses, by

Figure 1: Traditional two-story adobe houses in Peru highlands

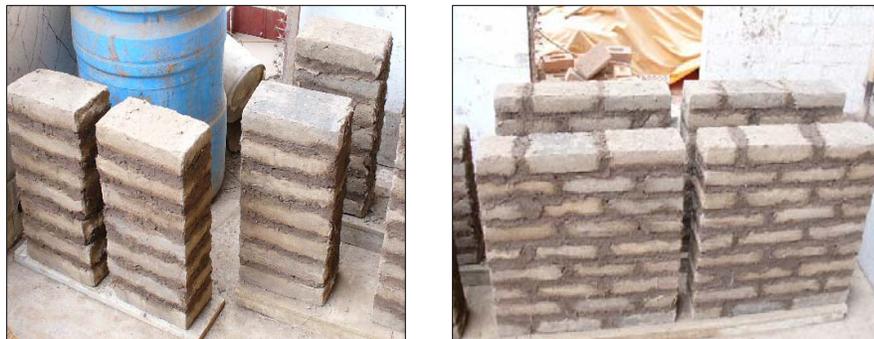
Compression tests were performed on 4 prisms (Figure 3). These prisms had 7 layers with 20 mm joint thickness. The average compressive resistance was $f'_m=0.9$ MPa. Four small walls with 0.80m side were also constructed in order to perform diagonal compression tests to evaluate the shear resistance. However, some units of these small walls had such a weak adherence that they detached from the wall during the handling prior to the test. Therefore, the shear resistance values were very low and with high dispersion, so those values are not useful.

Figure 3: Adobe prisms and small walls

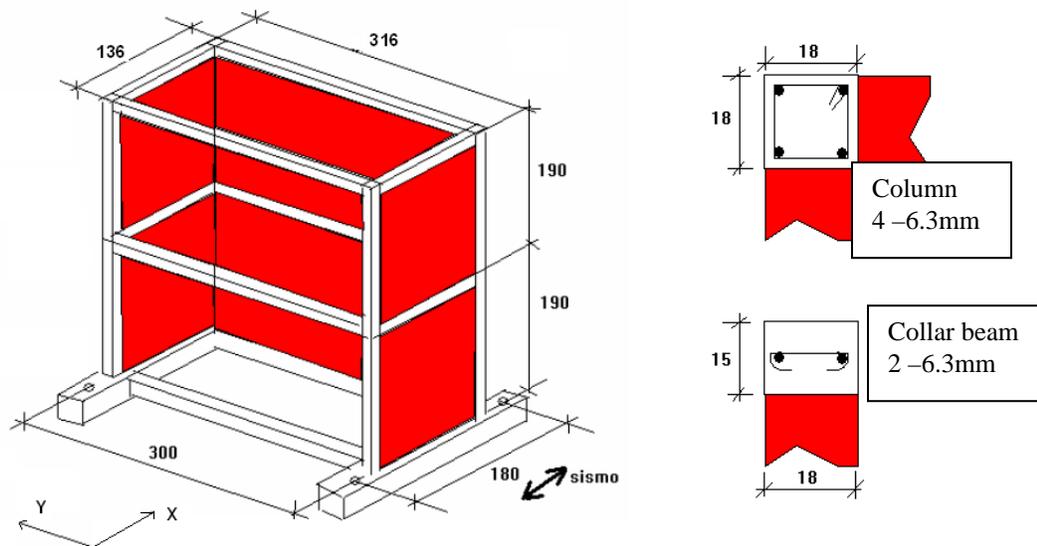
The reinforcement should be able to resist the diagonal cracking load of the walls parallel to the movement. Then, using the same steel ratio, the reinforcement for the scaled model was obtained. Columns had a section of 180 mm square, with 4 – 6.3 mm (1/4”) longitudinal bars, and closed ties 1 at 50mm, 4 at 100 mm, rest at 250 mm. The collar beams had a 180x150mm section with 2 – 6.3 mm (1/4”) longitudinal bars, and hooks 1 at 50mm, 4 at 100 mm, rest at 250 mm. The first story featured 1 bar 6.3 mm (1/4”) every 5 layers, along the wall and anchored in the columns (Figure 4).

Figure 4: Adobe two-story specimen

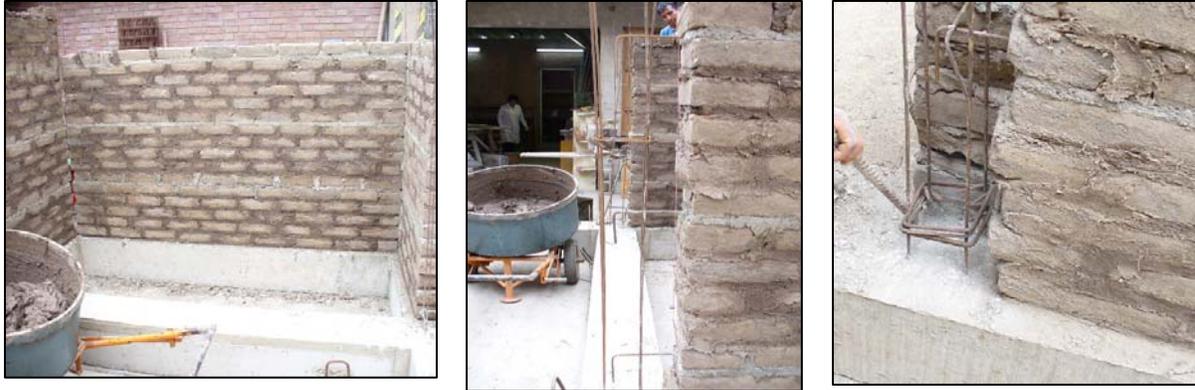
The construction procedure is described as follows (see Figure 5 for the first story and Figure 6 for the second story). First, the adobe units were wetted prior to placing to reduce their suction. The adobes were placed using mud mortar and had 20 mm joints controlled with a stick. The adobe-column connection was vertical and a one-6.3 mm horizontal bar was placed inside a joint of 1:5 cement mortar every 5 layers. After the adobe wall was finished, the concrete of the columns was poured. Next, the collar beam concrete was poured. The removal of forms was done the day after the pouring. For the second floor, the construction procedure was similar, except that no horizontal reinforcement was included and no anchoring bars were used to join the columns and adobe walls. To simulate the stories, wood beams were used laying on the longer collar beams and connected with wires in U shape embedded in the longitudinal collar beams.

Figure 5: Details of the first story construction

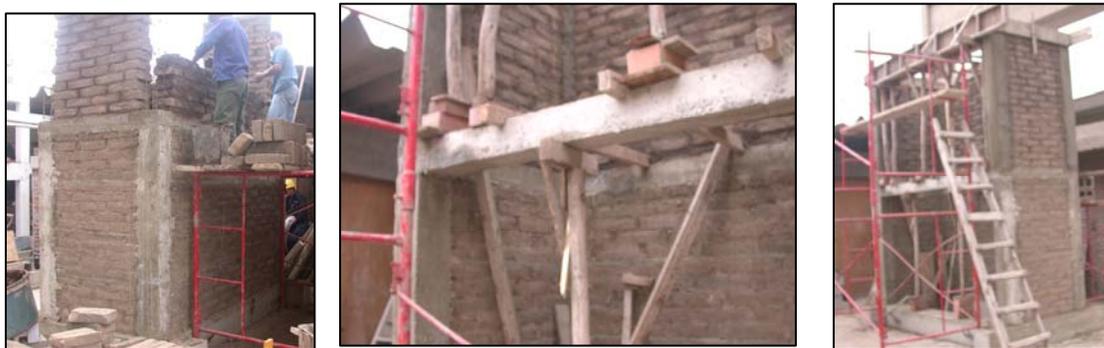
Figure 6: Details of the second story construction

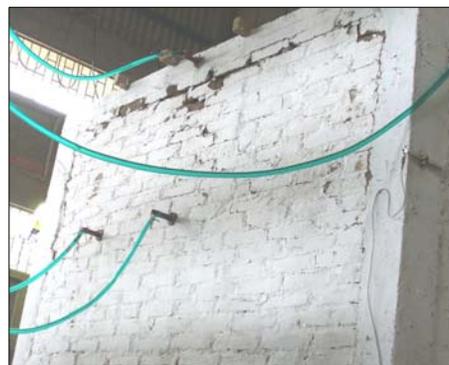
After step 2, the first crack become thicker, and vertical cracks started at the connection between column and flexure wall in the mid height of the second story (Figure 8). A stair-step diagonal shear crack appeared in the first story shear walls and in the lower half of the second story shear walls. At this stage, no cracks had appeared in the columns or collar beams. The failure probability of the second story flexure wall was quite high at this moment so the accelerometers A5, A7 and LVDT D5 were removed. Two wooden columns were installed at the model outside (with 30 mm gap with the adobe wall) to prevent outward collapse.

Figure 8: Second story flexure wall after step 2.

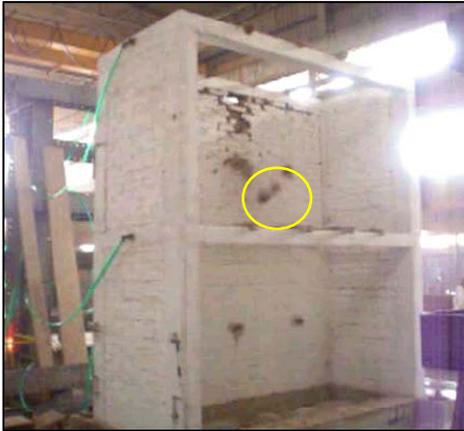
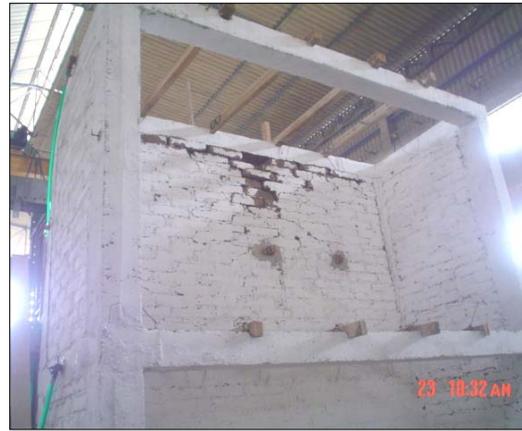
At the end of step 3, one unit of the upper layer of the second story flexure wall fell down, and it could be seen that this wall was near collapse (Figure 9). The stair-step shear cracks in the shear walls were amplified. Also, some vertical cracks appeared at the first story column-beam connection. It must be mentioned that no cracks appeared in the first story flexure wall.

Figure 9: Specimen during step 3 (left) and after step 3 (right).

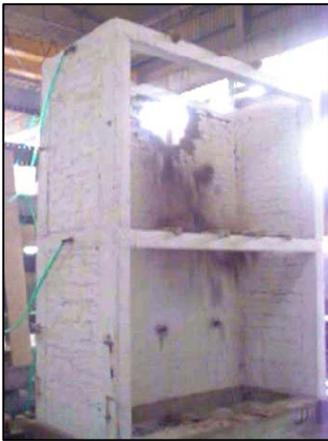
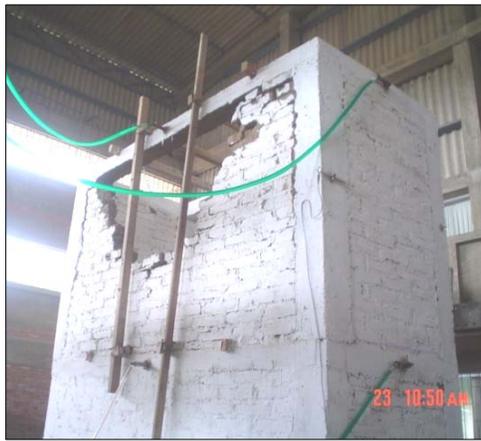
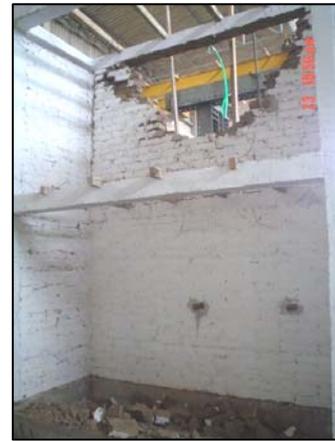
During step 4, the central triangular part of the second story flexure wall collapsed (Figure 10). The shear cracks continued increasing their width, but the adobe units were not crushed. The first story flexure wall remained without cracks.

Figure 10: Specimen during step 4 (left) and after step 4 (center and right).

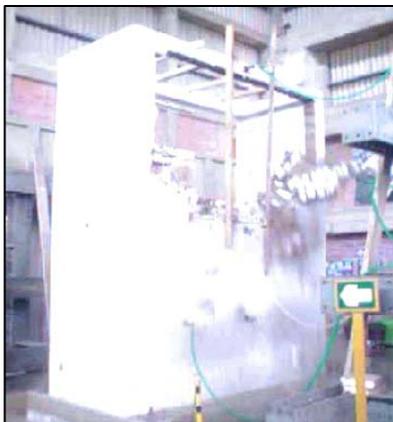
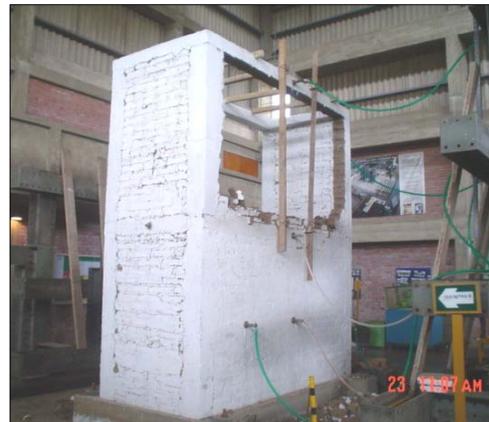
During step 5, the whole second story flexure wall collapsed (Figure 11). Some small cracks started to appear in the first story flexure wall. All the shear cracks widened as well as those cracks in the connection with the columns; however, the adobe units remained uncrushed.

Figure 11: Specimen during step 5 (left) and after step 5 (right).

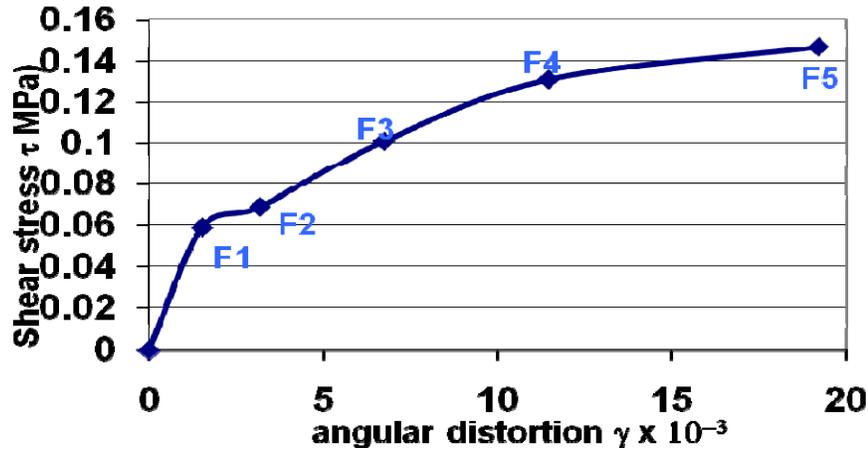
The envelope of the shear stress – angular distortion curves for the first story (Figure 12) was calculated using the peak values of maximum shear stress obtained at either the positive or negative loop of the V-d curve for each step. In figure 12, between steps 1 and 2, an almost flat relation can be observed. This fact agrees with the diagonal cracking of the shear walls. Afterwards, there was a continuous increase in the shear resistance that could be attributed to the horizontal reinforcement in the first story wall.

Figure 12: Shear stress vs. Angular distortion for first floor

Finally, the angular distortion obtained without loss of resistance during step 5 reached 0.018. However, for the system to be reparable, the adequate maximum distortion could be set at 0.005, which corresponds to an intermediate situation between steps 2 and 3. This seems adequate because the flexure wall of the second floor was near collapse at the end of step 3.
