## **EFFECTIVE SYSTEM FOR SEISMIC REINFORCEMENT OF ADOBE HOUSES**

### **SUMMARY**

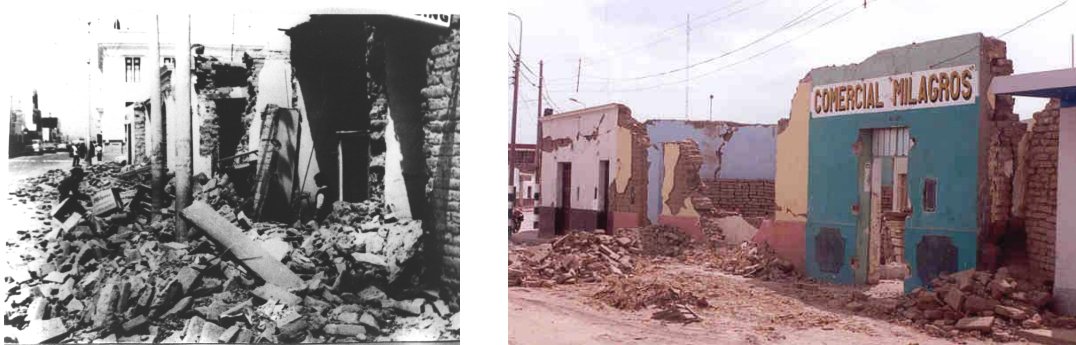
**Fig.1. Collapse of traditional adobe houses due to severe earthquakes in Peru.**

goal was to find a way to prevent the sudden collapse of traditional adobe houses during earthquakes, which usually cause human casualties and loss of properties (fig. 1). The main objective was to provide the adobe house with the enough seismic resistance, so that the habitants could get out before it collapsed.

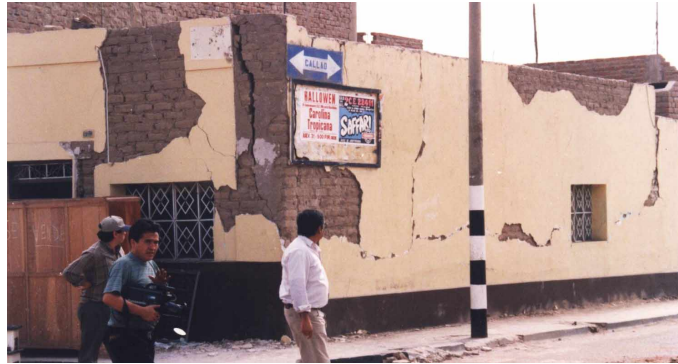
**Fig. 2. Typical cracks on adobe houses due to out-of-plane seismic forces.**

The first part consisted on a series of seismic simulation tests on shaking table, using isolated U-walls as well as house modules, searching for easy and economic ways to provide external reinforcement to the adobe walls, in order to prevent the collapse. The preliminary tests are described by Zegarra et. al. [2] (1996). Different types of reinforcements were used: wood tables, ropes, chicken wire mesh, and electrically welded wire mesh. It was concluded that for existing one-story houses, the objective could be achieved, by reinforcing the weak zones (fig. 2), which are the intersection of perpendicular walls, as well as the upper part of the walls. The electrically welded wire mesh is nailed in vertical and horizontal strips, simulating columns and beams, at both sides of the walls. Every 0.5m, both vertical meshes are connected by wires that pass through holes previously done on the walls. Later, these strips are covered with mortar of cement :sand 1:4, as shown in fig. 3 and described by Zegarra et. al. (1997) [3].

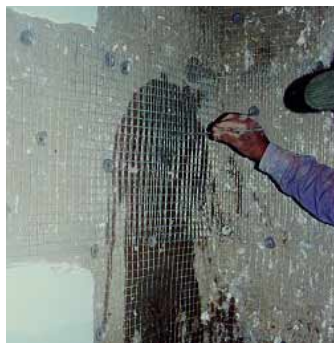
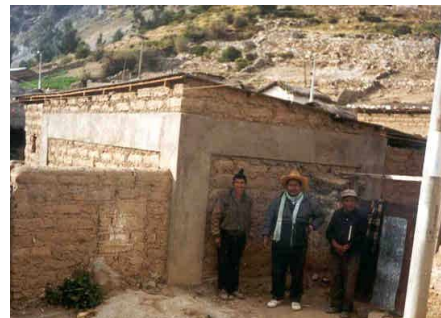
**Fig. 3. Sequence of reinforcement on an existing house: Remove the existing cover and perforate the wall (left), connector wire and wire mesh installation (middle), and final cover (right).**

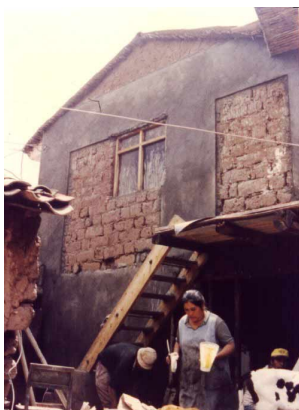
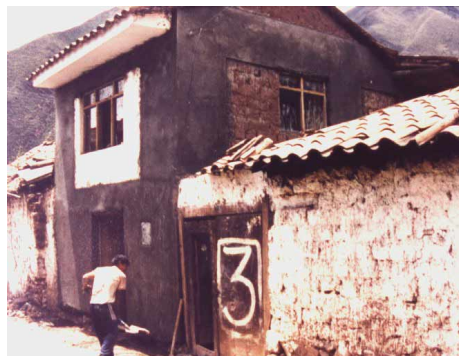
**Fig. 4. Reinforcement for existing 2-story houses.**

The seismic forces increase with the amount of stories, therefore, in case of two-story houses, it is necessary to put the wire mesh over the whole surface of the first-story walls, and use strips of wire mesh for the second story walls, as shown in fig. 4.

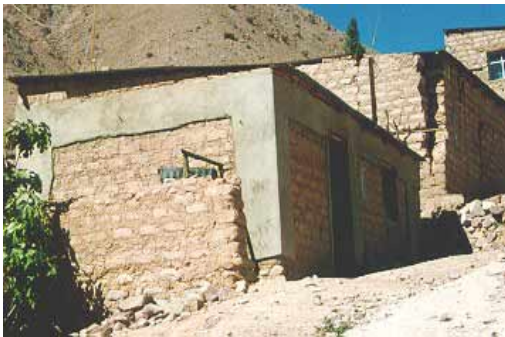
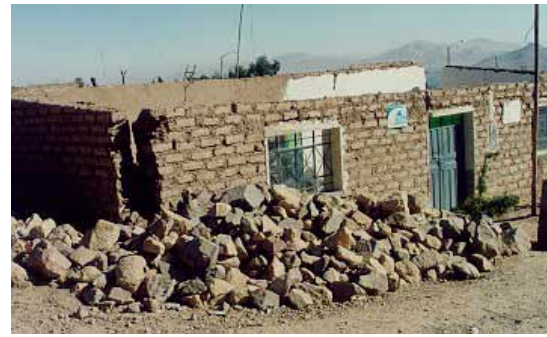
**Fig.5. Reinforced house and unreinforced neighbor houses after the 2001 earthquake.**

The earthquake of June 23, 2001 (Mw=8.4) caused important damages, especially at traditional adobe constructions located in the south of Peru (Arequipa, Moquegua, Tacna). However, the 6 houses that were reinforced with the system proposed in this paper: three at Moquegua, two at Tacna and one in Arica (Chile), withstand the earthquake and the aftershocks without any damage, while neighbor houses had severe damage or collapsed (fig. 5), see Zegarra *et. al.* (2002) [6].

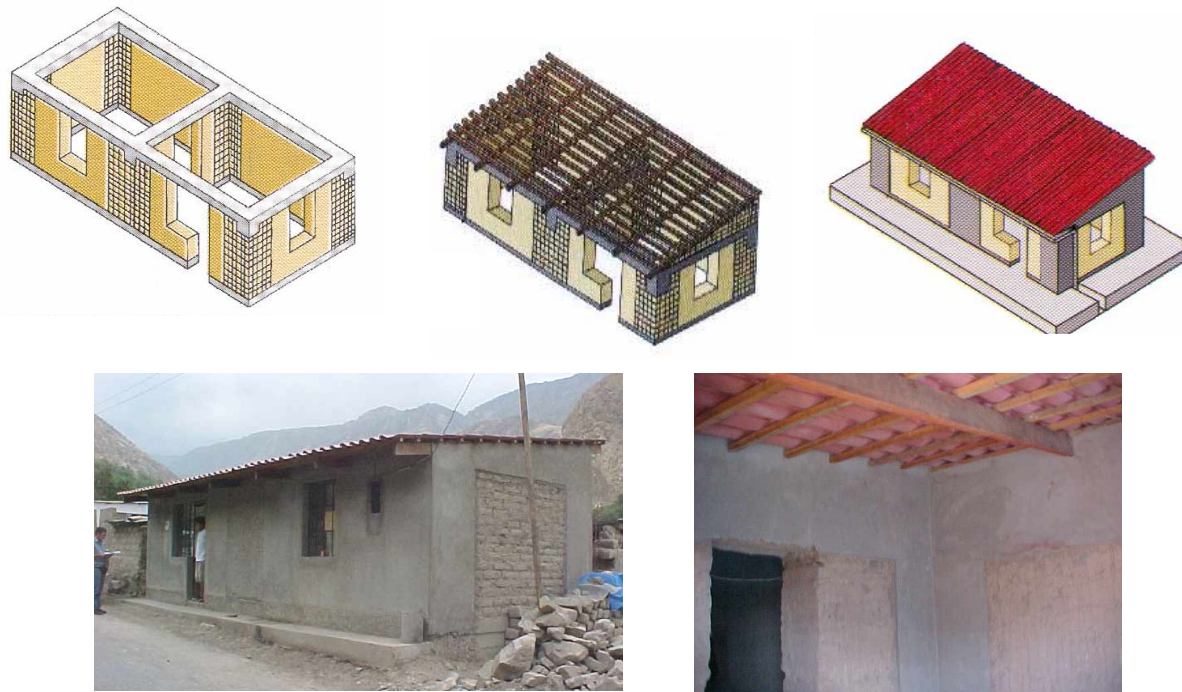
**Fig. 6. Views of the new reinforced houses built in Arequipa.**

The basic module architecture is shown in fig. 6, in which the vertical strips of wire mesh covered with mortar may be appreciated. The module was conceived in such a way that could be adapted to different areas and that future modules for expansion could be added by duplicating this basic module.

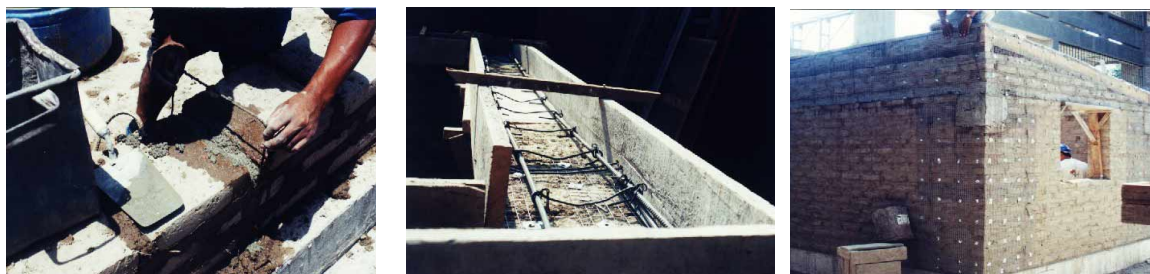
**Fig. 7. Some structural improvements in the new adobe houses: wire connector in joint (left), collar beam (middle), and shear key (right).**

Some of the structural improvements, designed at PUCP, are indicated in fig. 7, and include the following: 1) use of plain concrete for the foundation; 2) the construction procedure, like the wetting of the adobe units before placement, the use of a marked stick to control the 2 cm joint width, the installation of the connector at the vertical joints covered with cement mortar; and, 3) the collar beam of poor concrete ( $f'_c=10$  MPa), used as lintel in doors and windows, reinforced with two #3 bars.

At the end of the collar beam, at the intersection with an orthogonal wall, a plain concrete shear key was included to avoid sliding of the beam during seismic movements. The purpose of this beam is to connect the walls, and in case the collapse of the unreinforced part of the walls occurs, this beam can still carry the roof weight, supported on the corners of the house that have wire mesh reinforcement.

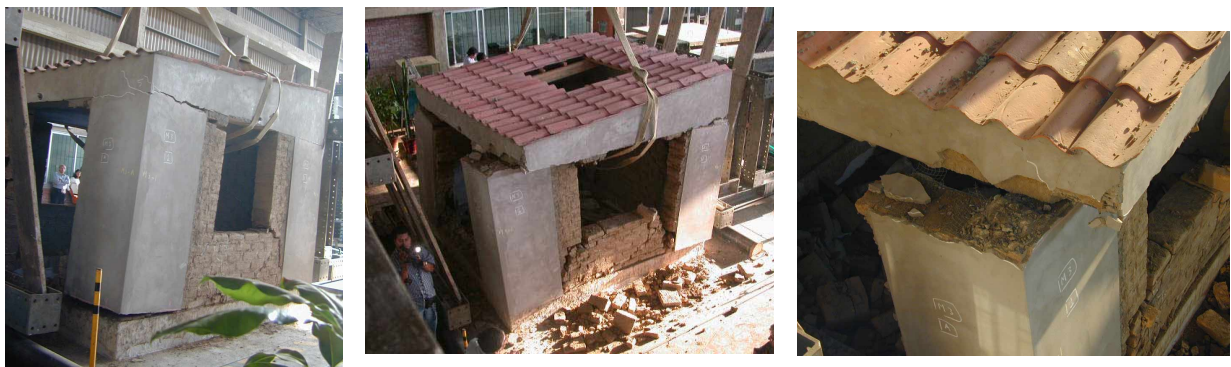
**Fig. 8. Behavior of the module during the catastrophic earthquake simulation test (left), after the test (middle), and failure of the plain concrete shear key (right).**

The module withstand without any damage the mild earthquake, with unimportant damage the moderate earthquake, and with moderate damage the severe earthquake. Only for the catastrophic earthquake the module nearly reached collapse, generated by the shear friction failure of the plain concrete key located at the upper corners.

A conclusion driven from this test was that the seismic behavior of the proposed system for reinforced adobe houses could be still improved, in order to withstand even catastrophic earthquakes. The new features could include vertical dowels to connect the foundation with the wire mesh strips, reducing the rocking observed, and on the other hand, reinforcing the upper key with vertical dowels, to control the shear friction failure observed (fig. 8).

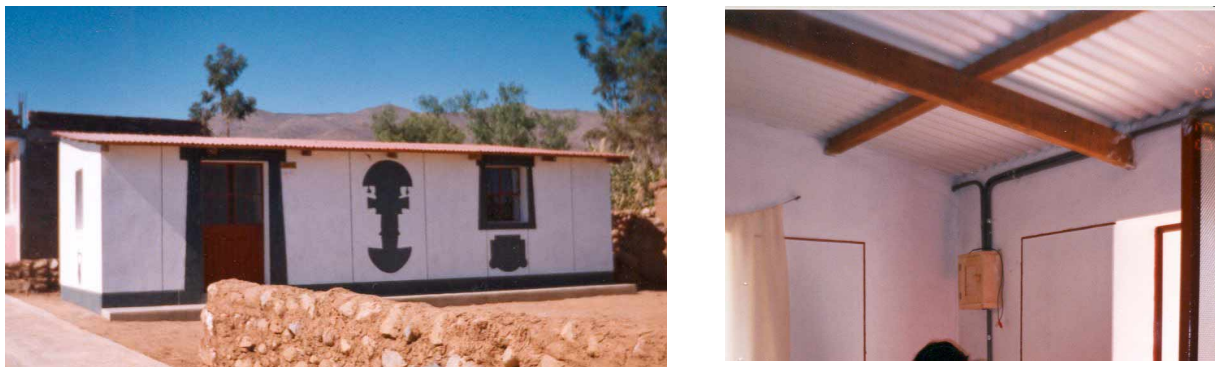
**Fig. 9. New adobe house built by PNUD-SENCICO.**

In this program, almost 100 adobe houses have been constructed, following the module plans initially developed by the COPASA-SENCICO-PUCP team. Most of these houses have the roof with a single slope, and only a few have a two-sloped roof. The roof cover is of metal sheets. In fig. 9 some of the houses of this project are shown, in which it can be observed the correct location of the visible electrical installations by the outer side of walls and roof, in order to keep the structure intact.
