## EXPERIMENTAL STUDY ON ADOBE WALLS WITH LONG TERM WATER EXPOSURE DUE TO FLOODS

### ABSTRACT

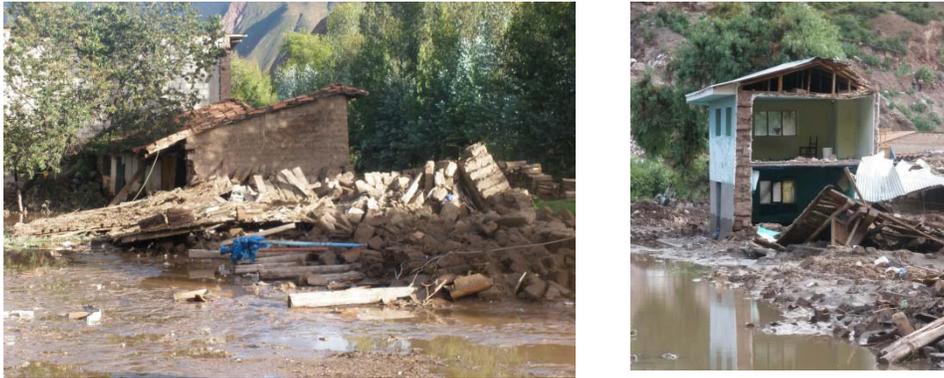
**Figure1: Collapse of adobe houses under floods, Cusco Perú - 2010.**

As result of our climatic diversity, Peru rural areas are periodically affected by intense rains that generate floods and river overflows. On the other hand, traditional adobe has a high vulnerability under prolonged contact with water product of these floods, which can cause the collapse of the structures (Figure 1). In this paper, two sets of experiments are reported, in which the water action of flooding was simulated on four adobe walls in each set. Eight walls were tested, two were traditional and the other six had some treatment or protection against water action. The solutions to protect the base of the adobe walls were all simple and economic. It is necessary to indicate that these solutions do not protect the adobes structures against the action of avalanches that drag large stones or rocks.

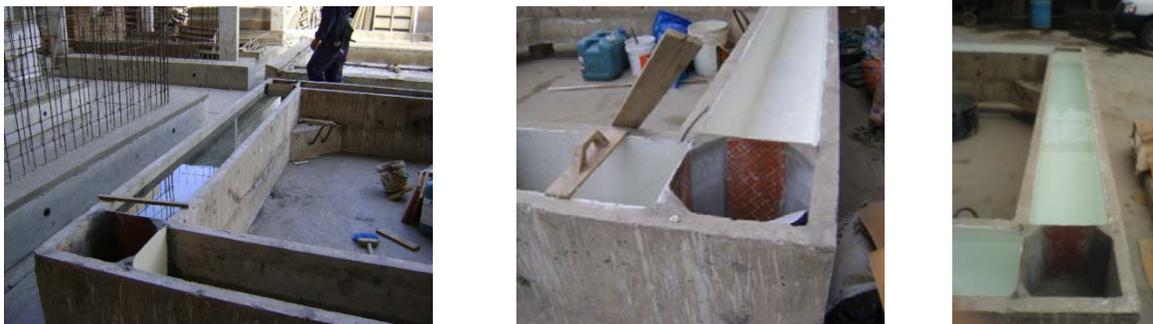
**Figure 2: Channel used in the test of flooding. Test of water tightness.**

A reinforced concrete channel with “U” section was used for the floods simulations, with an internal width of 280 mm. The channel fulfilled the requirements of impermeability and water tightness. It was divided into four sections of equal dimensions with independent channels as shown in Figure 2. In this way, the analyses of the variables of absorption, capillarity and performance along time of each wall were independent.

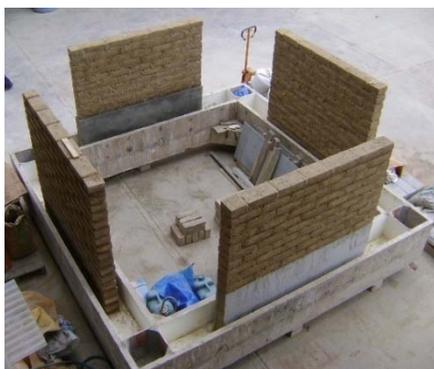
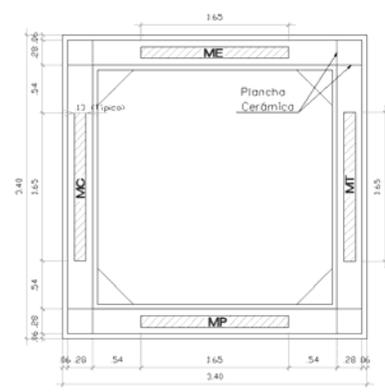
**Figure 3: View of the four walls of the first set**

The first set of four walls had a Traditional Wall (TW1) and three improved walls with different treatments against water action. The first treatment, Concrete Plinth Wall (CPW), used a plinth of plain concrete, instead of the traditional foundation of adobe walls made of stones. The second treatment, Stabilized Wall (SW), consisted in the use of stabilized adobe units with 5% cement in the bottom six layers exposed to flooding. In the third treatment, Plastered Wall (PW1), the units under water action were protected with a cement-sand (1:5 volume proportion) mortar cover applied over a henhouse mesh made of galvanized wires, connected to the wall. The main characteristics of the walls inside the channel are shown in Figure 3. With exception of the wall PW1 whose thickness increased due to the mortar plaster, all the walls had the same dimensions: 1.50m height, 1.65m length and 0.13m thickness. All the walls were constructed by the same masons. The vertical and horizontal joints of the walls had 15 mm thickness and the mortar was prepared with the same material used in the adobes.

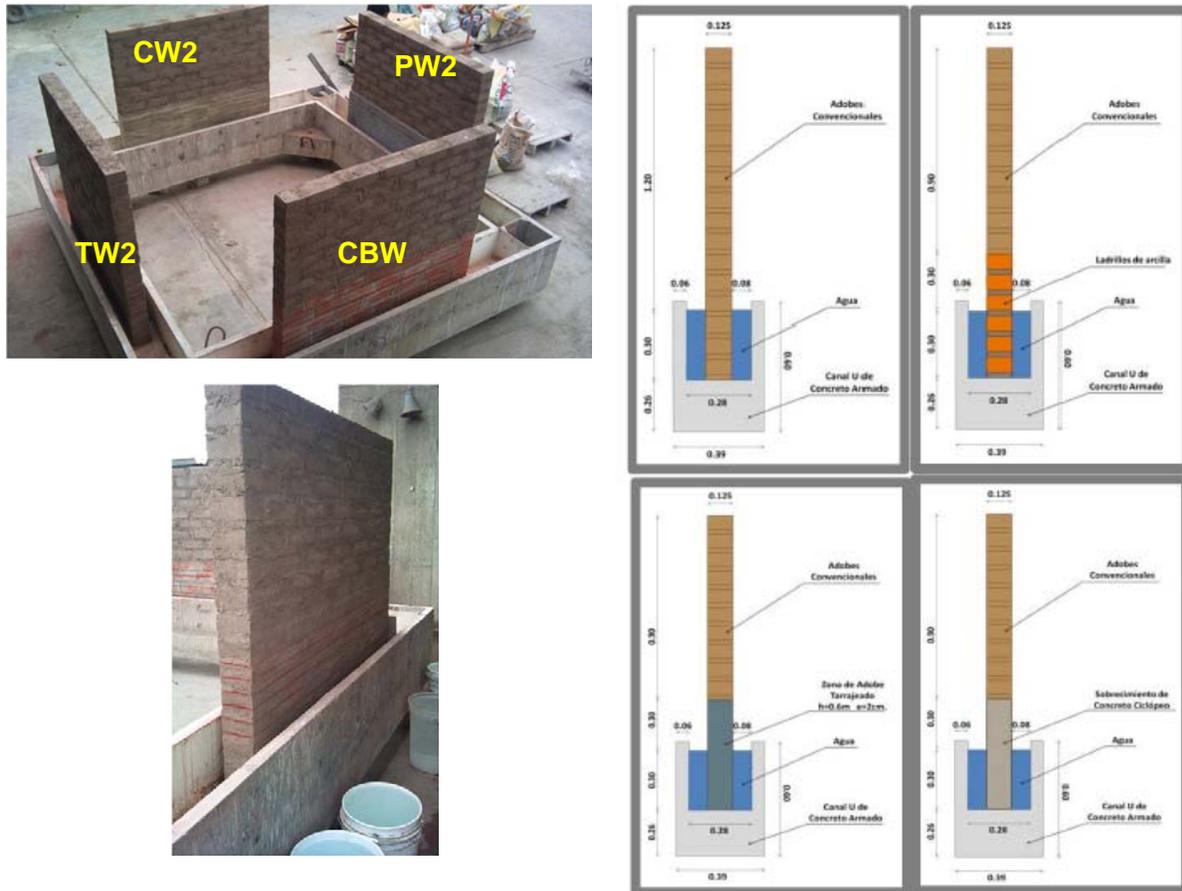
**Figure 8: Walls of set2 – in the drawings TW2 (upper left), CBW (upper right), CW2 (lower left), and PW2 (lower right).**

The second set of four walls had a Traditional Wall (TW2) and three other improvements in the wall treatment against water action. The CBW wall had the bottom six layers of clay brick units, as a brick plinth of 600 mm height, which is twice the area in contact with water. The mortar mix was cement-sand 1:4 volume proportion. The following 10 layers were of traditional adobe units, similar to TW2. The CW2 wall had a plinth of low resistance plain concrete; it had 600 mm height in which concrete was poured in layers, with 75 mm (3") previously washed stones placed in each layer. The last wall PW2 was built similar to the TW2, but a mortar cement plaster was applied afterwards over a welded wire mesh, to a height of 600mm and 20 mm thickness over the perimeter. The wire mesh was placed on both sides of the wall and it was connected to the wall with smaller wires in the vertical joints every 250mm. Finally, the plaster surface was polished by using cement powder with water.

Figure 8 displays the characteristics of the four walls of this second set. Also their position inside the concrete channel is shown.

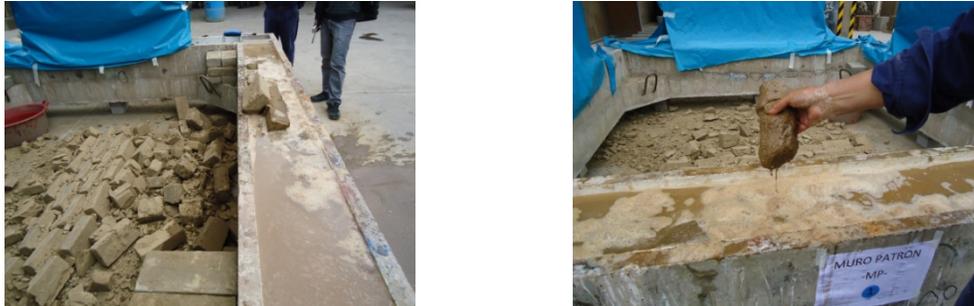
Figure 9: Overturned wall TW1 and condition of the adobes in the base.

The traditional adobe walls collapsed after 20 and 73 minutes, while the other six remained stable without danger of collapse. For the first set of walls, TW1 resisted less than the short period of flooding. The adobe units at the base disintegrated and immediately the wall overturned as can be seen in Figure 9. The other three walls of set 1, CW1, SW and PW1 resisted 16 days of flooding and they are shown in Figure 10.

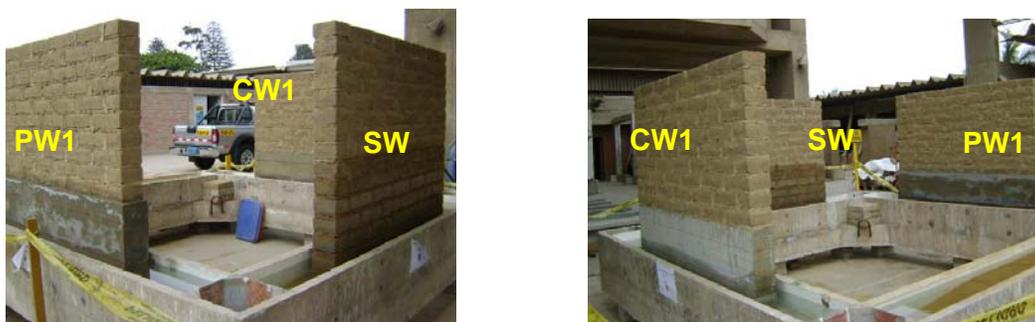
Figure 10: Three walls of set 1 that resisted the flooding simulation test

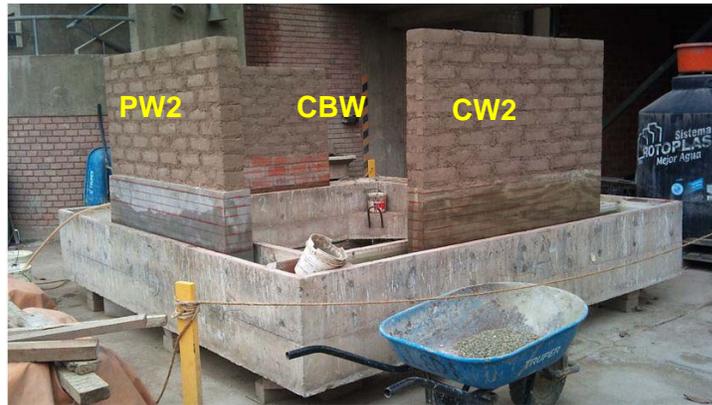
**Figure 11: Three walls of set 2 that resisted the flooding simulation test**

For the second set of walls, TW2 resisted 73 minutes of flood, also less than the short period of flooding. The other three walls of set 2, CW2, CBW and PW2 resisted all the 24 days of flooding before being demolished, as shown in Figure 11. Figure 12 shows the condition of adobe units of walls PW1 and SW of set 1, and the brick units of CBW of set 2.

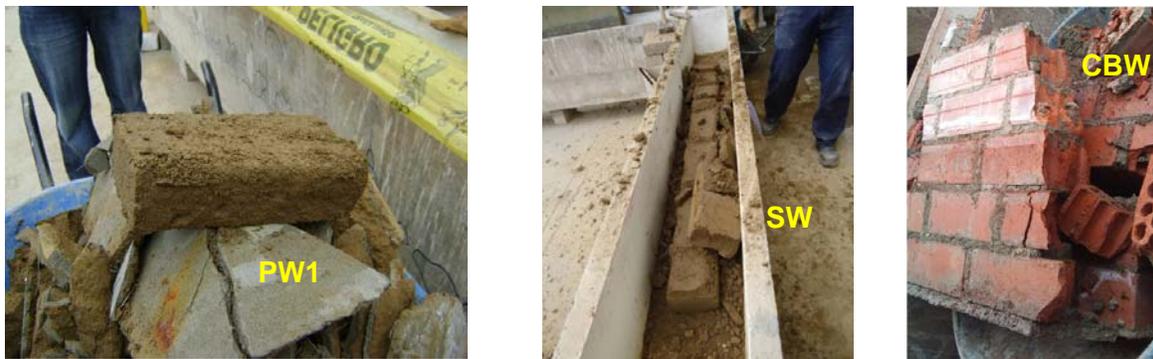
**Figure 12: Inspection of masonry units in the base after demolition of the walls.**

After finishing the tests, the walls had all their 15 layers carefully dismantled. For set 1 of walls, the first 8 layers of SW and the first 6 layers of PW1 were humid, whereas all the units of CW1 were dry. Therefore, the humidity ratio can be set as 4:3:0 for walls SW, PW1 and CW1, respectively. For set 2 of walls, the first 3 layers of CBW and the first 4 layers of PW2 were saturated, while the first 350mm, equivalent to 3 and a half layers, of CW2 were saturated. Therefore, the humidity ratio is 3:4:3.5 for the walls CBW, PW2 and CW2, respectively.

The consistency of the units was defined as the touch feeling. In this way, the adobe units at the base for walls SW and PW1 had partial instability, whereas CW1's adobes were dry. Therefore the proportion can be set as 1:1:0 for the set 1 walls SW, PW1 and CW1, respectively. Similarly, for set 2 walls, the units of CBW and PW2 were unstable and the units of CW2 were dry. Therefore the proportion can be set as 0:1:0 for the walls CBW, PW2 and CW2, respectively.

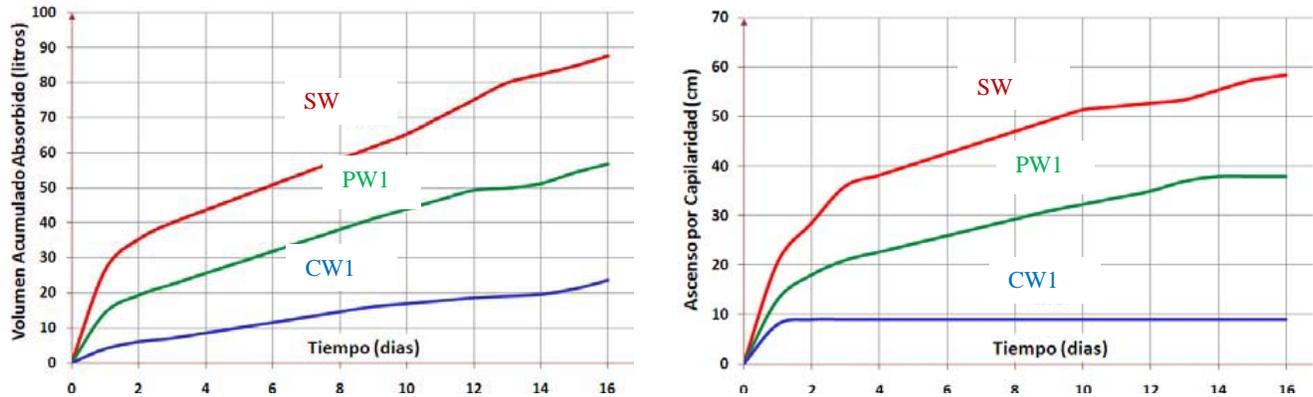
Figure 13: Results for set 1 of walls, absorption (left) and capillarity (right)

In Fig.13 the water absorption (in liters) of the walls and the capillary rise (in cm) during the 16 days of test of set 1 are shown. A rapid absorption of water during the short period of flood is clear, whereas during the long period of flood the slopes of the graphs for walls SW, PW1 and CW1, are in a proportion 3:2:1 respectively. Regarding the capillarity, the rise for CW1 was of only 9cm without reaching the adobe layers and became stable after 48 hours. At the end of the test, the capillary rise proportion was 1.65: 1: 0 for walls SW, PW1 and CW1, respectively. In Fig. 14, the water absorption and the capillarity rise during the 24 days of test of set 2 are shown.

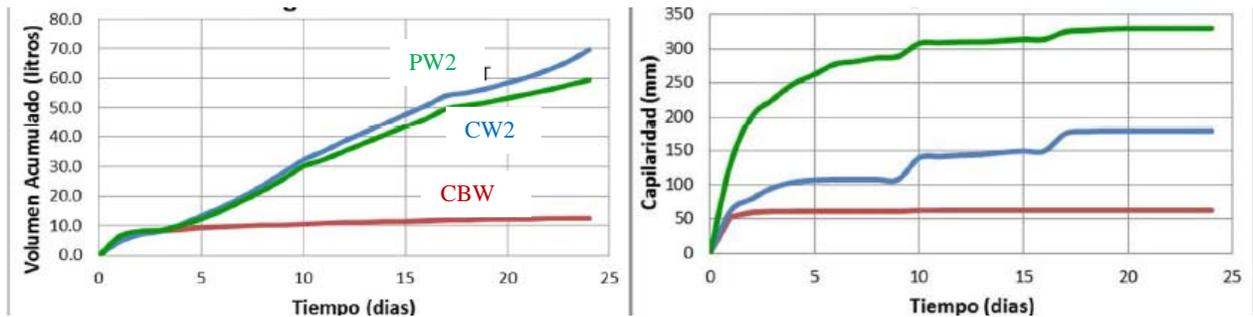
Figure 14: Results for set 2 of walls, absorption (left) and capillarity (right)

Also a rapid absorption of water during the short period of flood is clearly similar for the three walls. Regarding the capillarity, the maximum rise was only 55mm for CBW and for CW2 it was nearly 330mm by day 20. At the end of the test, the capillary rise proportion was 2: 3: 7 for walls CBW, PW2 and CW2, respectively.
