Preliminary Reconnaissance Report - 12 January 2010 Haiti Earthquake

Eduardo Fierro and Cynthia Perry of BFP Engineers, Inc.

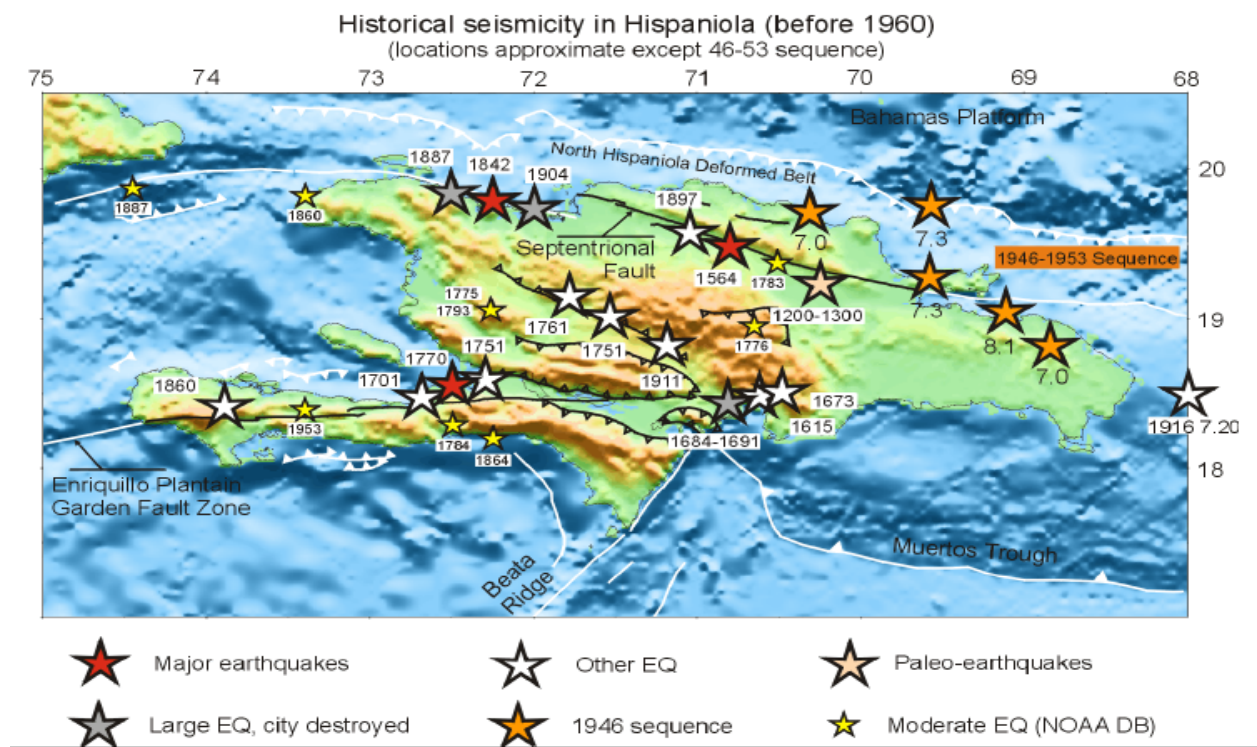
Figure 1: Historical Seismicity in Hispaniola prior to 1960. Last major earthquake near Port-au-Prince was in 1770.

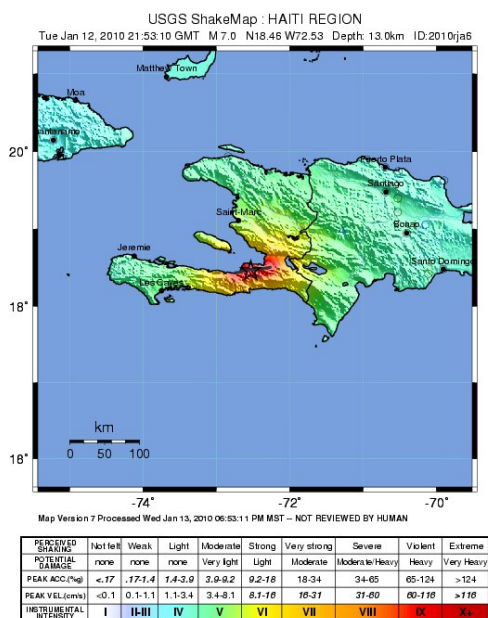
The USGS has published Shakemap instrumental intensity estimates (Figure 2) and estimated peak ground accelerations (PGA) (Figure 3). Note that the blue dots in Figure 3 indicate instrument locations; the one instrument located in Haiti is along the north coast, far from the epicenter. Figure 3 shows a maximum PGA of 0.30g. Based on the observed damage, Mr. Fierro estimates the PGA was more likely 0.45g in Port-au-Prince and possibly higher west of the epicenter in the direction of the rupture due to forward directivity. Structures in Leogane and other communities west of Carrefour suffered a higher level of damage than similar construction in Port-au-Prince.

Figure 2: MMI Intensity (USGS Shakemap)

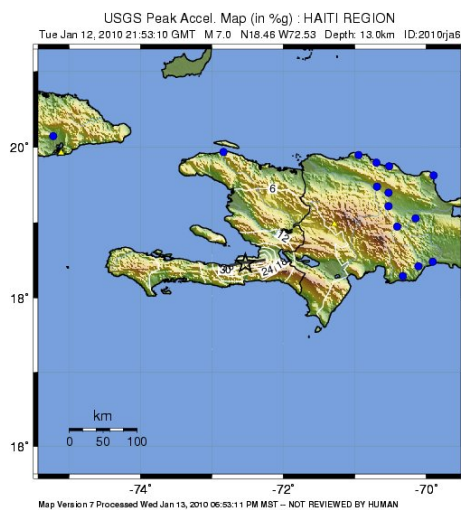
Figure 3: Peak ground acceleration (USGS)

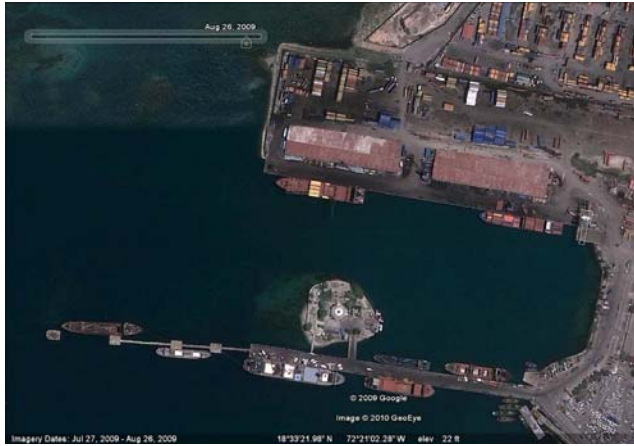
The infrastructure of Haiti will take many years to recover from this devastating earthquake. The main port in Port-au-Prince had two primary docks; one of these collapsed completely and the other suffered a partial collapse (see Figures 20-22). The adjacent fuel port lost the seaward end of the dock and the piles supporting the remaining section were all misaligned (Figures 23-27). The glazing all fell from the control tower at the international airport and masonry infill walls in the terminal were cracked, closing the airport temporarily. The team visited two electric power plants; neither one was in operation. The first was out primarily due to failures in the distribution system outside the plant; the second was down due to the failure of a fire water tank. The tank farm adjacent to the fuel port suffered extensive damage. Roads and bridges throughout the area suffered damage.

Figure 20: Port-au-Prince main commercial port prior to earthquake. (Google Earth images used for Figures 20, 21, 24, and 25).

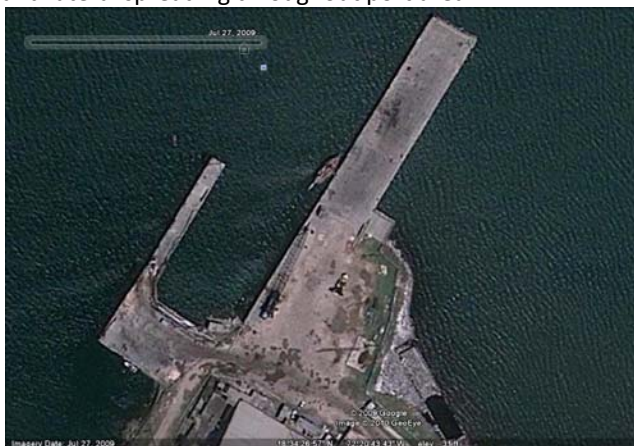
Figure 24: Fuel port prior to earthquake.

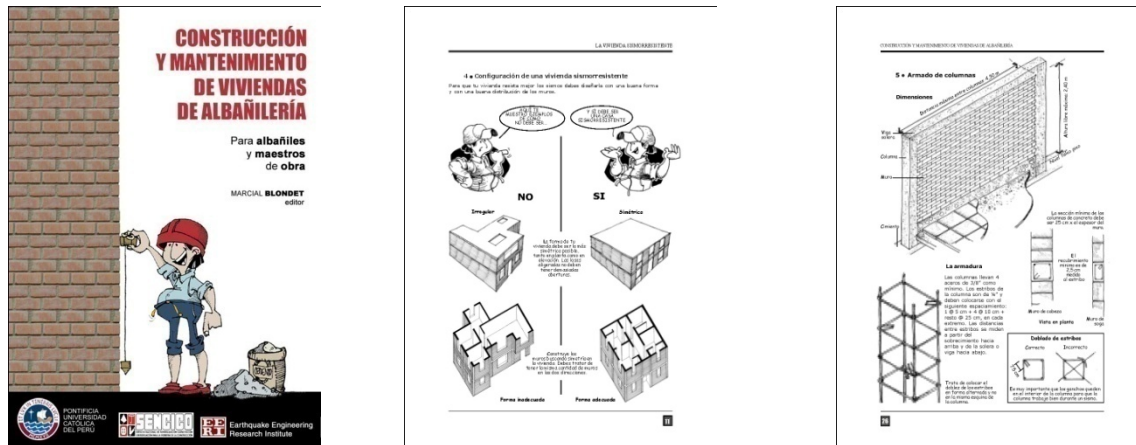
Figure 32: Peruvian booklet on confined masonry construction; sample pages. (Blondet)

Nevertheless, successful seismic resistant schools, hospitals, commercial structures, and residences can be built utilizing the same concrete, steel, and concrete block used in Haiti. Other countries such as Peru and Turkey share many of the problems seen in Haiti, and use confined masonry for the majority of their building structures. Since 1999, schools in Peru have been built following a standard design that has been shown to resist ground motion on the order of 0.50g without any damage. The government of Peru also sponsored the production and dissemination of a handbook for property owners and laborers showing cartoon-style how to build a confined masonry home, including step by step instructions for digging footings, mixing concrete, arranging the bars, etc. (Blondet). Several pages from the Spanish language version of this booklet are shown in Figure 32.

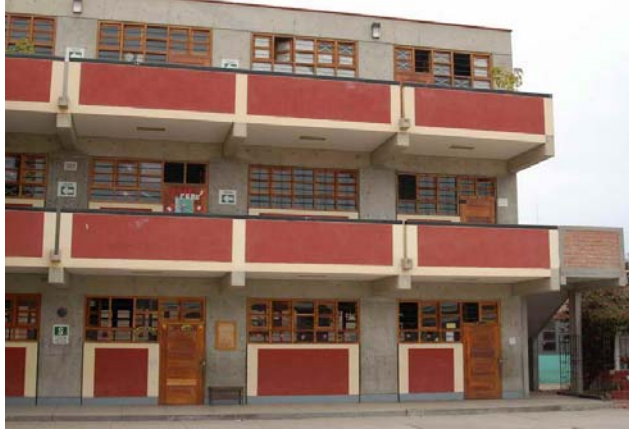
In closing, here are photos of school construction in Peru (Figures 33-34). The school shown at left (Figure 33) and the school in the background in Figure 34 both experienced ground motion of 0.5g during the 2007 Pisco, Peru Earthquake. This was a magnitude 7.9 event; 80,000 structures collapsed in Pisco, but these schools were undamaged. The wing in the foreground (Figure 34) was under

Figure 33: School in Pisco, Peru survived 7.9M 2007 Pisco earthquake without damage (PGA 0.5g). Peruvian government developed standard plans for school construction in 1999.

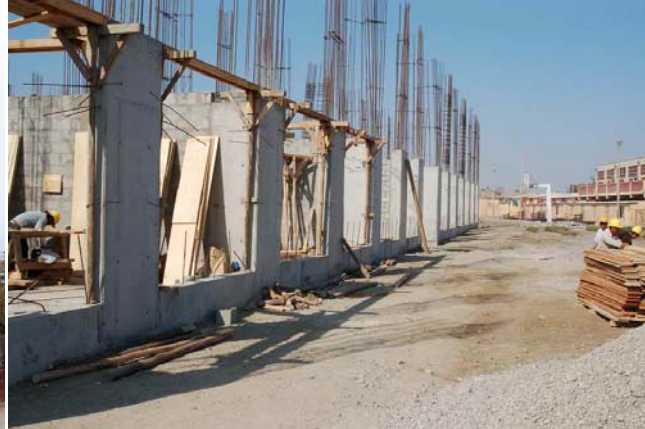
construction during July 2008. At that time, we met a woman who identified herself as the Engineer of Record and had designed the school; she was in the field personally tying all the bars for the column cages because she said no one else could be trusted with such an important task. May engineers everywhere take a lesson from her.

Figure 34: School under construction, Pisco, Peru July 2008. Building has 1m T-shaped longitudinal wall at location of each transverse wall; rest of transverse wall is solid unreinforced concrete block masonry infill.
