Northridge-USA-17-01-1994

M = 6.7, 4:31 a.m. t = 20 seg, Foco: 20Km

Edición: A. San Bartolomé. Fuentes:

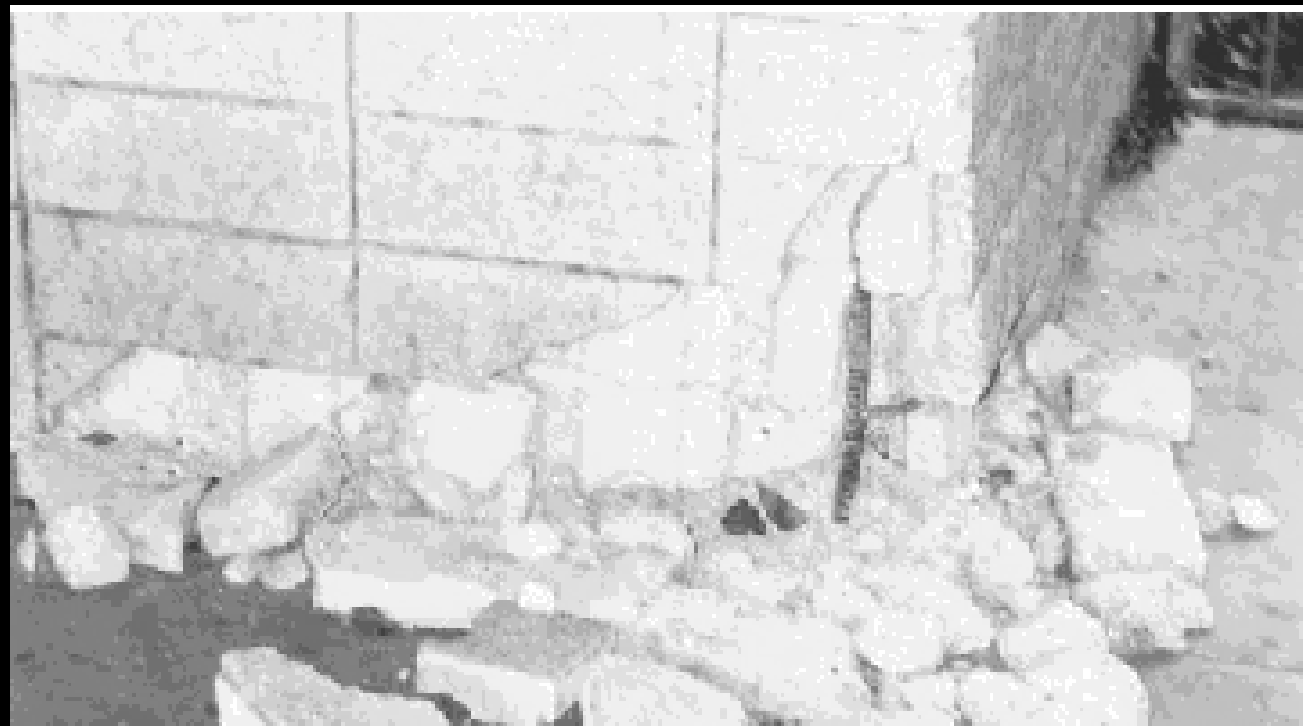
**Talón de un
muro de
albañilería
armada**
