Seismic behaviour of a three-story half scale confined masonry structure

A. San Bartolomé, D. Quiun & D. Torrealva
Catholic University, Peru

PROCEEDINGS
of the
TENTH
WORLD
CONFERENCE
on
EARTHQUAKE
ENGINEERING

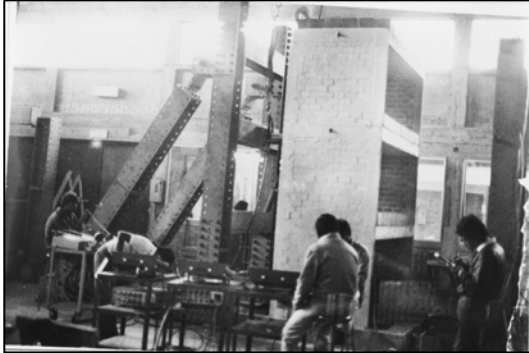
Fig. 2 Static test to evaluate [f]

The experimental evaluation of [f] was performed subjecting the specimen to a lateral increasing load, applied independently in each of the specimen's three floors (Figure 2); the lateral displacements were measured with LVDT.

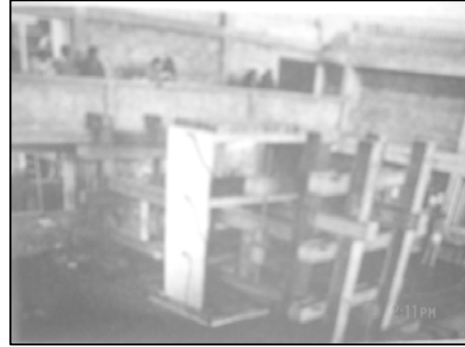
Fig. 3 Shaking table test

Two experimental methods were used for free vibration test, in which the specimen response was measured using an accelerometer located at the third story. The first one consisted in hitting the specimen at each level; the second method consisted in applying small pulses at the base of the specimen once it was installed on the shaking table (Figure 3).

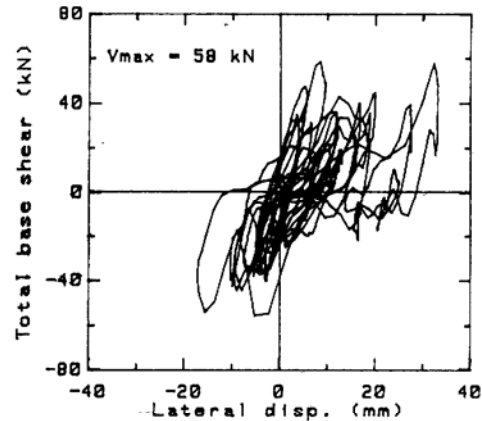
Fig. 8 Total base shear force vs. displacement at level 1 in run C
