Northridge-USA-17-01-1994

M = 6.7, 4:31 a.m. t = 20 seg, Foco: 20Km

Edición: A. San Bartolomé. Fuentes:

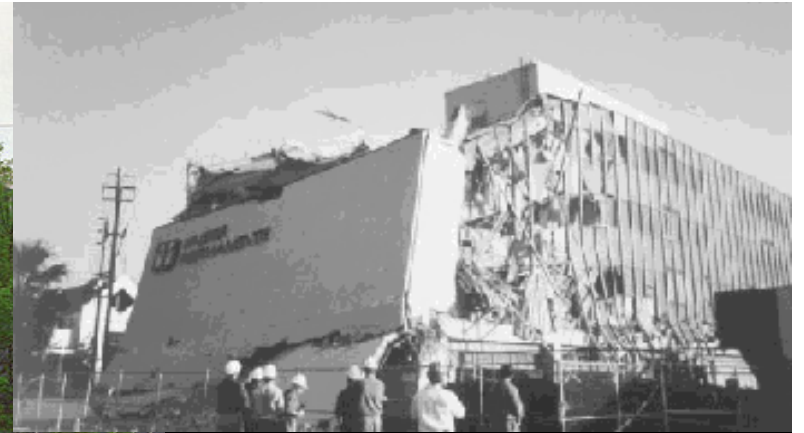
Supermercado

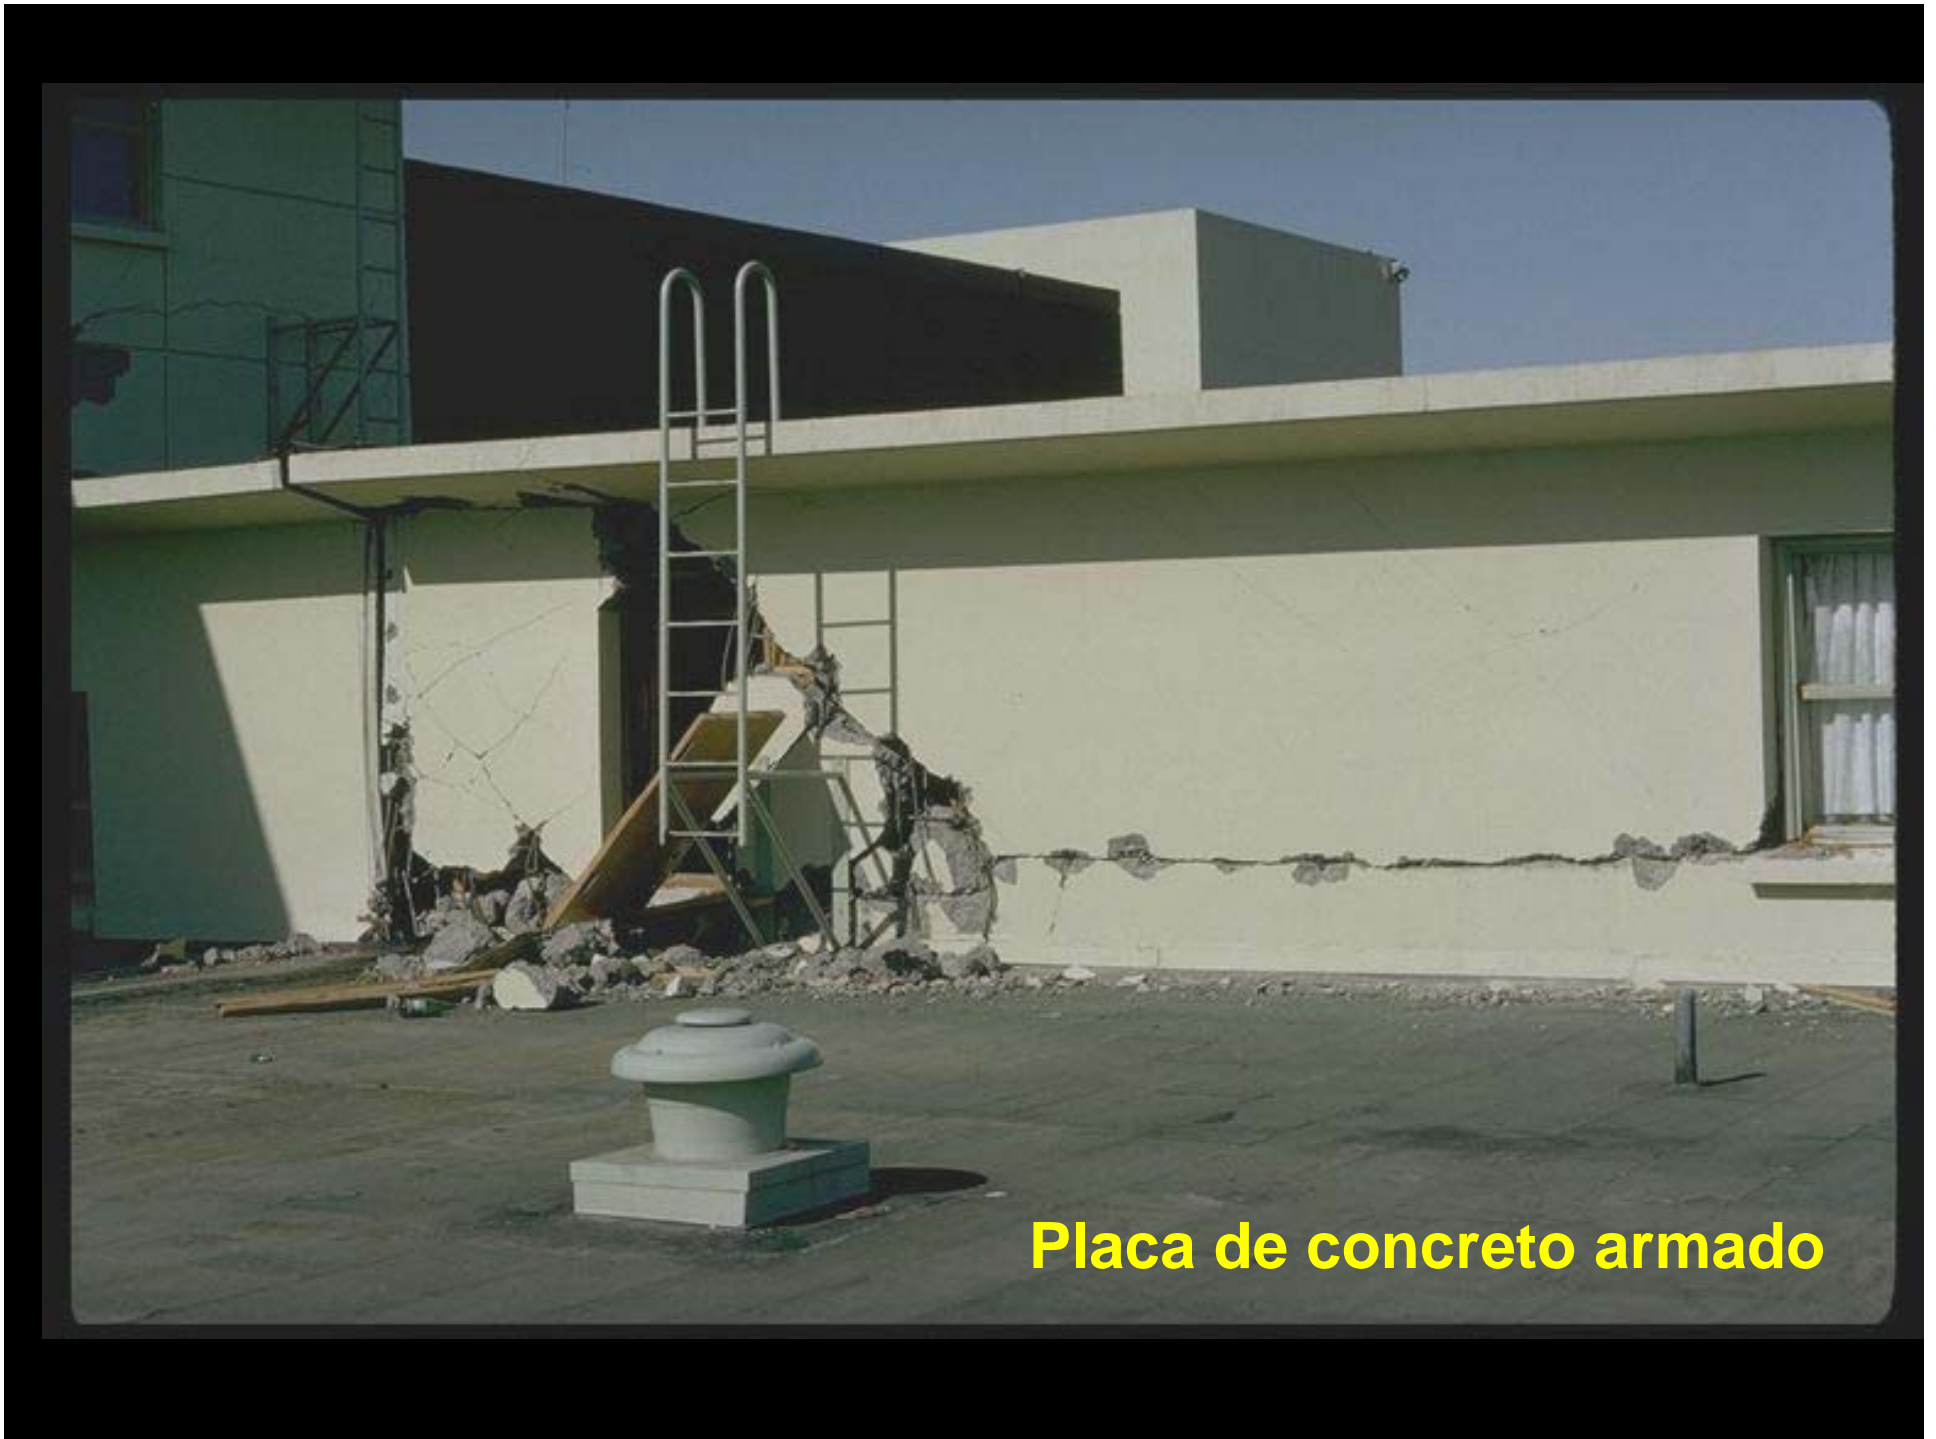
Placa de concreto armado

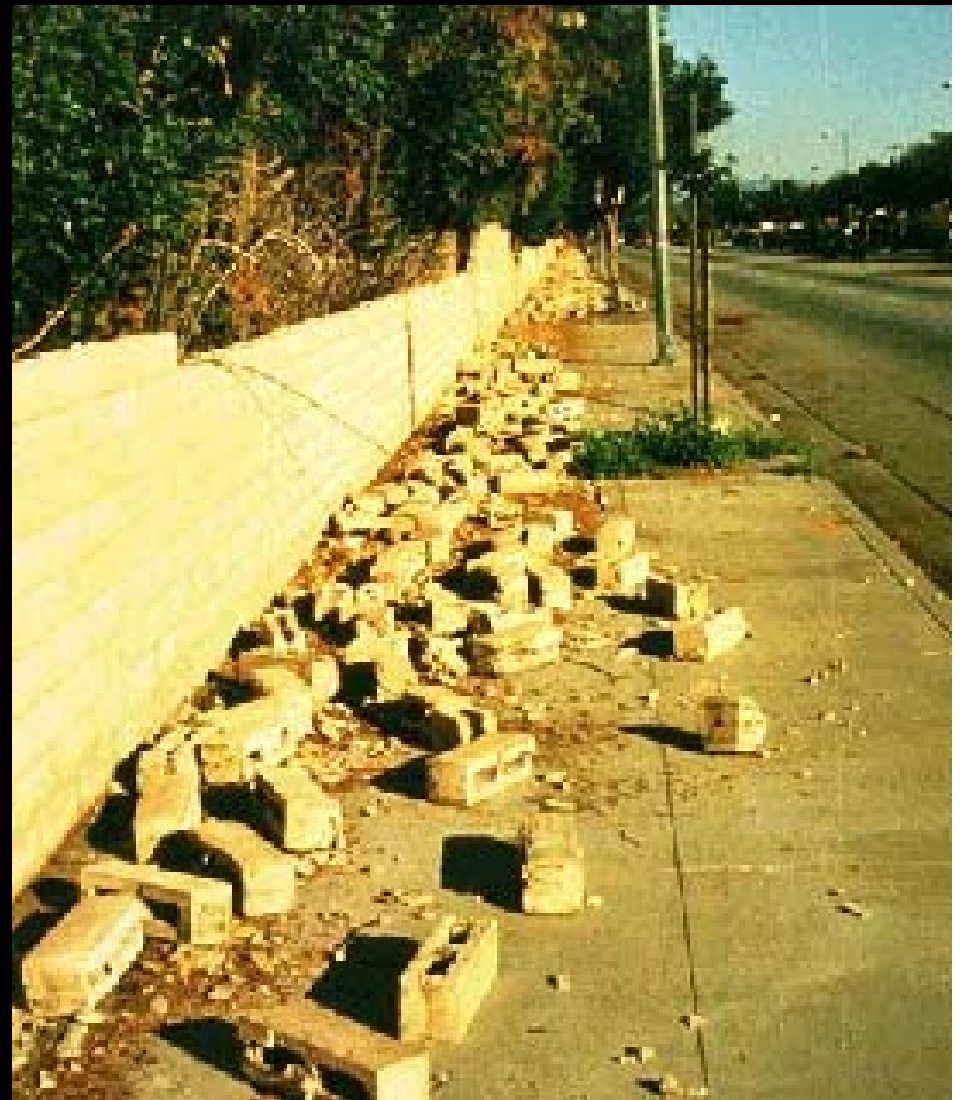
**Cercos hechos con
bloques de concreto**

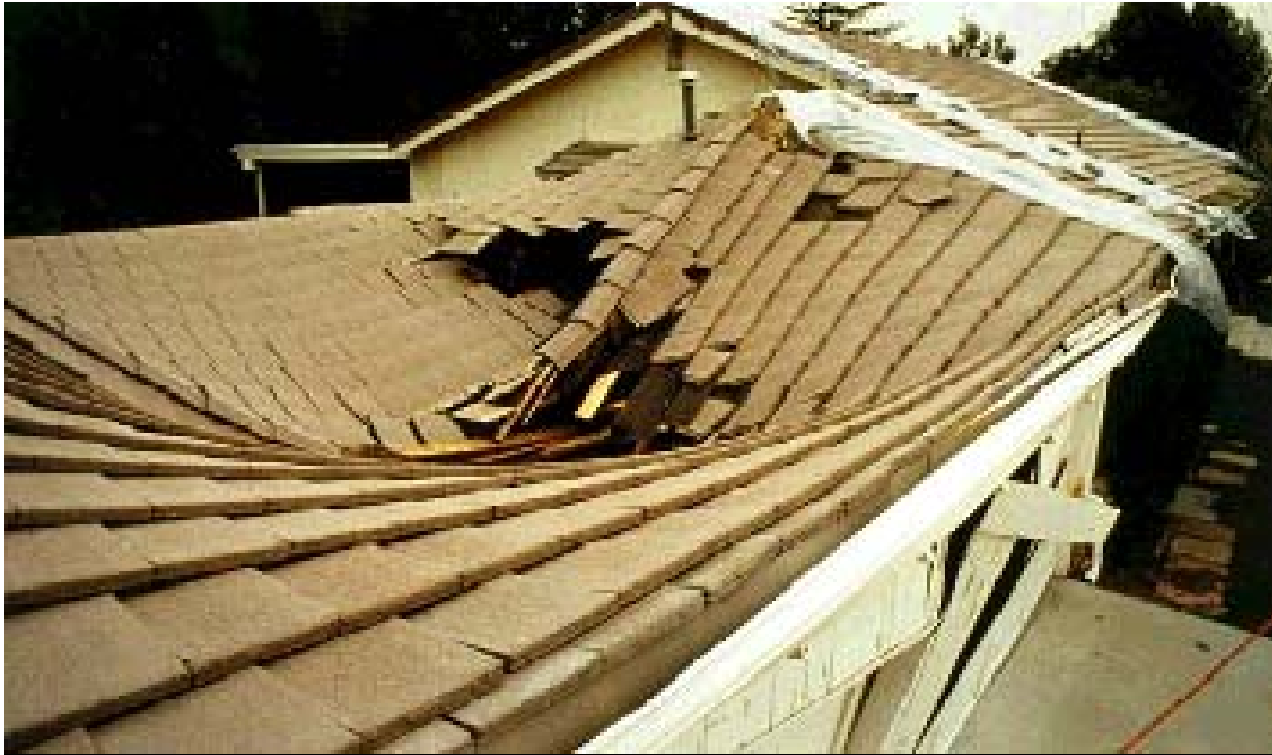
Tejas

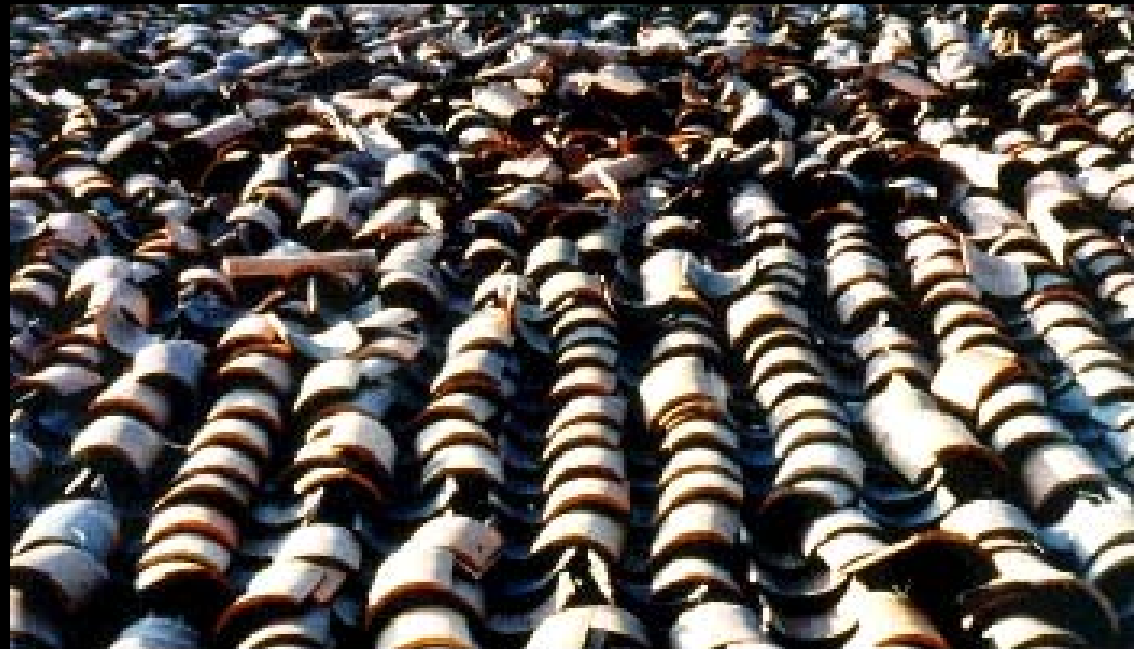
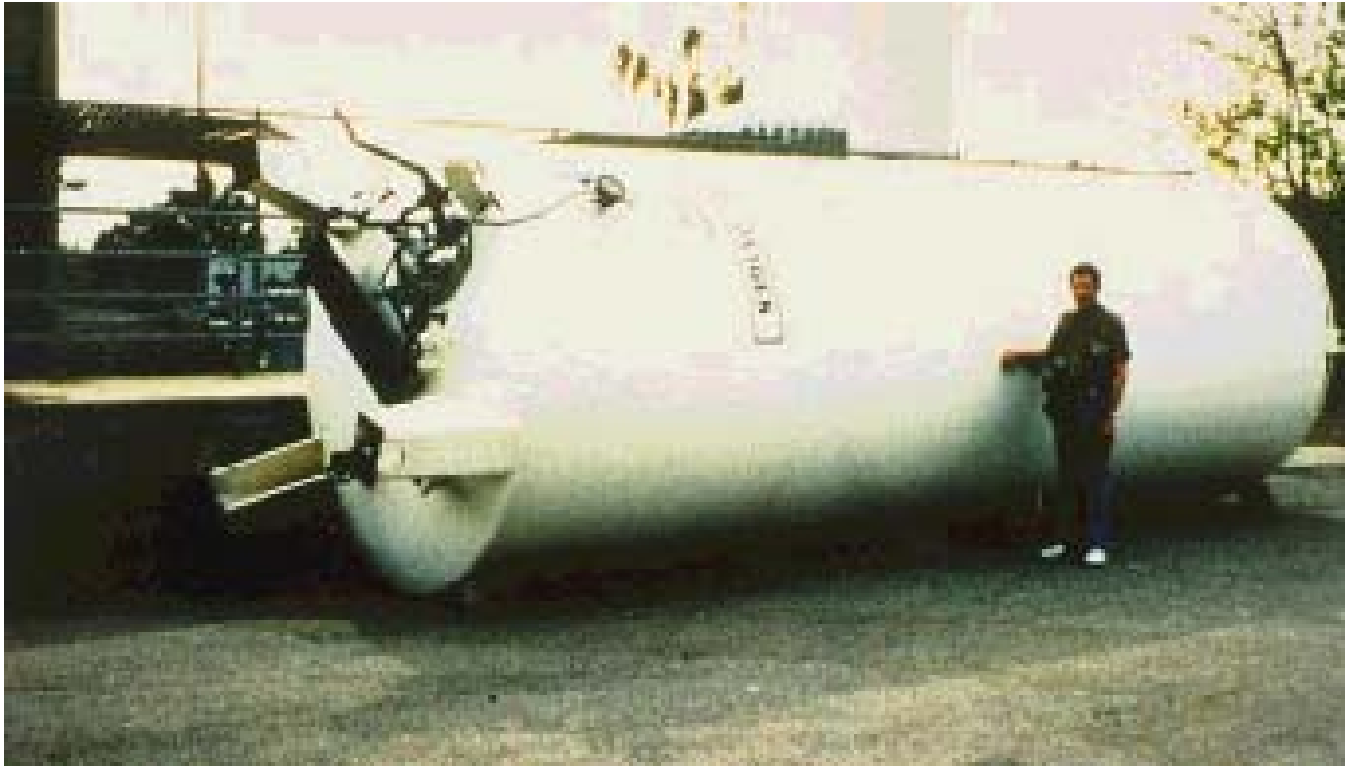
Tanque de oxígeno

Cielo raso

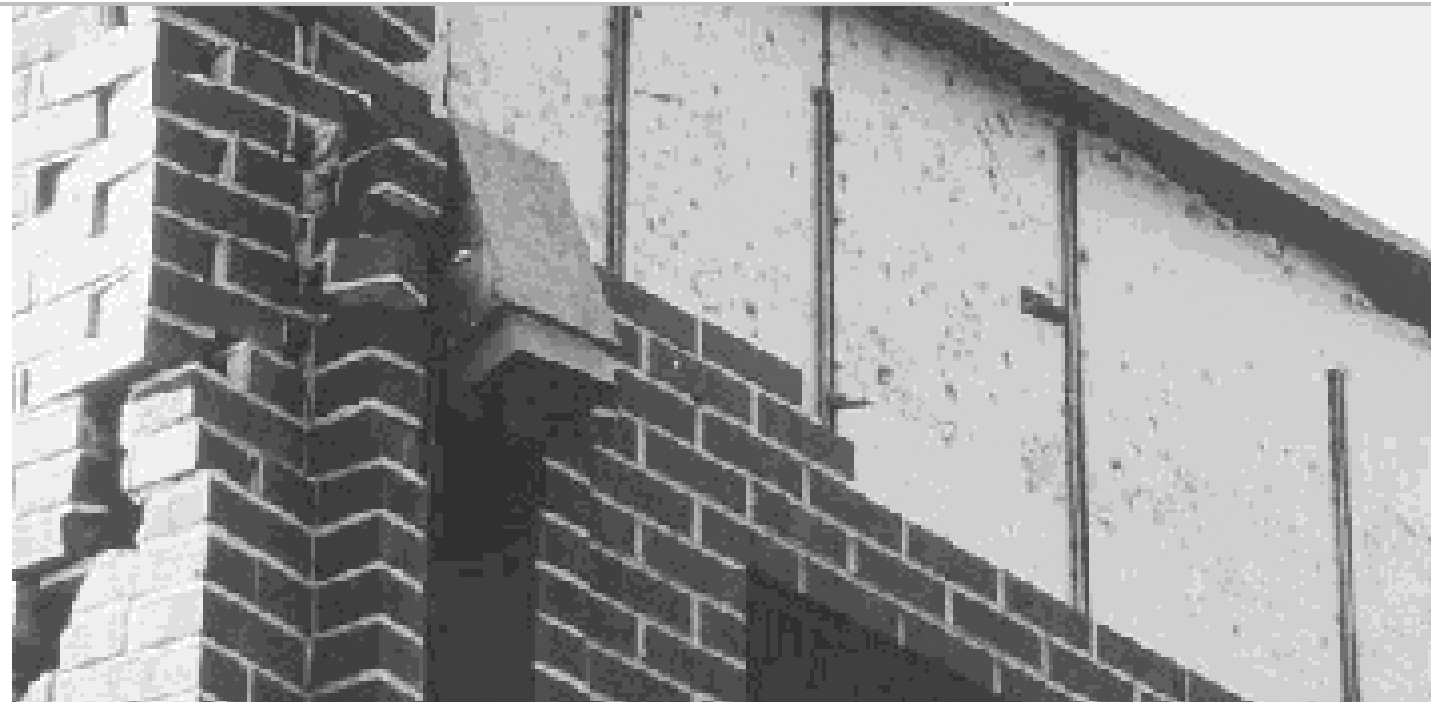
Veener Wall

(albañilería decorativa)

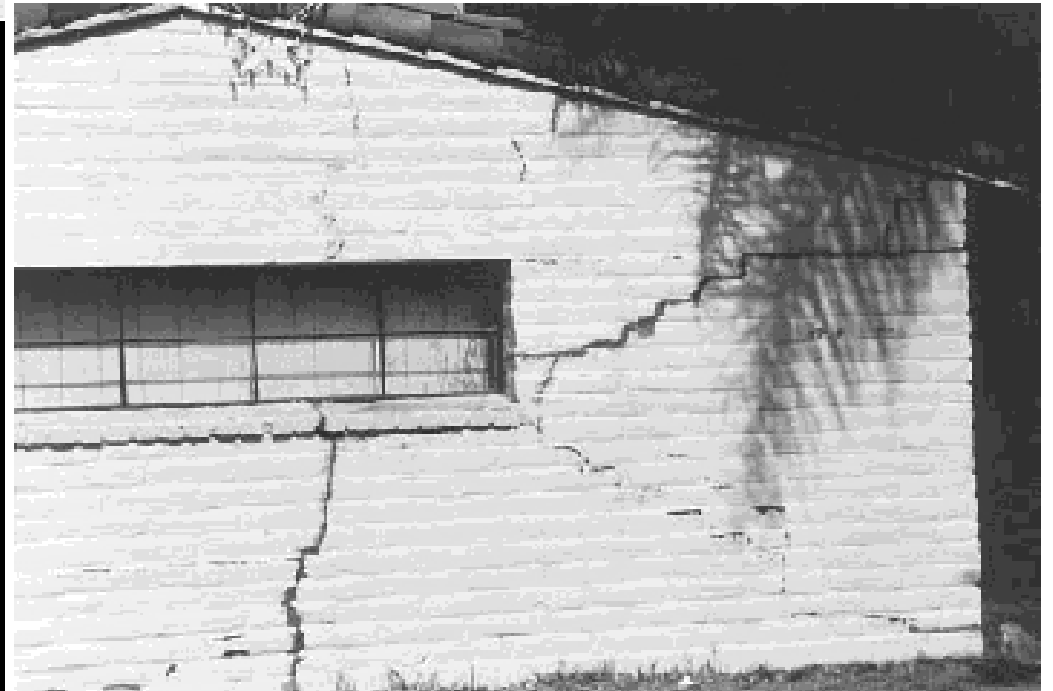
**ADOBE REFORZADO
CONSTRUIDO EN 1940**

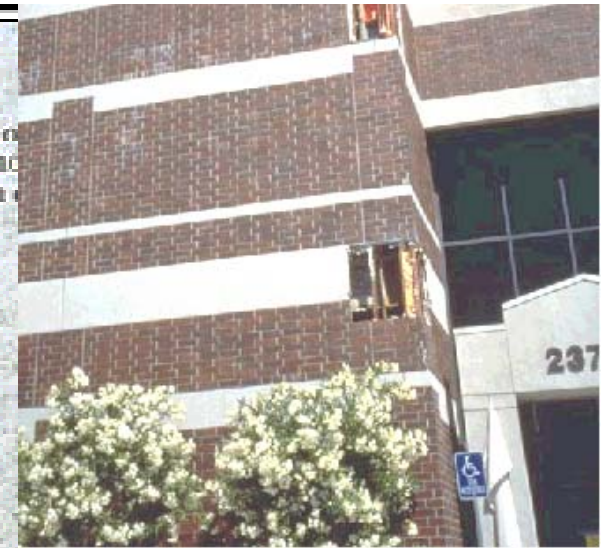
Metálico

Quake Cracks Steel Buildings

In past earthquakes, unreinforced brick and stiffly designed concrete buildings were considered more vulnerable to collapse. Buildings made of steel were deemed safer, because they tend to bend but not break. The Northridge earthquake shattered those assumptions. Engineers have identified a dozen or more steel buildings as high as 10 stories with badly cracked welds and supporting steel columns. Although they did not collapse, they were seriously weakened.

Two types of cracks

Moment resisting frame

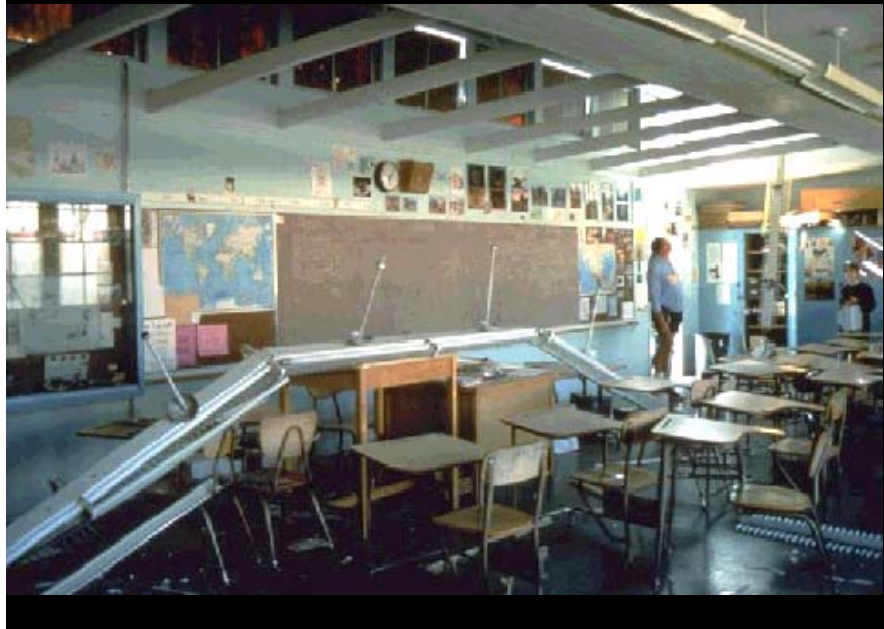
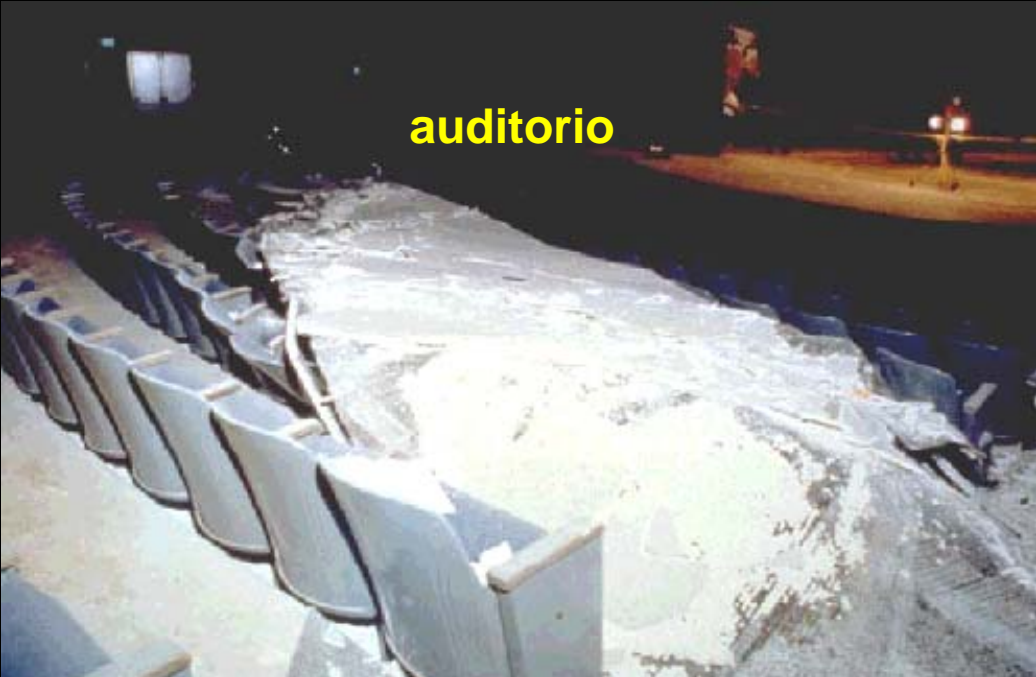
**Daños no
estructurales**

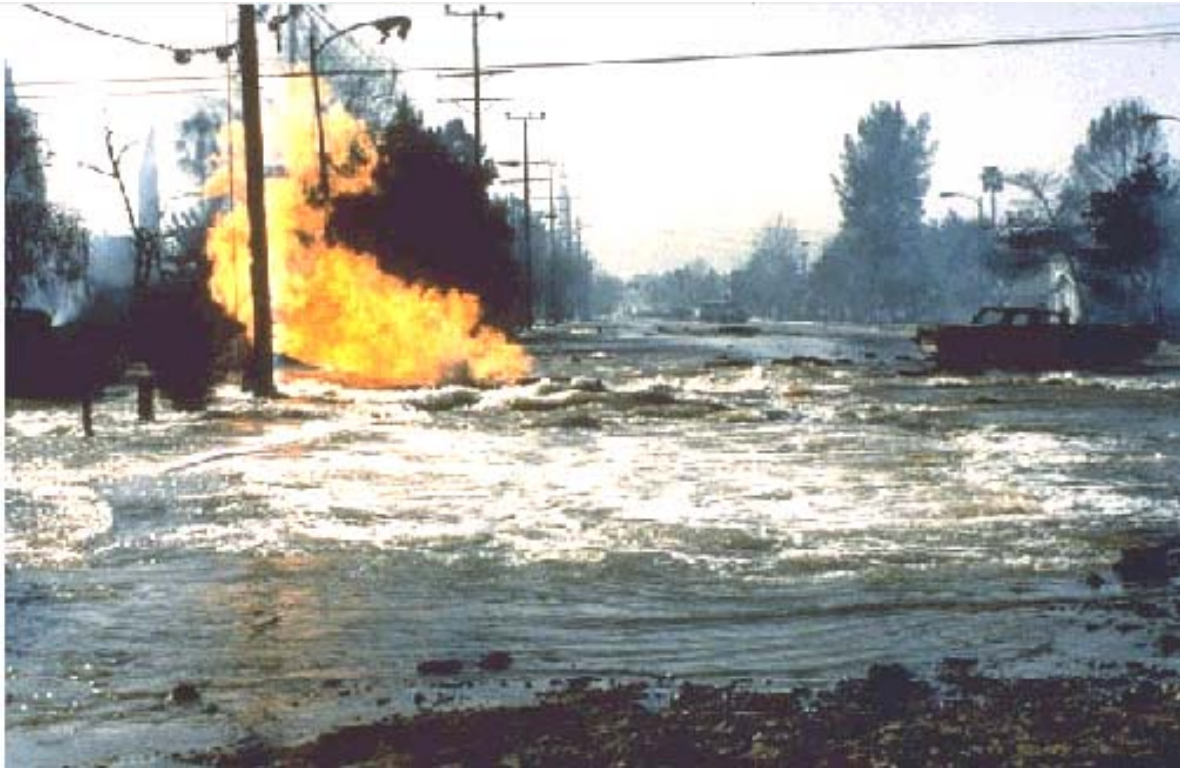
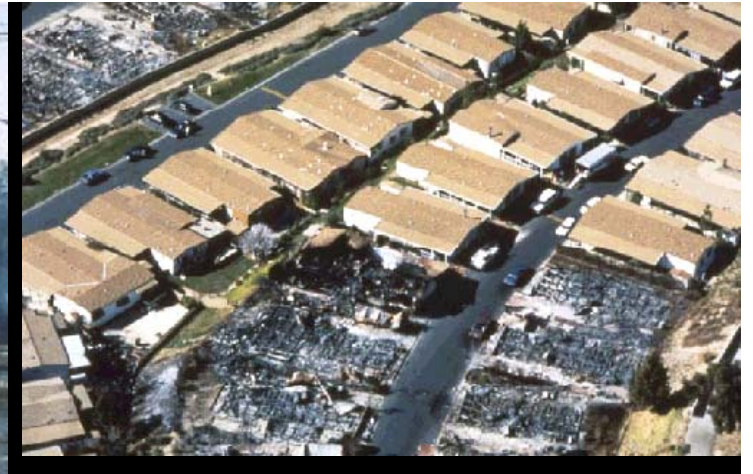
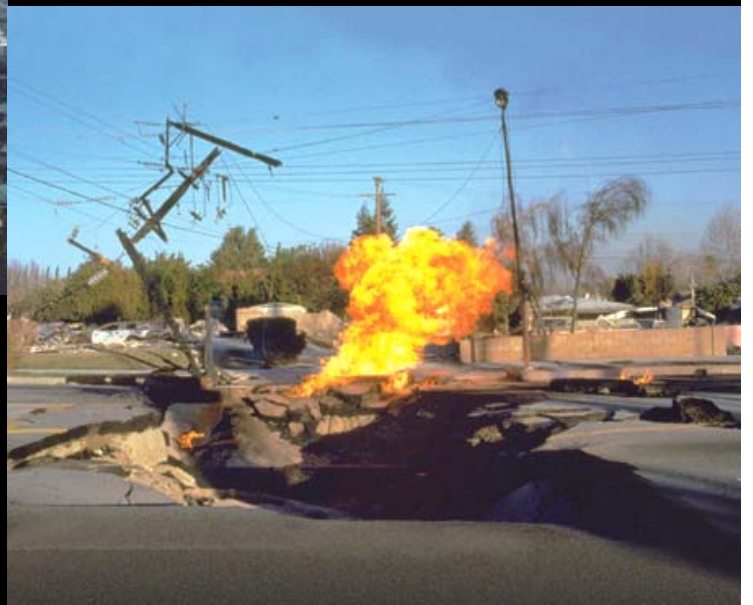
Incendios

Broken gas and water mains on Balboa Boulevard in Granada Hills created this scene of flood and fire (slide 68). The fire burned five homes, as shown in the aerial view of slide 69. In the Sylmar area, about 100 trailers burned in three mobile home parks (slide 70). These fires were attributed to breaks in gas lines, and the multiple firegrounds shown indicate more than one ignition.
